JANUARY 2003

FLIGHT SAFETY

Most Fatal U.S. Commercial Helicopter Accidents Occur in Instrument Meteorological Conditions

A study of 147 accidents from 1991 through 2000 involving helicopter operations conducted under U.S. Federal Aviation Regulations Part 135 found that 58 percent of the fatal accidents occurred in instrument meteorological conditions. Human error was the primary causal factor in 66 percent of the accidents. Many human-error accidents occurred during the en route phase of flight and involved inadequate in-flight planning and decision making or inadequate evaluation of weather information.

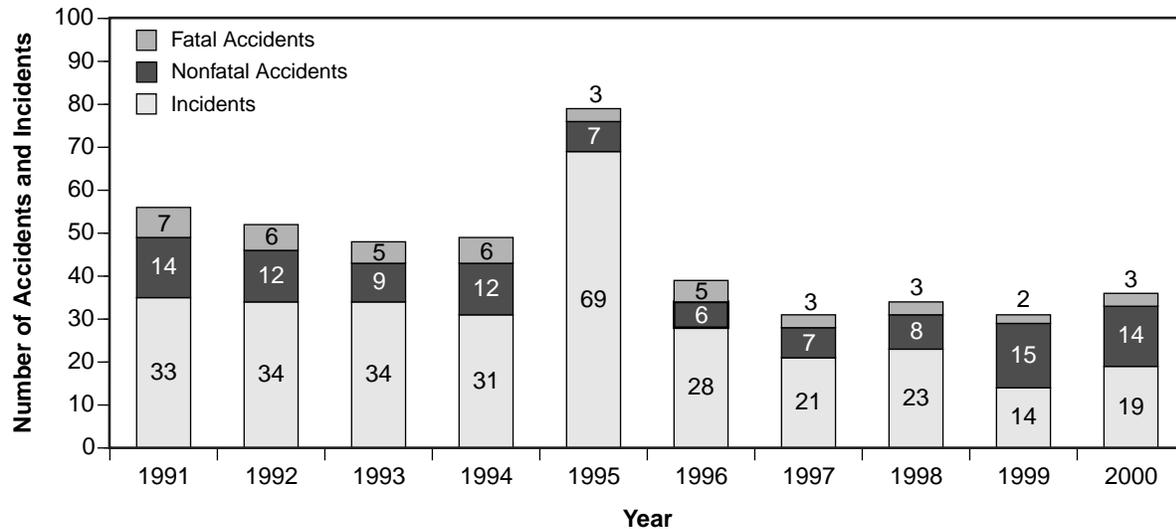
Figure 1

U.S. Federal Aviation Regulations Part 135 Helicopter Accidents and Incidents, 1991–2000

From January 1991 through December 2000, there were 147 accidents and 306 incidents involving helicopters operated under U.S. Federal Aviation Regulations (FARs) Part 135 (Figure 1, page 2). The accidents included 43 fatal accidents (29 percent of the total).

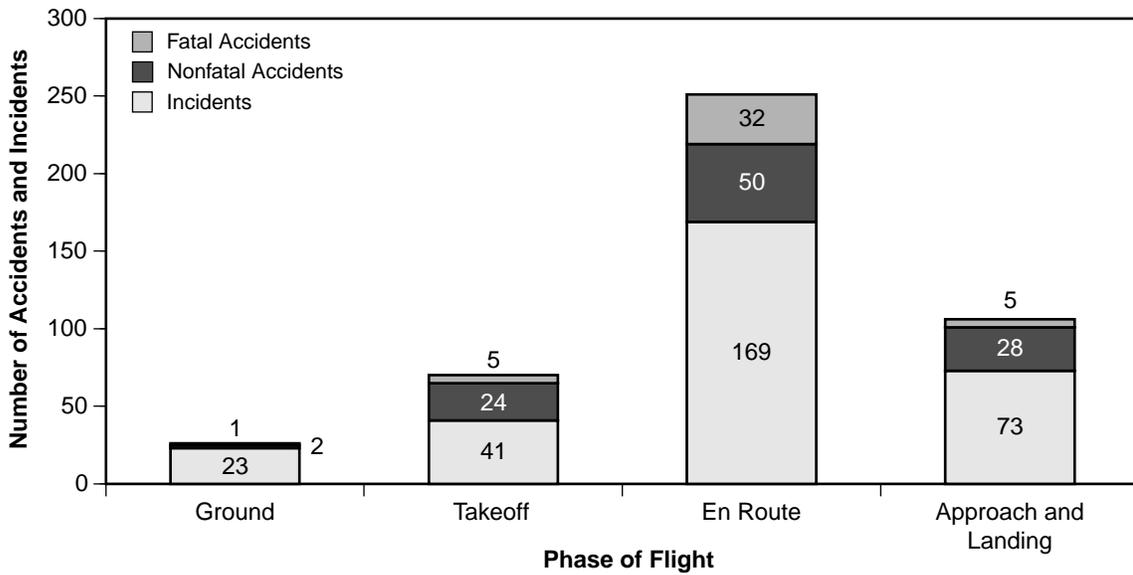
Figure 2

Phase of Flight for U.S. Federal Aviation Regulations Part 135 Helicopter Accidents and Incidents, 1991–2000

- Forty-two of the 147 accidents (29 percent), including 25 (58 percent) of the 43 fatal accidents, occurred during instrument meteorological conditions (IMC). Fifteen (36 percent) of these accidents involved controlled flight into terrain (CFIT).² Thirteen accidents (31 percent) involved loss of control and/or spatial disorientation;
- Eighty-two (56 percent) of the accidents, including 32 (74 percent) of the fatal accidents, and 169 (55 percent) of the 306 incidents occurred during the en route (cruise) phase of flight (Figure 2, page 3). Of the en route accidents, 43 (52 percent) resulted from human error

Eighty-two (56 percent) of the 147 accidents occurred during en route flight (Figure 2). Thirty-two (39 percent) of the en route accidents involved fatalities; 22 (69 percent) of the fatal

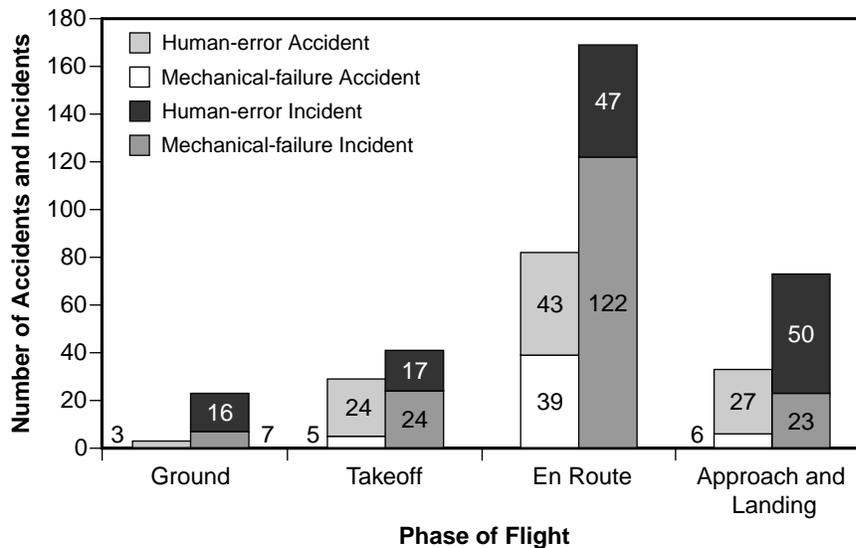
Figure 3

Involvement of Human Error and Mechanical Failure by Phase of Flight in U.S. Federal Aviation Regulations Part 135 Helicopter Accidents and Incidents, 1991–2000

(Figure 3, page 3). Thirty-two (39 percent) en route accidents occurred in low-visibility conditions; 22 (69 percent) of these accidents were fatal;

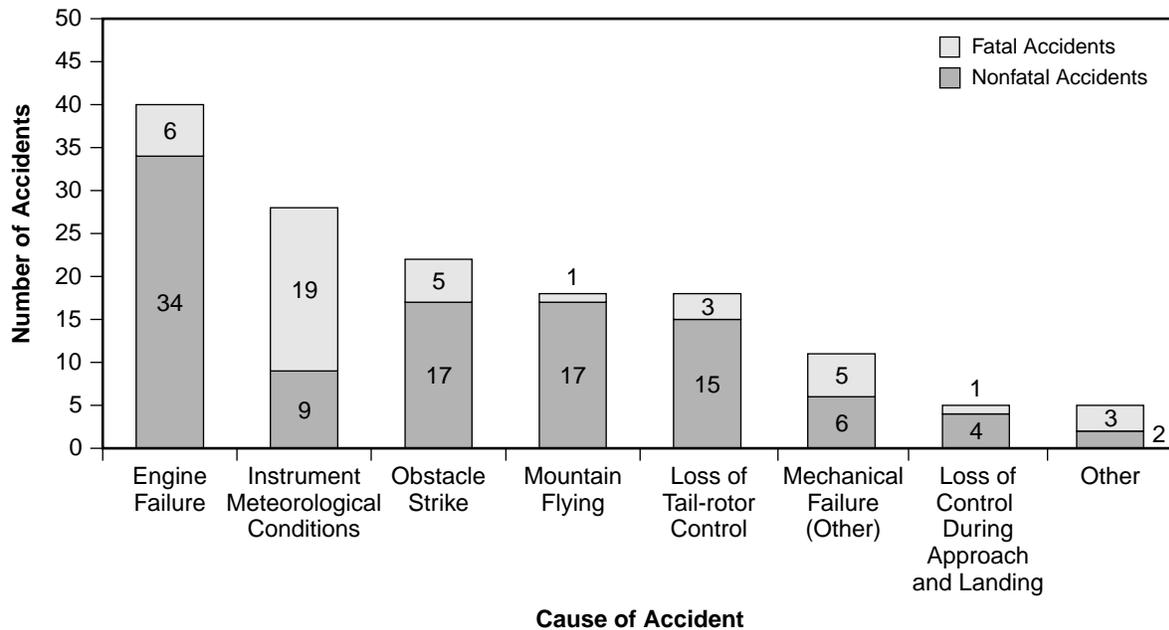
Primary Causes of U.S. Federal Aviation Regulations Part 135 Helicopter Accidents, 1991–2000

Figure 4 (page 4) shows the primary causes of the accidents. Forty accidents (27 percent), including six fatal accidents,

involved engine failure. Twenty-eight accidents (19 percent), of which 19 were fatal, involved CFIT or loss of control in IMC. Twenty-two accidents (15 percent), including five fatal accidents, involved obstacle strikes. Eighteen accidents (12 percent), including one fatal accident, involved aspects unique to mountain flying.

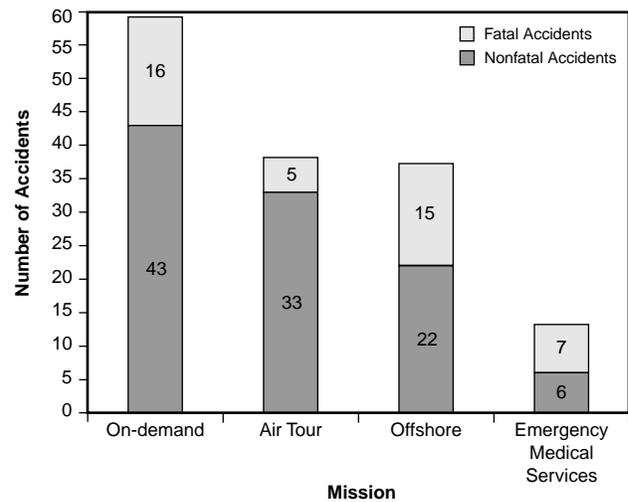
U.S. Federal Aviation Regulations Part 135 Helicopter Accidents by Mission, 1991–2000

Figure 5 shows the distribution of accidents by mission, including general on-demand operations, air-tour operations, offshore operations and EMS operations.

In general on-demand operations, there were 59 accidents, of which 16 were fatal. Fourteen of the 59 accidents occurred in IMC.

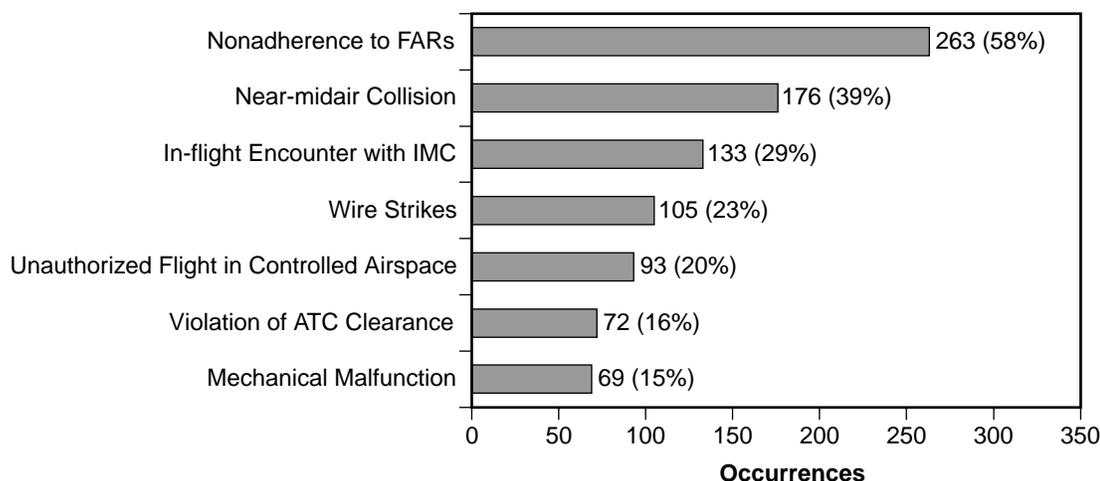
Subjects of 457 NASA ASRS Reports Involving U.S. Federal Aviation Regulations (FARs) Part 135 Helicopters, 1991–2000

Note: Many reports involved more than one subject.

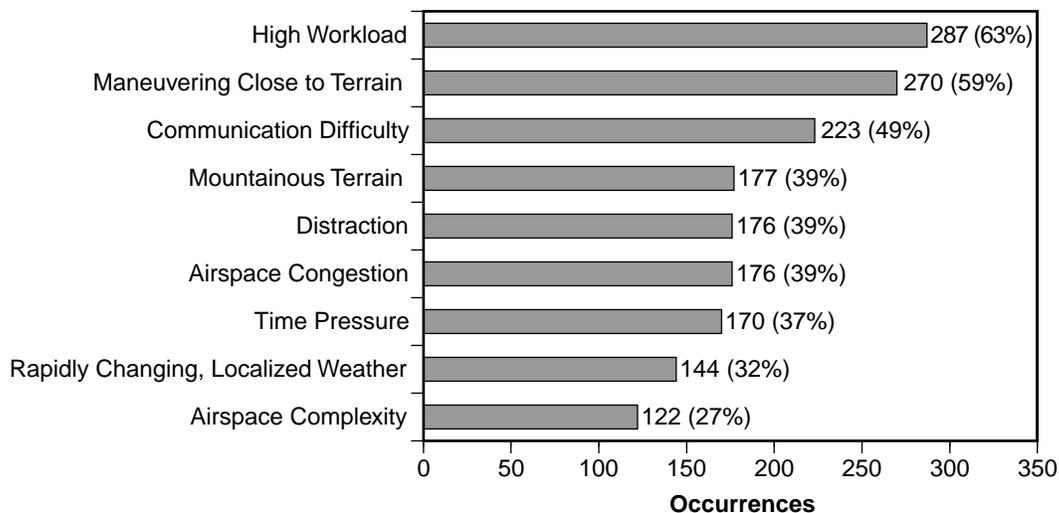
Contributing Factors to Human Error Cited in NASA ASRS Reports Involving U.S. Federal Aviation Regulations Part 135 Helicopters, 1991–2000

Note: Many reports involved more than one subject.

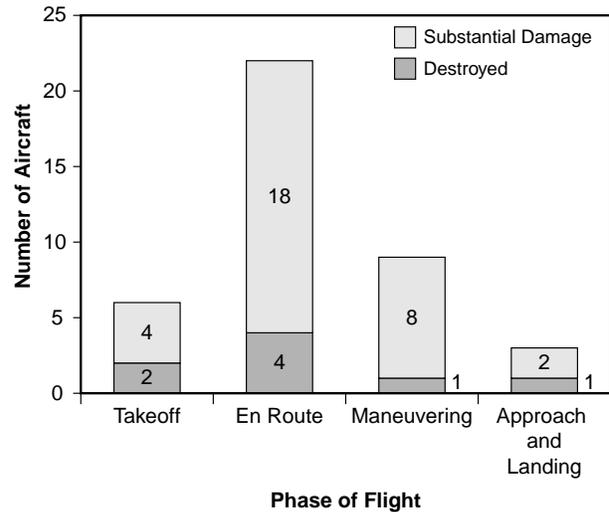
Figure 8

Aircraft Damage and Phase of Flight for U.S. Federal Aviation Regulations Part 135 Helicopter Engine-failure Accidents and Incidents, 1991–2000

Of the 40 engine-failure accidents, 22 engine failures (55 percent) occurred during en route flight (Figure 8). Two of the accidents were fatal; one accident involved serious injuries; 19 accidents resulted in minor injuries or no injuries.

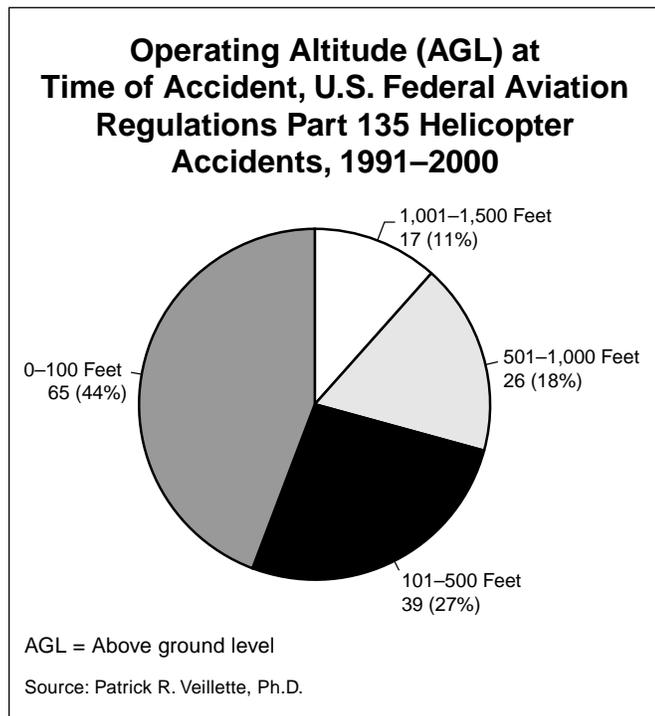
Figure 9 shows the altitudes above ground level at which the helicopters were being operated when the accidents occurred. Of the 147 total accidents, 65 accidents (44 percent) occurred at or below 100 feet AGL; 104 accidents (71 percent) occurred at or below 500 feet AGL; and 130 accidents (88 percent) occurred at or below 1,000 feet AGL.

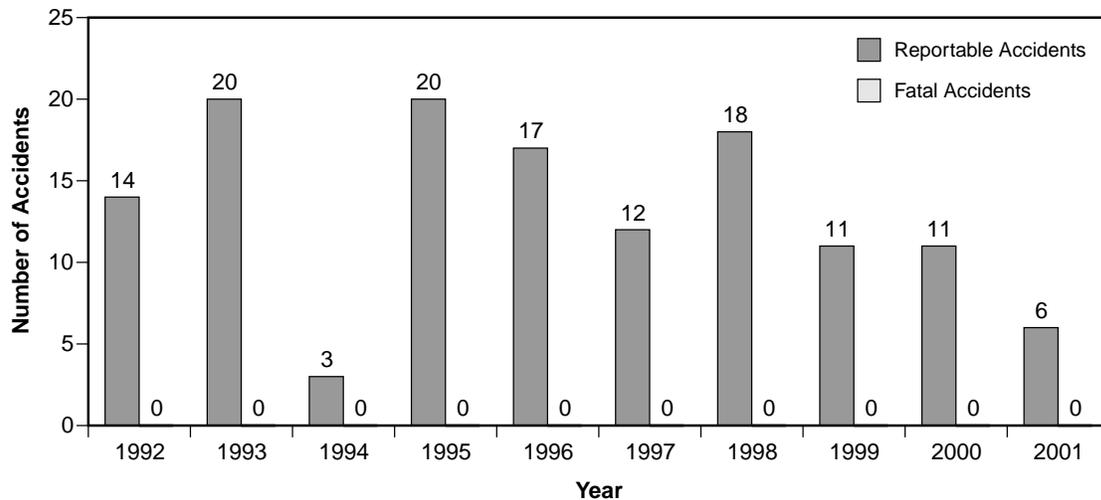
Figure 1

Fatal and Reportable Accidents, U.K. Airline (Passenger) Operations, 1992–2001¹

¹Data are for United Kingdom (U.K.)-registered or U.K.-operated airplanes having maximum takeoff weight authorized greater than 5,700 kilograms (12,500 pounds).

Among passenger flights, there were 133 reportable accidents during the period.² The annual numbers of accidents ranged from three in 1994 to 20 in 1993 and in 1995 (Figure 1, page 58). The overall trend in reportable accidents for passenger flights improved during the period — from a three-year moving average of 8.5 accidents per million revenue hours flown in 1992–1994 to 4.0 in 1999–2001.

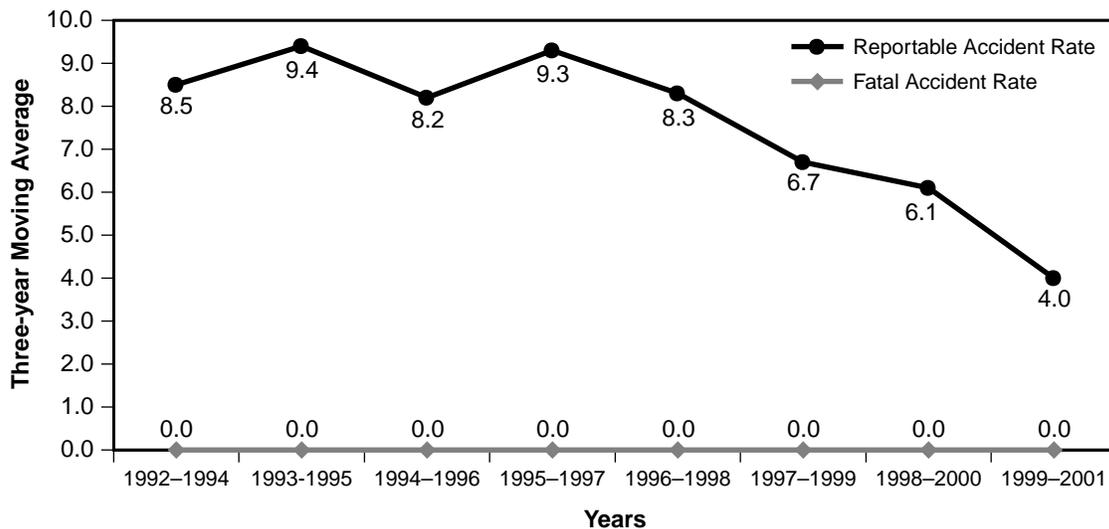
Figure 2

Fatal and Reportable Accidents per Million Revenue Hours Flown, U.K. Airline (Passenger) Operations, 1992–2001¹

¹Data are for United Kingdom (U.K.)-registered or U.K.-operated airplanes having maximum takeoff weight authorized greater than 5,700 kilograms (12,500 pounds).

The highest three-year moving average of reportable accidents per million revenue hours flown was 9.4 in the 1993–1995 period (Figure 2, page 58). Revenue flight hours in passenger operations increased 71 percent during the period.

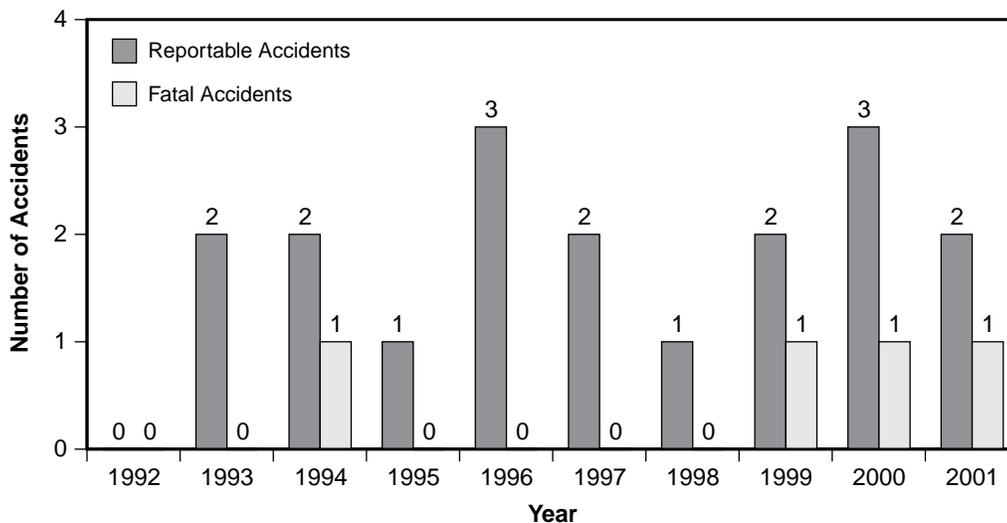
Figure 3

Fatal and Reportable Accidents, U.K. Airline (Cargo) Operations, 1992–2001¹

¹Data are for United Kingdom (U.K.)-registered or U.K.-operated airplanes having maximum takeoff weight authorized greater than 5,700 kilograms (12,500 pounds).

There were four fatal accidents in airline cargo operations involving U.K.-registered or U.K.-operated airplanes with MTWA greater than 5,700 kilograms during 0.3 million flights and 0.4 million revenue flight hours (excluding U.K. third-party fatal accidents) during the 1992–2001 period (Figure 3, page 59). The average annual fatal-accident rate was 10.35 per million revenue hours flown. The fatal-accident rate increased in the more recent years, partly because of a decrease in utilization in 2000 and 2001 and partly because of fatal accidents in each of the last three years of the period, CAA said.

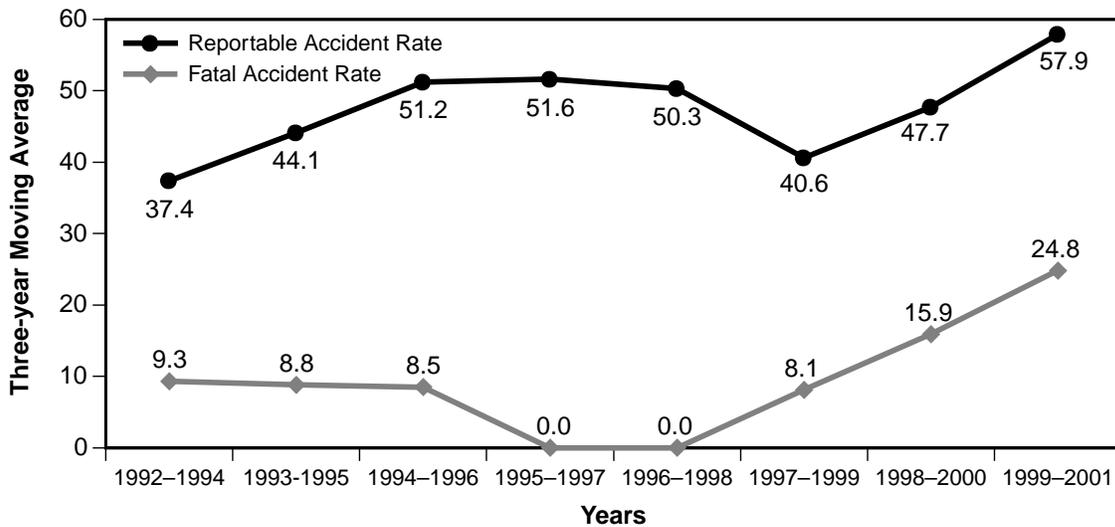
Figure 4

Fatal and Reportable Accidents per Million Revenue Hours Flown, U.K. Airline (Cargo) Operations, 1992–2001¹

¹Data are for United Kingdom (U.K.)-registered or U.K.-operated airplanes having maximum takeoff weight authorized greater than 5,700 kilograms (12,500 pounds).
