FLIGHT SAFETY FOUNDATION

JULY 2001

An Analysis of the Safety Performance of Air Cargo Operators

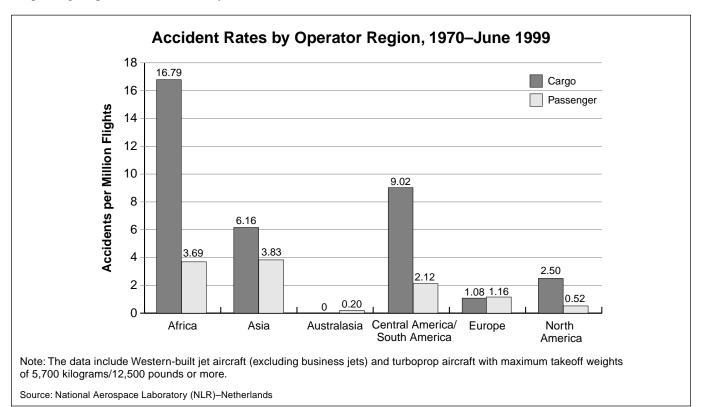
Figure 5 (page 8) shows that the highest accident rates in cargo operations involved aircraft registered in Africa, Asia and Central America/South America. The variation in the accident rates among the regions generally is much greater for cargo operations than for passenger operations. Also noteworthy is that Europe's cargo-operations accident rate is relatively low and does not differ significantly from the accident rate for passenger operations.

Figure 5 and Figure 6 indicate that the regions with the lowest economic performance have the highest accident rates.
