Research Identifies Common Errors Behind Altitude Deviations

Nearly 500 pilots and 48 air traffic controllers provided data in a recent study designed to analyze an alarming increase in altitude deviations.

—
by
John A. Pope
Aviation Consultant

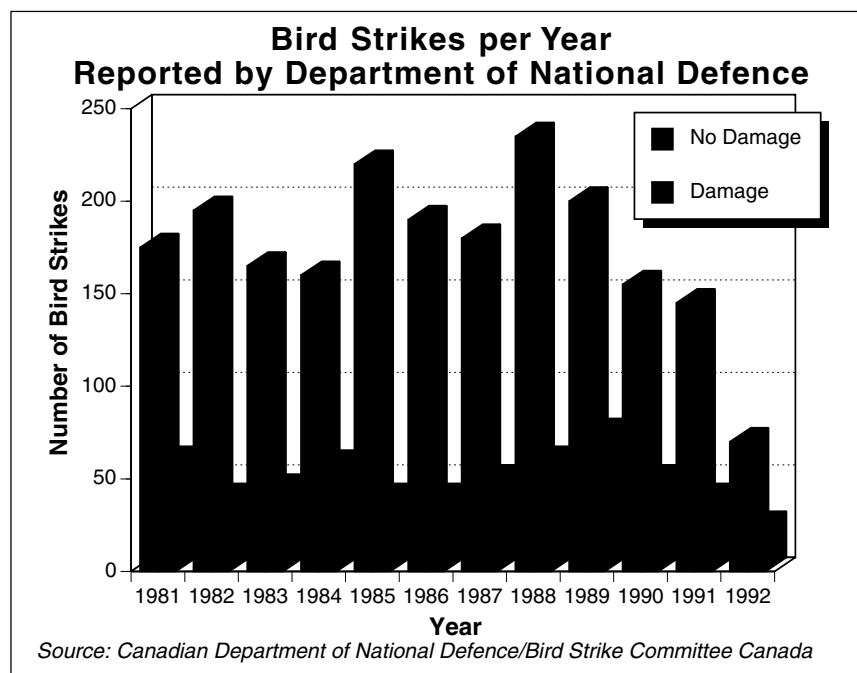
Figure 1

A summary of the DND's 1991 data indicated that the overall number of bird strikes continued to decrease; a total of 186 were recorded in 1991, of which 20 percent resulted in some kind of damage to aircraft engines (Figure 1).

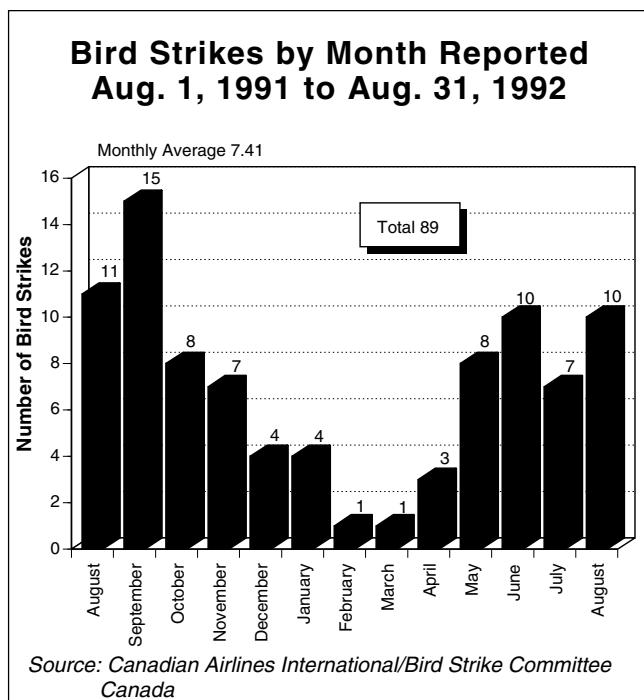
Figure 4

Boeing 737s encountered 80 percent of the reported strikes, followed by the B-767 with 10 percent and the A320 with 6 percent. The most strikes occurred in September, followed by August and June (Figure 4).
