FLIGHT SAFETY FOUNDATION

MARCH 2001

## Understanding Airplane Turbofan Engine Operation Helps Flight Crews Respond to Malfunctions

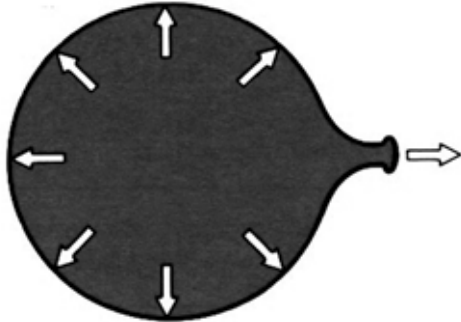
**Figure 2**

The simplest example of the propulsion principle is an inflated balloon (container) where the stem is not closed (Figure 2, page 2). The pressure of the air inside the balloon exerts forces

everywhere inside the balloon. For every force, there is an opposite force on the other side of the balloon, except on the surface of the balloon opposite the stem. This surface has no opposing force because air is escaping out the stem. This results in a net force that propels the balloon away from the stem. The balloon is propelled by the air pushing on the front of the balloon.

**Unbalanced Force Opposite Released Stem Propels Balloon**

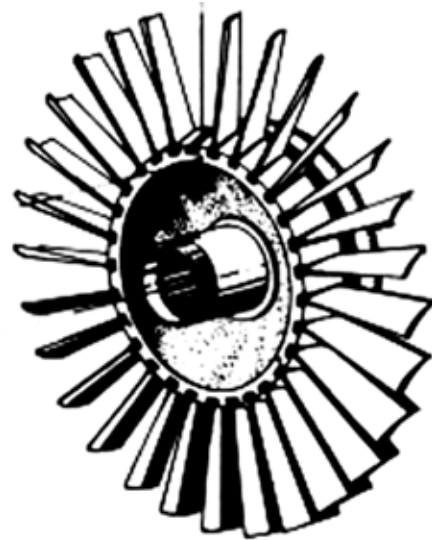
**Figure 6**

The compression is accomplished by a rotating disk containing many airfoils, called blades, set at an angle to the disk rim (Figure 6). Each blade resembles a miniature propeller blade, and the angle at which it is set on the disk rim is called the angle-of-attack. This angle-of-attack is similar to the pitch of a propeller blade or an airplane wing in flight. As the disk is forced by the turbine to rotate, each blade accelerates the air, thus pumping the air behind it. The effect is similar to a household window fan.

### Compressor Rotor Disk

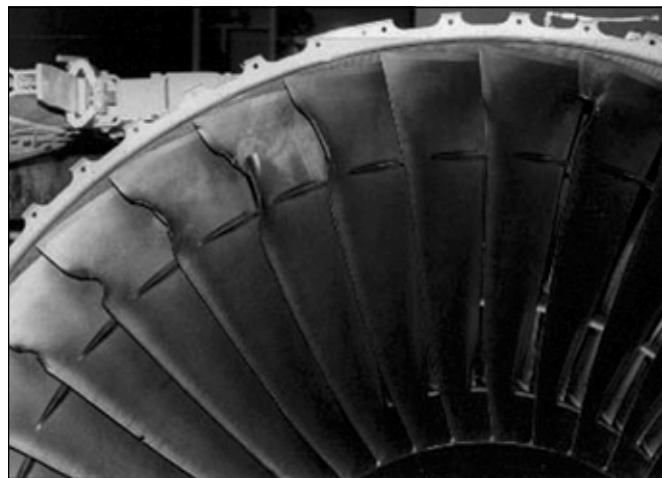
Bird strikes can damage an engine; the photo on this page shows fan blades bent by the ingestion of a bird. The engine continued to produce thrust with this level of damage. FOD from other sources, such as tire fragments, runway debris or animals, also may occur, with similar results.

*Fan blades bent by ingestion of a bird.* Photo: U.S. Federal Aviation Administration

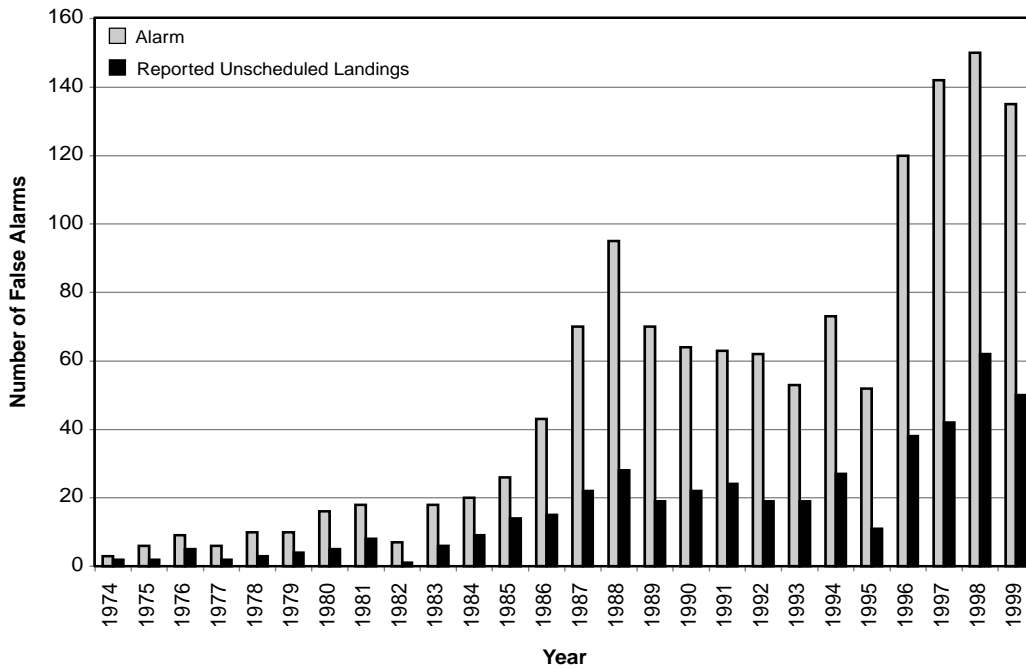
### Unscheduled Landings Resulting From False Cargo-compartment Fire Alarms in U.S.-registered Aircraft, 1974–1999

Figure 2 (page 24) shows the number of reported unscheduled landings that resulted from the false cargo-compartment fire alarms. Not every false alarm results in an unscheduled landing, partly because some alarms occur while the aircraft is on the

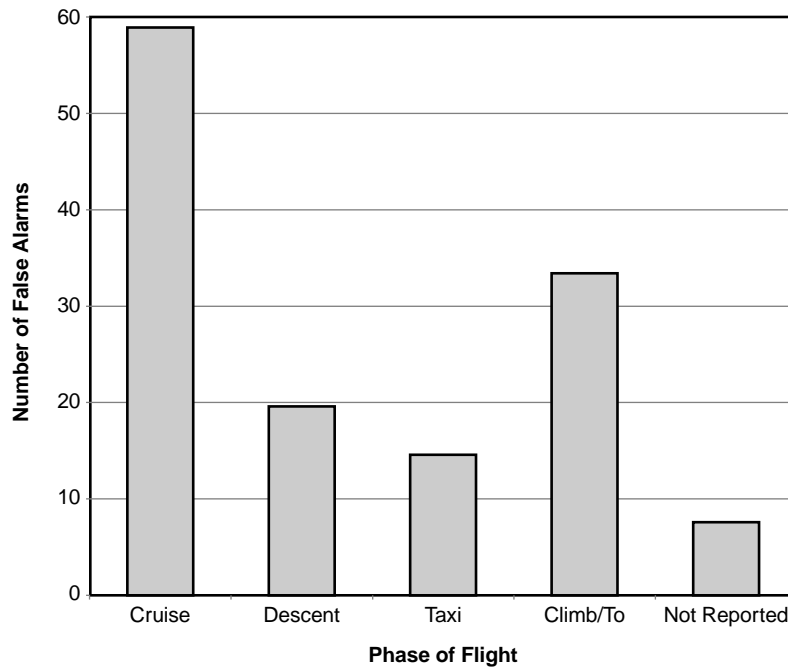
### False Fire Alarms in Cargo-compartments of U.S.-registered Aircraft Per Phase of Flight, 1974–1999

Figure 7 (page 26) shows the number of false alarms that occurred during each phase of flight. Most false alarms occurred during cruise, the phase in which the majority of flight time occurs. Nevertheless, the number of false alarms that occurred during takeoff/climb and descent was nearly as high as the number that occurred during cruise.

“This result would not normally be expected,” the technical note said. “One possible reason ... could be the increased vibrations during the high engine power settings used for takeoff and initial climb. Another possible factor is that the temperature-and-pressure environment within cargo compartments changes most rapidly when the airplane is changing altitude during climb and descent. Because the reasons for the false alarms in the vast majority of cases are never determined, the above possibilities are only speculation.”♦
