Volcanic Hazards and Aviation Safety: Lessons of the Past Decade

—
*Thomas J. Casadevall
Project Chief, Volcanic Hazards and Aviation Safety
U.S. Geological Survey*

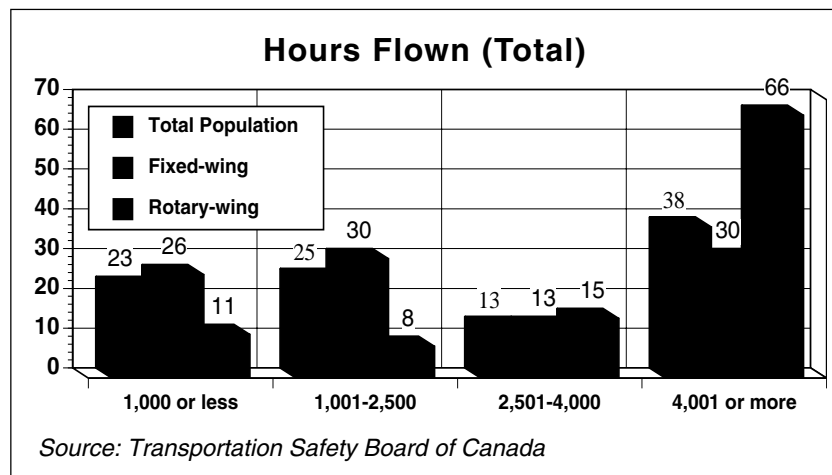
Figure 2

bers than low-time rotary-wing pilots. At the upper end of the scale, high-time rotary-wing pilots were proportionately more numerous than their fixed-wing aircraft colleagues (Figure 2).

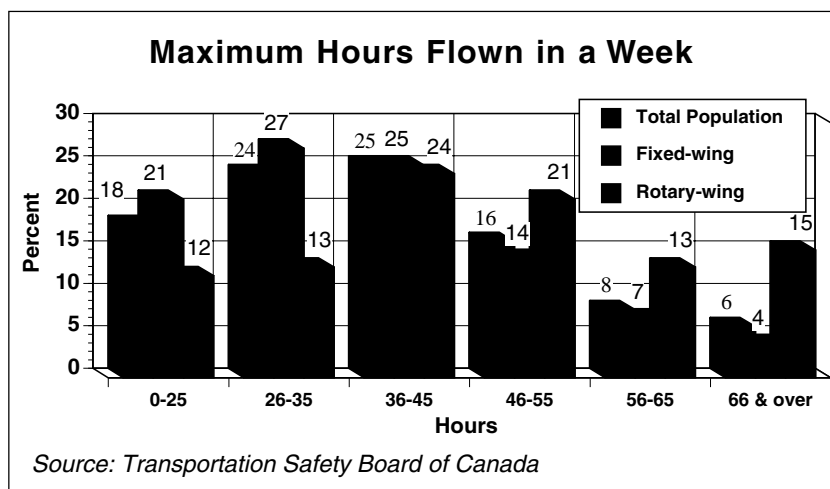
Figure 3

On average, 50 percent of the pilots reported flying between zero to four hours daily, 37 percent five to seven hours and 8 percent eight to 10 hours (Figure 3). The mean was 4.8 hours. The mean of the average flying hours per week was 19.3. In a year, rotary-wing pilots reportedly flew less than their fixed-wing counterparts; only 14 percent flew more than 600 hours, while 29 percent of their fixed-wing colleagues flew more than 600 hours. The yearly mean for the group was 461.6 hours. Concerning days off and duty days, 45 percent of the respondents flew more than six consecutive days and 28 percent flew more than 12 consecutive days often or very often.
