The Case for Better Microburst Detection

Improvements upon the present low-level windshear advisory system (LLWAS) are suggested by the author.

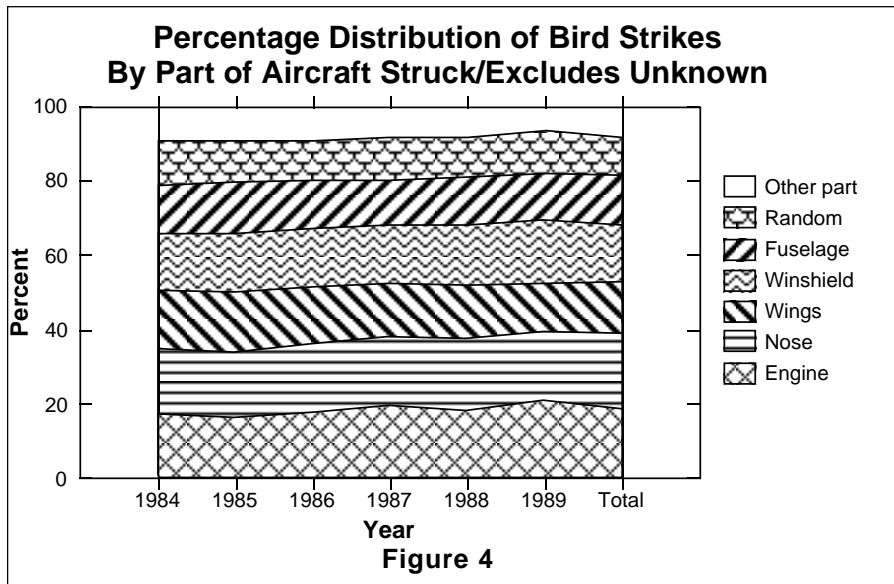
Figure 4 shows the damage to aircraft by location of the strikes. The aircraft engine appears to be struck slightly more often than other parts of the aircraft. In terms of annual distribution, the chance of aircraft engine, nose, wings, windshield,

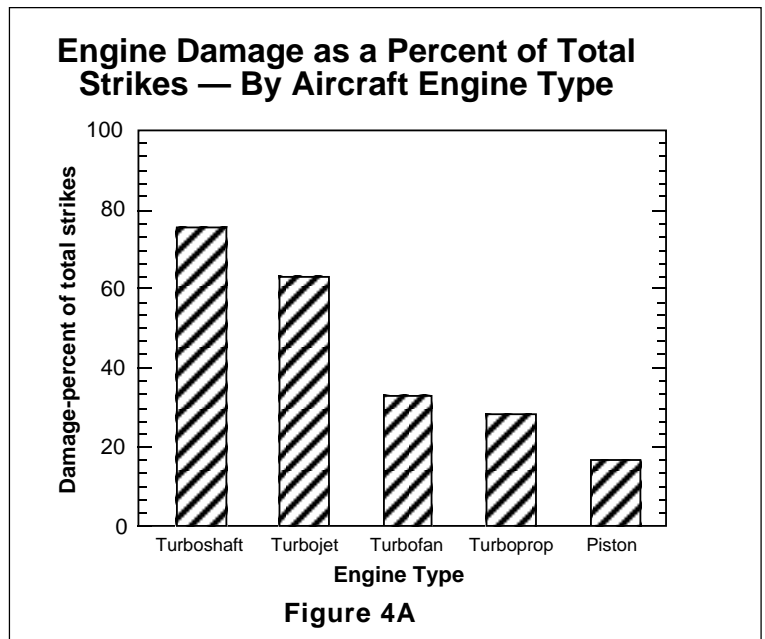
fuselage and random locations to be struck has been very constant. Of the type of engine to be struck, the damage ratio for turbine engines was much higher than for reciprocating engines (Figure 4A). Of all types of turbine engines, the damage ratio for turboshaft engines was the highest.

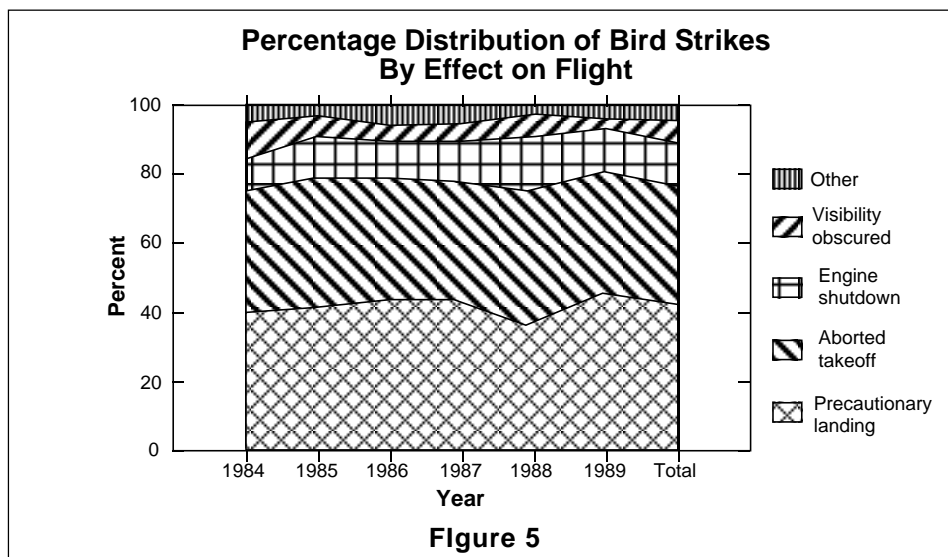
of bird strikes that were the cause/factor of aircraft accidents. ICAO information shows that of the total strikes, more than 24,000, or almost 89 percent, had no effect on flight. Of the 1,500 bird strikes which had an effect on flight, (11 percent of the totals), 684 strikes or 45 percent, caused a precautionary landing, 35 percent resulted in an aborted takeoff, while 11 percent caused engine shutdown (Figure 5). ♦
