FLIGHT SAFETY FOUNDATION

OCTOBER 2001

Survivability of Accidents Involving U.S. Air Carrier Operations, 1983–2000

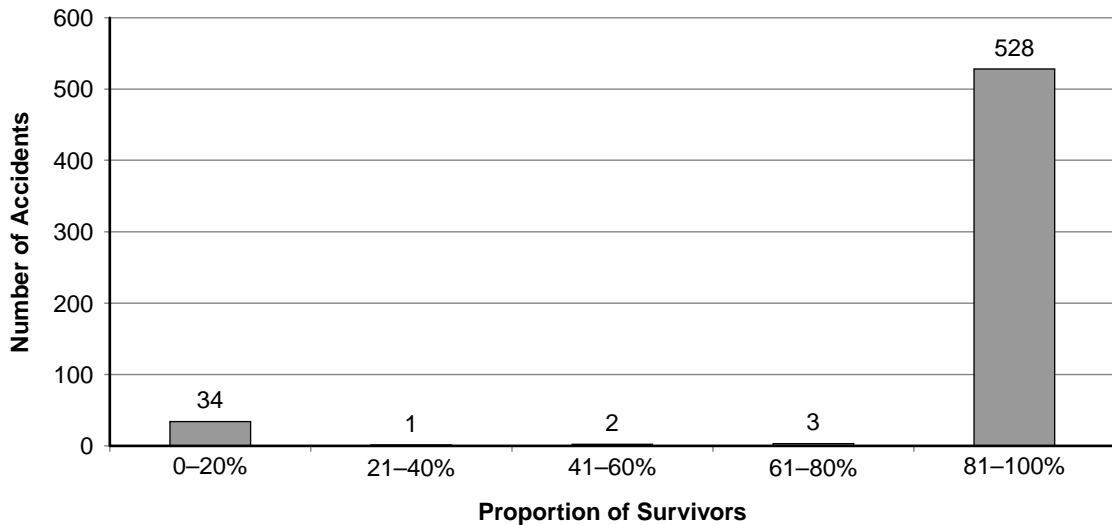
Figure 3

Percentage of Survivors in Accidents Involving U.S. Federal Aviation Regulations Part 121 Air Carriers, 1983–2000

Because a public perception is that aviation accidents are not survivable, NTSB also examined the proportion of occupants who survived in each accident for the period 1983 through 2000. Contrary to public perception, the most likely outcome of an accident is that most people survive. In 528 of the 568 accidents (93.0 percent), more than 80 percent of the occupants survived (Figure 3, page 5). Accidents that result in complete

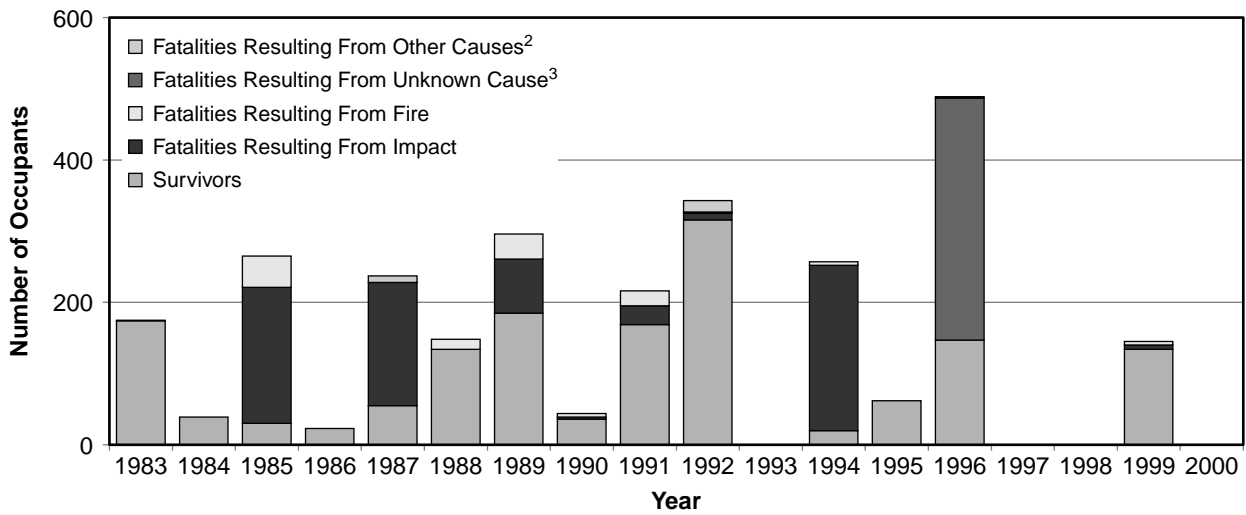
Causes of Fatalities Among Occupants of U.S. Federal Aviation Regulations Part 121 Passenger Flights Involved in Serious Accidents,¹ 1983–2000

¹A serious accident is defined as one involving a fire, at least one serious injury or fatality and either substantial aircraft damage or aircraft destruction.

²Fatalities in the “other” category were reported by a pathologist or coroner to have been caused by drowning, mechanical asphyxia or trauma as a result of intrusion by engine parts or propeller parts.

From 1983 through 2000, NTSB investigated 26 accidents involving fire, serious injury and either substantial aircraft damage or aircraft destruction (Table 3). There were 2,739 occupants involved in these serious accidents; 1,524 (55.6 percent) of the occupants survived the accident, 716 (26.1 percent) of the occupants died from impact, 340 (12.4 percent) died from unknown causes,¹² 131 (4.8 percent) died from fire/smoke, and 28 (1.0 percent) died from other causes.¹³ The lowest survivability rates occurred in 1985, when 11.3 percent

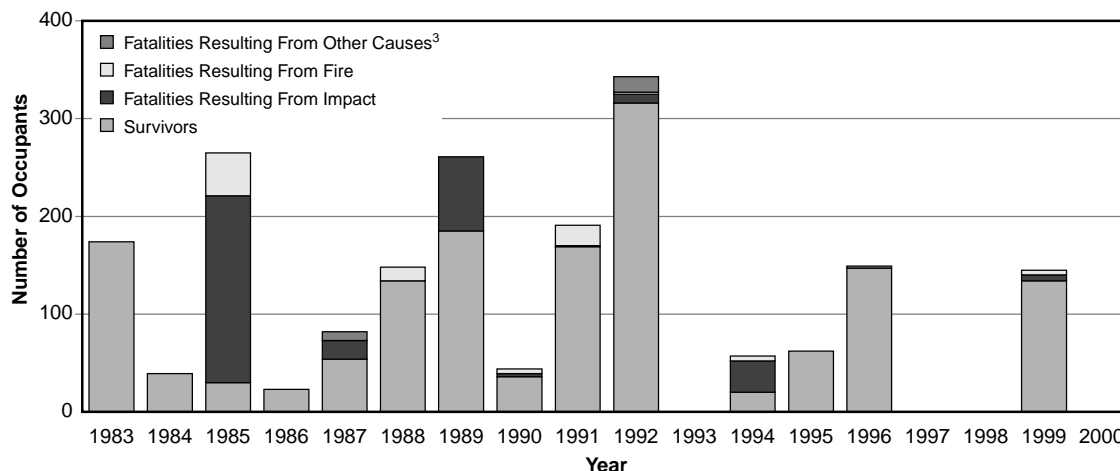
Causes of Fatalities Among Occupants of U.S. Federal Aviation Regulations Part 121 Passenger Flights Involved in Serious¹ but Survivable² Accidents, 1983–2000

¹A serious accident is defined as one involving a fire, at least one serious injury or fatality and either substantial aircraft damage or aircraft destruction.

²A survivable accident is defined as one in which the forces transmitted to occupants through their seat and restraint system do not exceed the limits of human tolerance to abrupt acceleration and in which the structure in the occupants' immediate environment remains substantially intact to the extent that a livable volume is provided for the occupants throughout the accident.

Nineteen of the 26 serious accidents involving Part 121 air carriers were at least partially survivable, as indicated in accident reports; 1,523 (76.6 percent) of the 1,988 occupants in these accidents survived, 306 (15.4 percent) of the occupants died from impact, 131 (6.6 percent) died from fire, and 28 (1.4 percent) died from other causes (Table 5, page 10). In the survivable serious accidents, more than twice as many occupants died as a result of impact forces than as a result of fire. Figure 6 (page 11) shows the cause-of-death data by year for the survivable serious accidents.
