# Flight Safety

OCTOBER 2004

# Global Implementation of RVSM Nears Completion

**Reduced vertical separation minimum (RVSM) for aircraft being flown at 29,000 feet through 41,000 feet has been applied in many regions; North America, South America and the Caribbean will follow in January 2005. Experience has shown that increased traffic congestion below RVSM airspace and wake-turbulence encounters in RVSM airspace have not been significant problems.**

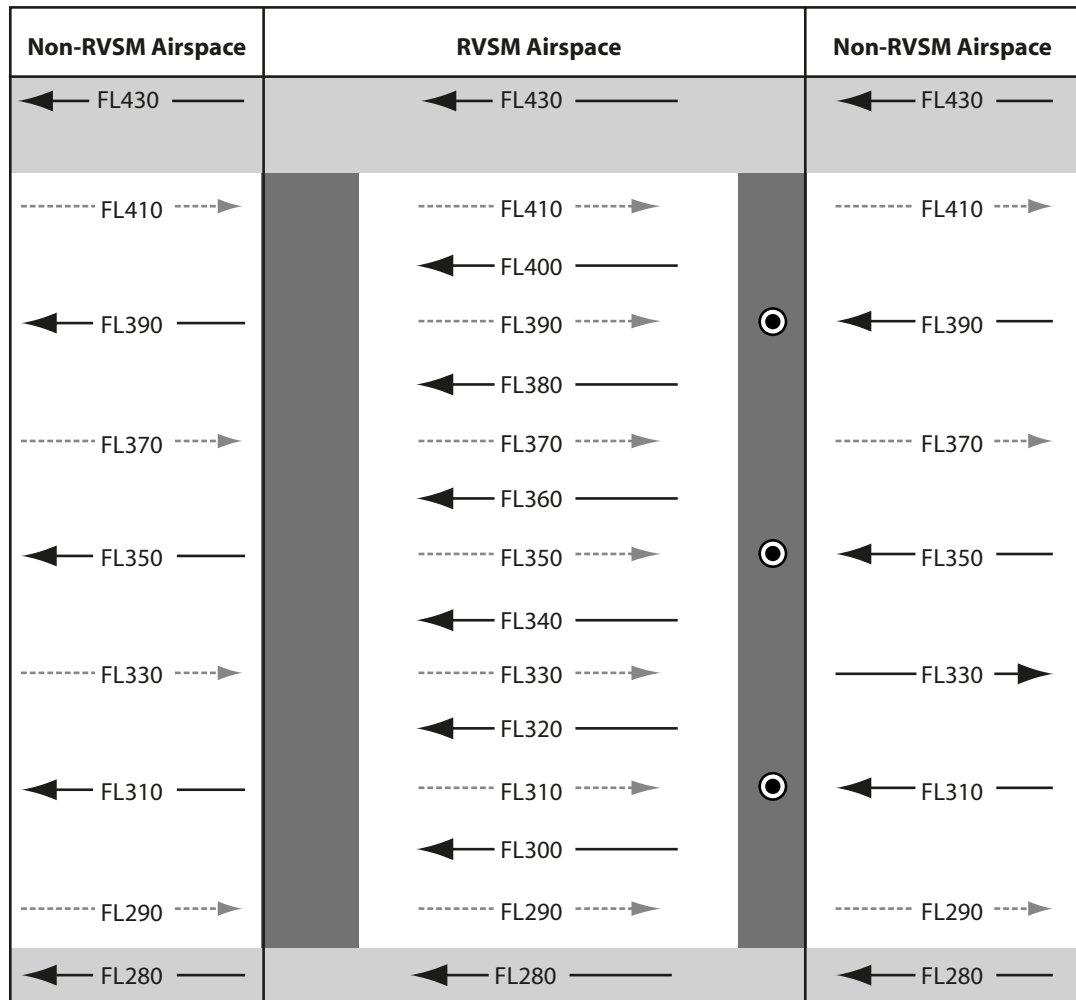
**Figure 2**  
**Reduced Vertical Separation Minimum (RVSM)/Non-RVSM Transition Areas**

⊙ Cruise direction conflict will be resolved during transition.

To safely accommodate the flow of traffic between regions using RVSM airspace and regions continuing to apply 2,000-foot/600 meter VSM, transition areas in the adjoining airspace and transition-coordination procedures in the transition areas have been established (Figure 2; Figure 3, page 9).

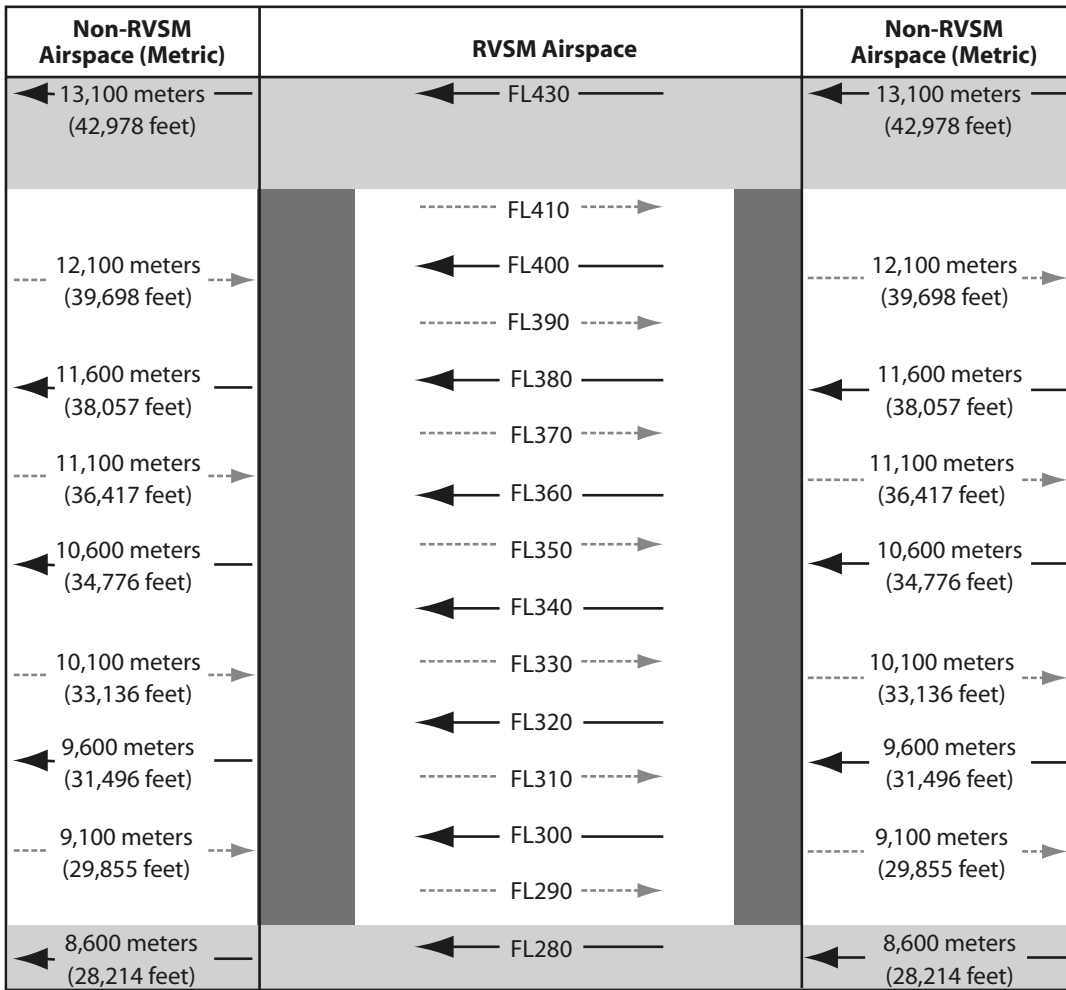
**Figure 3**  
**Reduced Vertical Separation Minimum (RVSM)/Non-RVSM (Metric) Transition Areas**

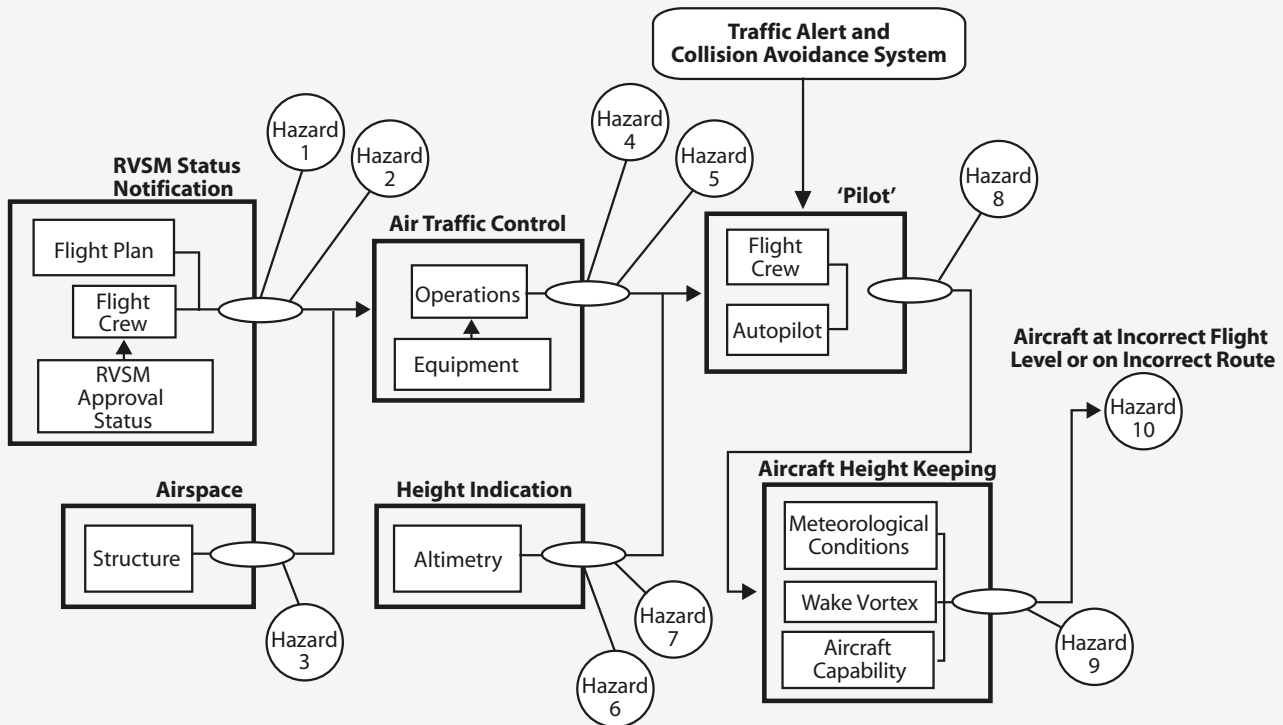
**Figure 4**  
**Reduced Vertical Separation Minimum (RVSM) Hazards Identified by Eurocontrol**

- Hazard 1:** Flight plans indicating RVSM approval for aircraft not approved for operation in RVSM.
- Hazard 2:** Inability of flight crews to tell air traffic control (ATC) about loss of RVSM capability.
- Hazard 3:** Incorrect airspace structure.
- Hazard 4:** ATC assignment of inappropriate flight levels to flight crews.
- Hazard 5:** Non-receipt by flight crews of ATC clearances/instructions.
- Hazard 6:** Undetectable altimetry-system errors.
- Hazard 7:** Loss of altimetry information or detectable errors in altimetry information.
- Hazard 8:** Flight crew deviations from assigned flight levels.
- Hazard 9:** Inability of flight crews to maintain assigned flight levels.
- Hazard 10:** Aircraft entering RVSM airspace from non-RVSM airspace at incorrect flight levels or on incorrect routes.

Figure 4 (page 12) shows the higher-level hazards identified after RVSM implementation. They include the following:

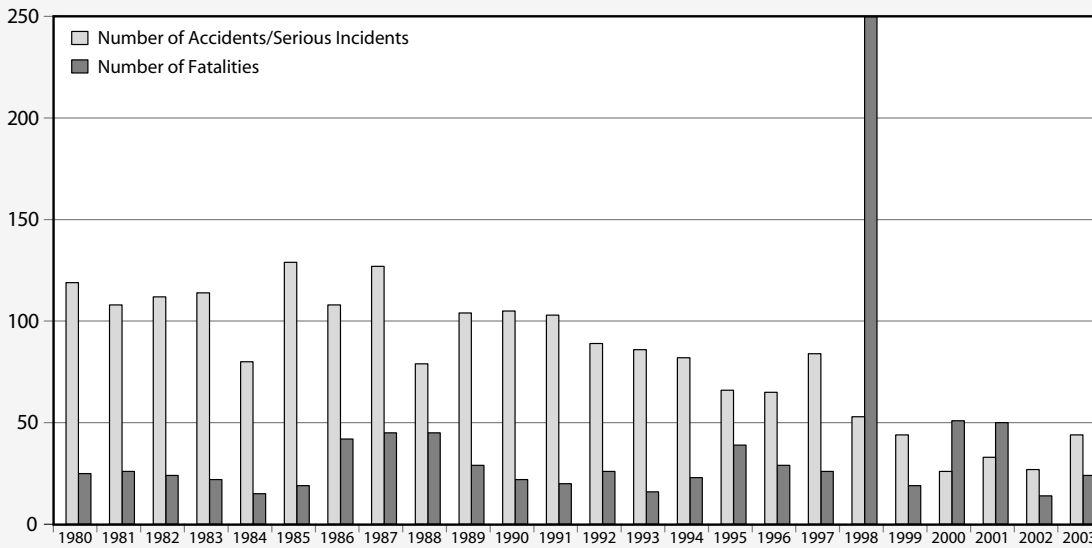
**Figure 1**  
**Accidents/Serious Incidents and Fatalities Involving Swiss-registered Aircraft, 1980–2003**

The annual numbers of accidents/serious incidents involving all Swiss-registered aircraft have declined from 1980 through 2003 (Figure 1, page 24), although the numbers of fatalities have varied with no discernible trend. The sharp increase in fatalities for 1998 reflects the fatal accident involving Swissair Flight 111 on Sept. 2, 1998, near Peggy’s Cove, Nova Scotia, Canada. [The airplane was destroyed and its 229 occupants were killed after a fire began above the cockpit ceiling and spread rapidly, leading to loss of control, and the airplane struck water.]
