Manuals, Management and Coordination

John A. Pope

On Oct. 25, 1986, a Boeing 737-222 with 114 passengers and five crewmembers overran a landing runway at Charlotte, N.C. Three passengers were seriously injured and 28 passengers and four crewmembers sustained minor injuries.

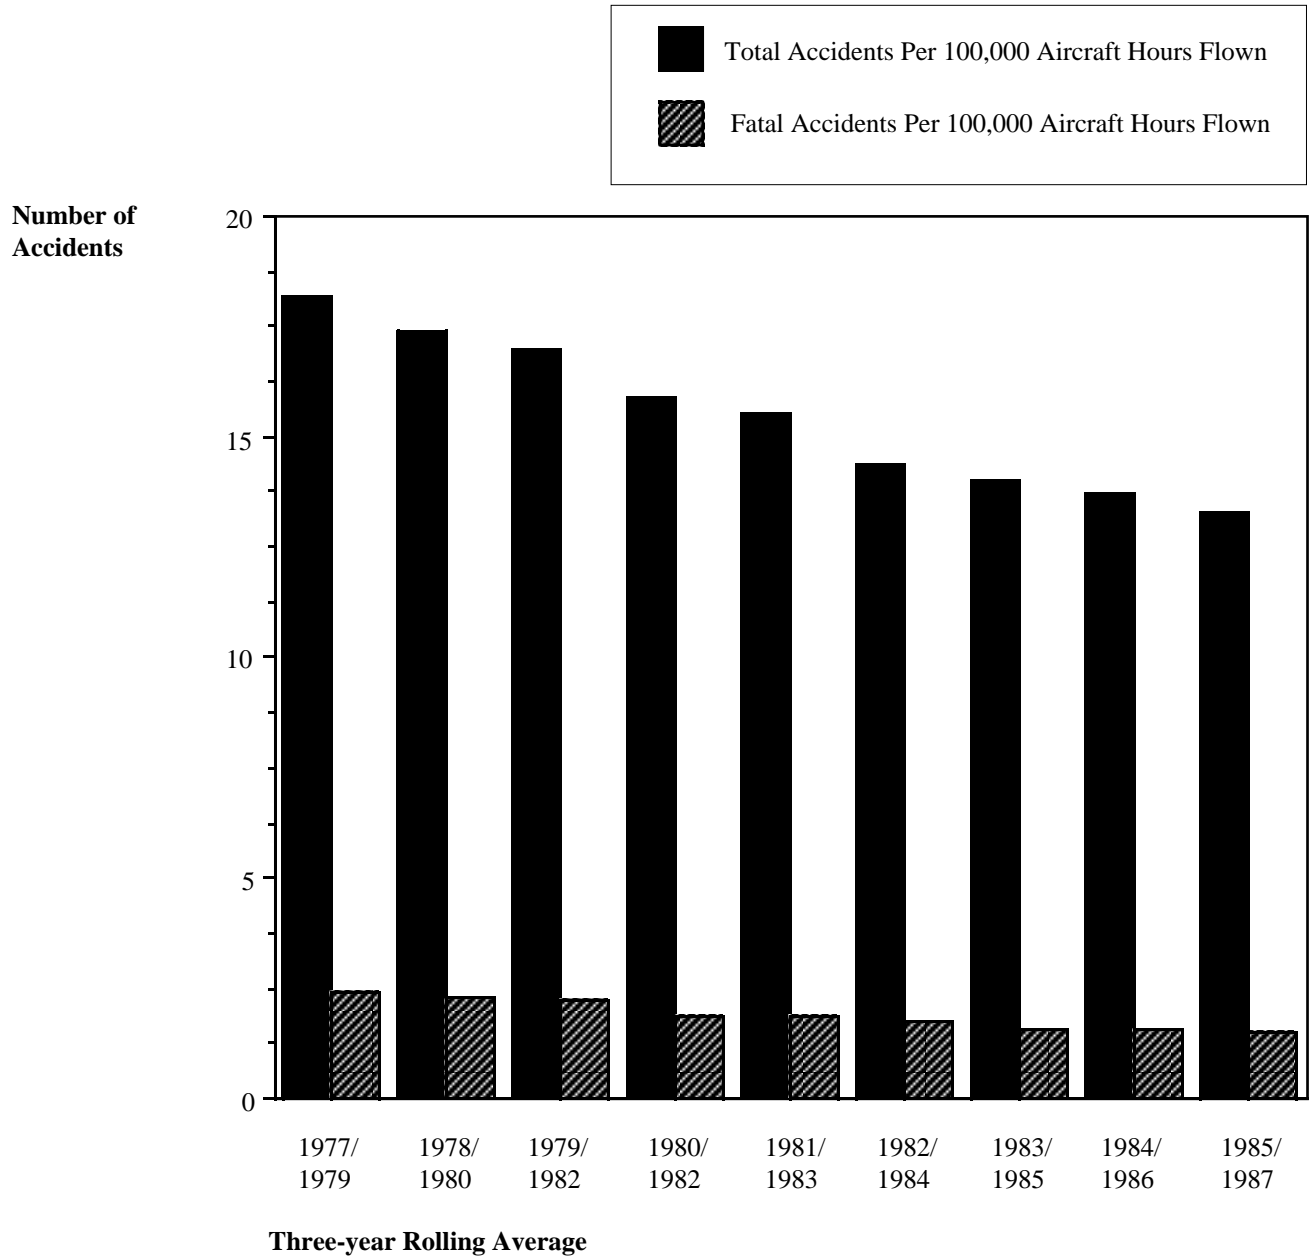
Figure One Safety Trends Canadian Civil Aviation 1979—1987

* Registered aircraft with a valid Certificate of Airworthiness.

the breakdown of airline fixed-wing and rotary-wing aircraft hours and accident data are not available. However, it should be noted that in Canada, most airlines (not included air taxi) operate large fixed-wing aircraft and the hours flown of which accounted for about 23% of total civil aircraft flying hours but number of airline accidents accounts for less than 2% of the total. Apparently, the accident rate for small fixed-wing aircraft accident rates would go up much higher than that for rotary-wing aircraft if airline exposure and accident data are excluded from the comparison.
