Flight Safety

SEPTEMBER 2003–FEBRUARY 2004

Waterproof Flight Operations

■ A comprehensive guide for corporate, fractional, on-demand and commuter operators conducting overwater flights

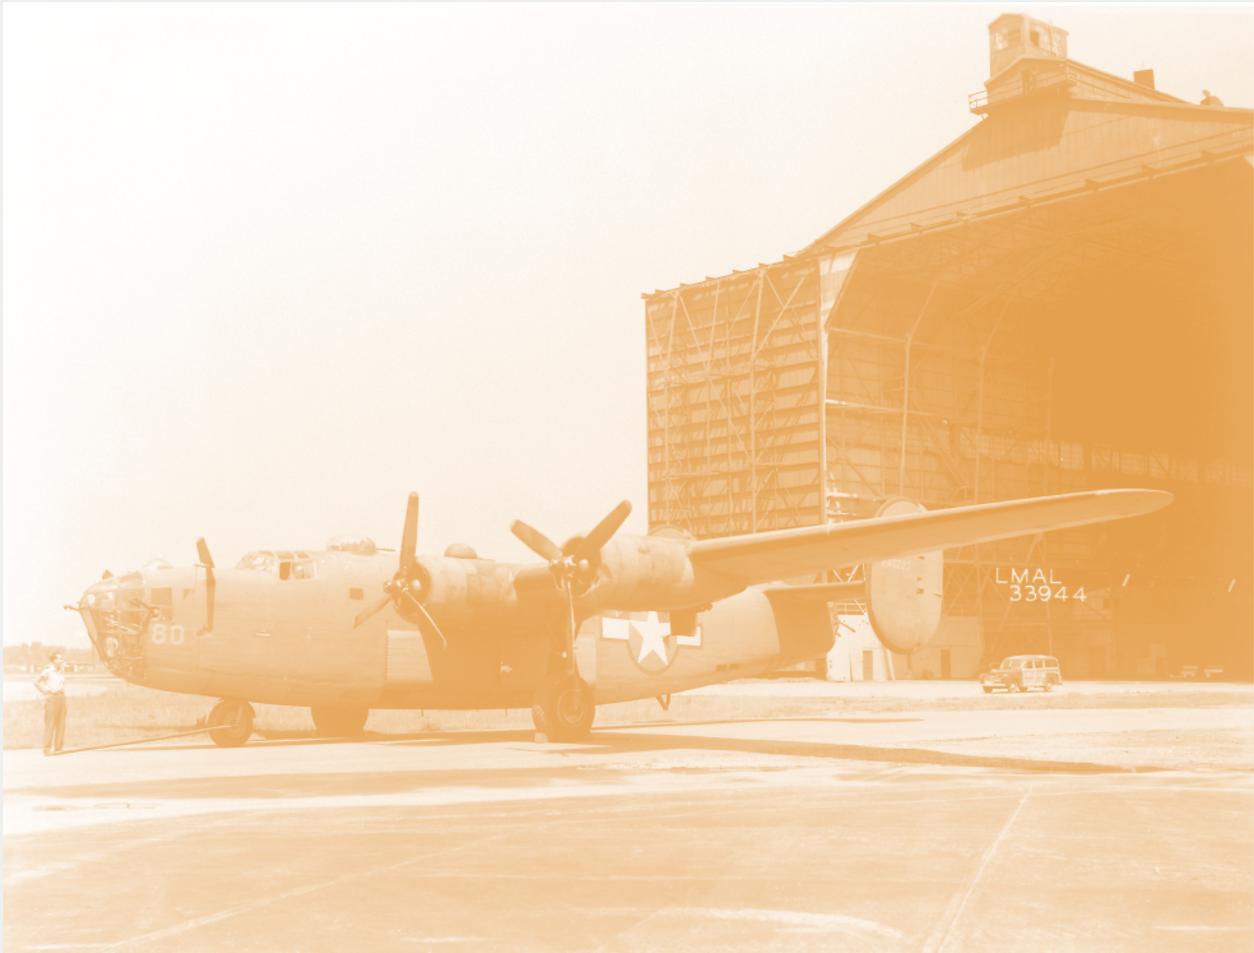
Known as a ‘bad ditcher,’ the Consolidated B-24 Liberator bomber did not have safety belts for all 10 crewmembers, and a bulkhead tended to collapse on impact.

The Consolidated B-24 Liberator [71,200 pounds (32,296 kilograms) MTOW], North American B-25 Mitchell [35,000 pounds (15,876 kilograms)] and the Martin B-26 Marauder [38,200 pounds (17,328 kilograms)] were known as bad ditchers. In 41 ditchings of B-24s during the war, 140 of the 400 occupants (35 percent) either were killed on impact or drowned when the airplanes sank.

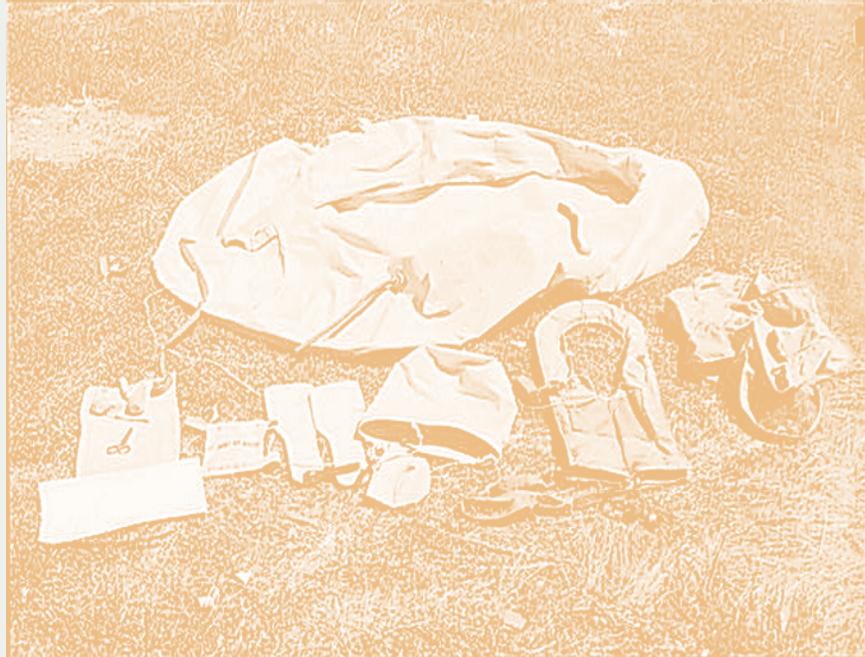
Airman's safety equipment included a life raft, a kit to mend bullet holes, a sea bucket, a life vest and a dye sack.

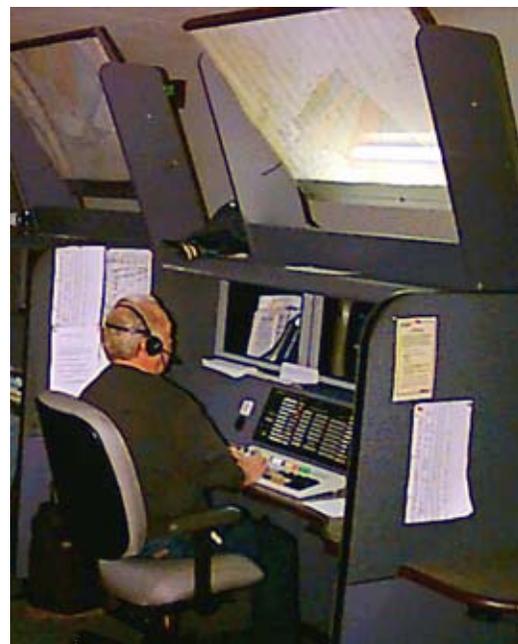
Pilots flying over deep water communicate with ATC through ARINC radio operators.

ARINC operators do not monitor emergency radio frequencies; they do, however, monitor all of the frequencies in the families for the areas they are working. Stutz said that the primary frequency is channeled to one earpiece in the radio operator’s headset; the secondary frequency and the other frequencies in the family are channeled into the other earpiece.

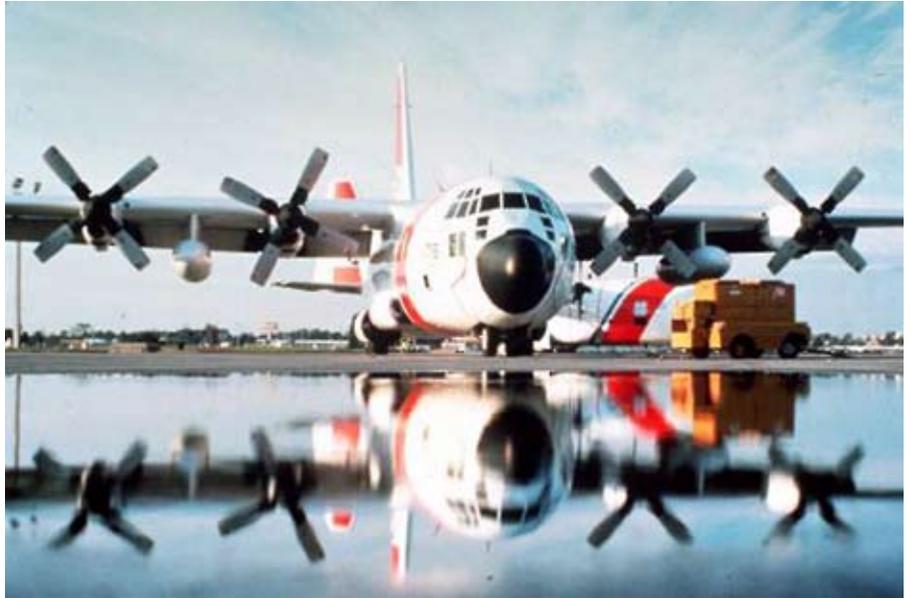
The U.S. Coast Guard has launched C-130s and helicopters to intercept and escort crews of distress aircraft.

“During an escort, our crews usually will not be able to do anything other than to monitor the distress aircraft, help during any communication failure, let the RCC know the status of the aircraft and be on site if a ditching does happen,” Steward said.

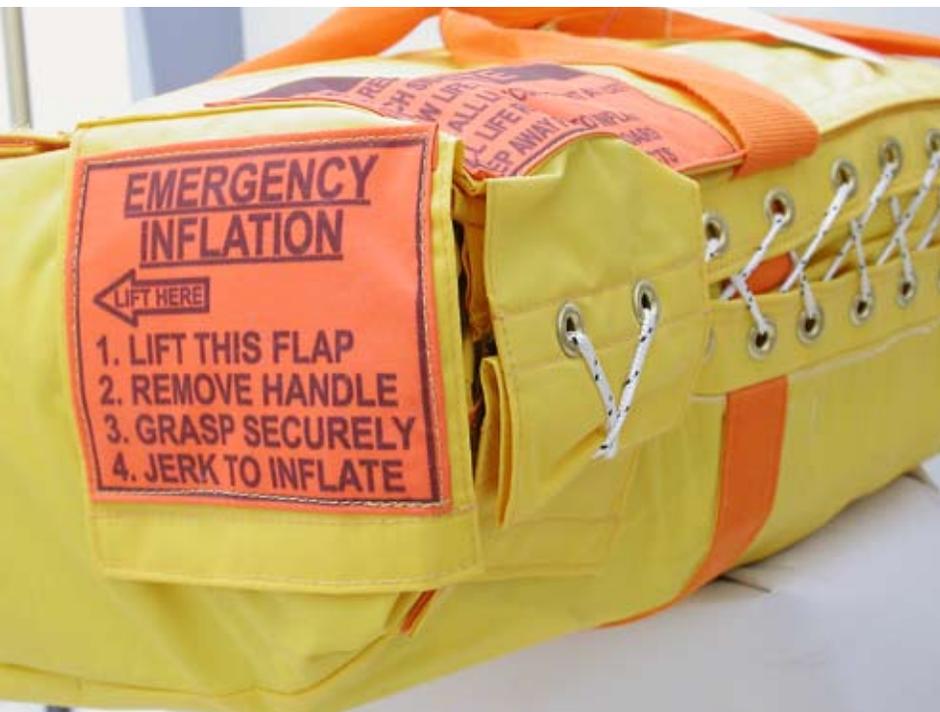
To remove or not to remove life rafts from storage before ditching — a subject of debate among safety specialists.

Some ditching checklists recommend that life rafts be removed from their storage areas and secured with seat belts to empty seats near the emergency exits, so that they are readily available.

Burton said that this is a good procedure because a life raft might be difficult to remove from its storage area. Normal cabin-pressurization cycles tend to cause a life raft to swell, he said. If the life raft is packed in a nonflexible container, there should be no problem; but if the life raft is packed in a valise (“soft pack”), the swelling could cause difficulty in extracting the life raft from its storage compartment.

Several safety specialists recommend that life rafts not be removed from storage until after the airplane comes to a stop on the water. For example, Stanfield said that instructors at FSI's Savannah center adhere to the recommendation on most Gulfstream ditching checklists — that the life rafts be removed from storage after the airplane has been ditched.

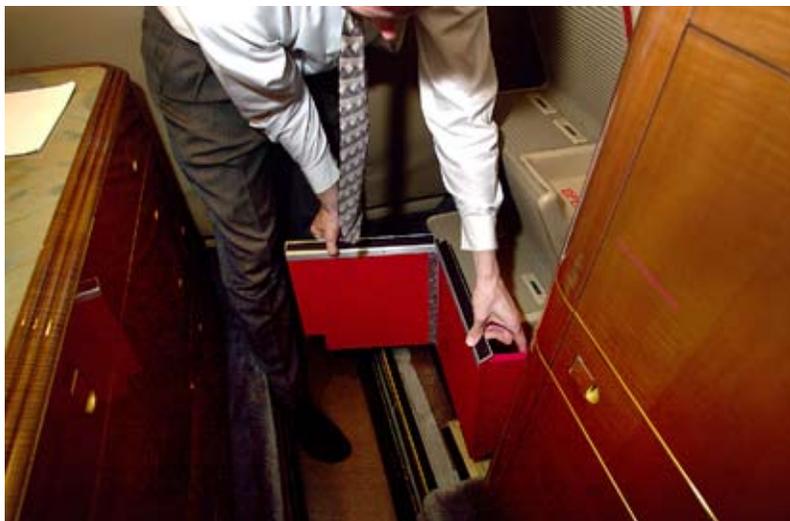
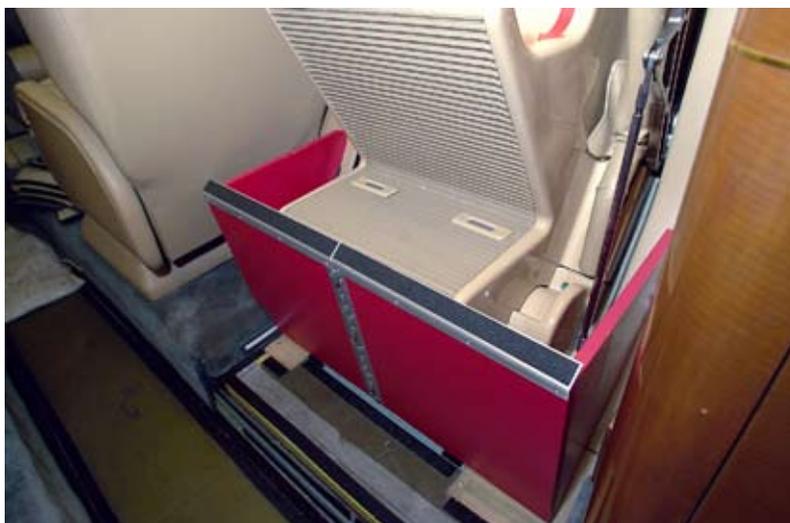
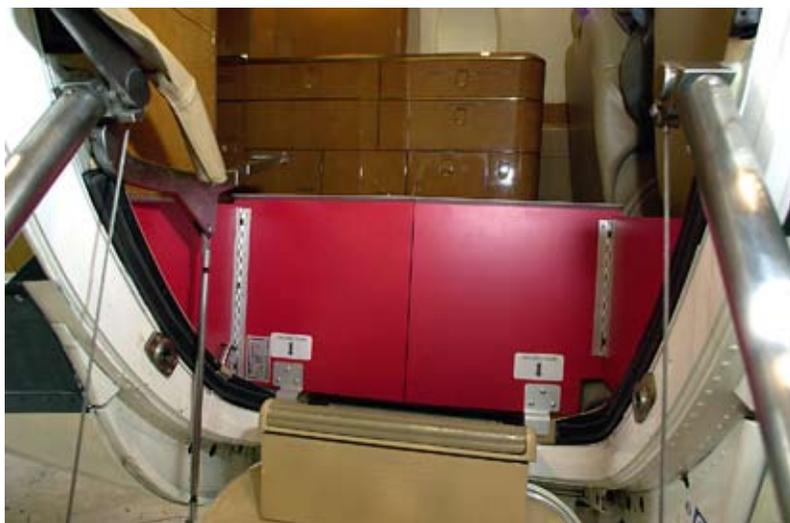
- The Cessna Citation Excel, Citation Sovereign and Citation X have a “water barrier” (photo, right) that must be attached to the frame around the bottom of the cabin door to prevent water from entering the cabin if the door is used for evacuation. (The ditching checklists for the Citations say, “If possible, the main cabin door should remain closed and evacuation [should be] made through the emergency [overwing] exit. However, the water barrier will allow use of the cabin door as an additional egress route.”)

- The Dassault Falcon 10 and Falcon 20 have cabin-door ditching latches that must be engaged; opening the cabin door on the water is prohibited.
- The Falcon 50 has a “ditching handle” that closes the auxiliary power unit (APU) air inlet and prevents water from entering the airplane.

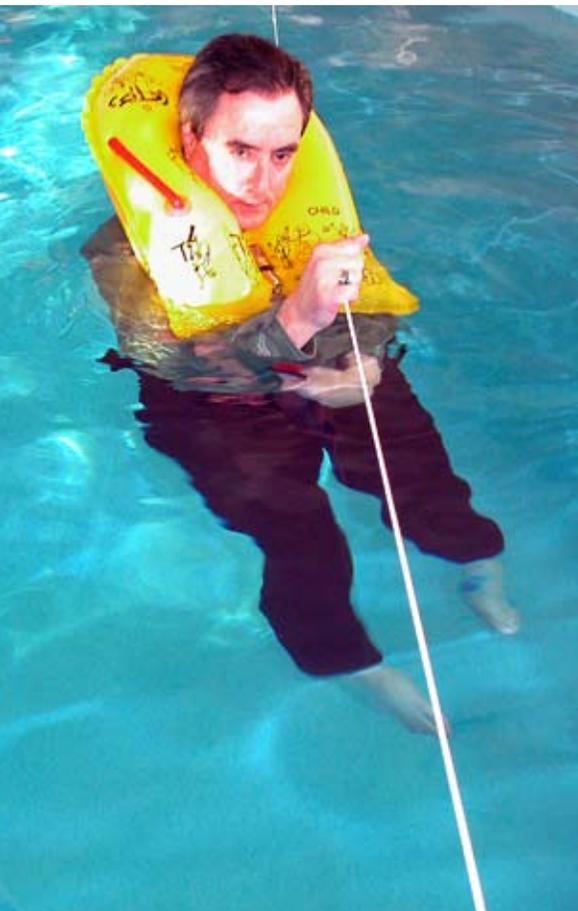
With the mooring/inflation line under one arm, the other hand is used to pull oneself toward the life raft.

- Enter the water with the mooring/inflation line under one arm;
- Wrap that arm around the mooring/inflation line and firmly grasp the waistband on your life vest (forming with your arm a “loop” through which the mooring/inflation line passes); and,
- Use your other hand to pull on the mooring/inflation line and propel yourself toward the life raft.

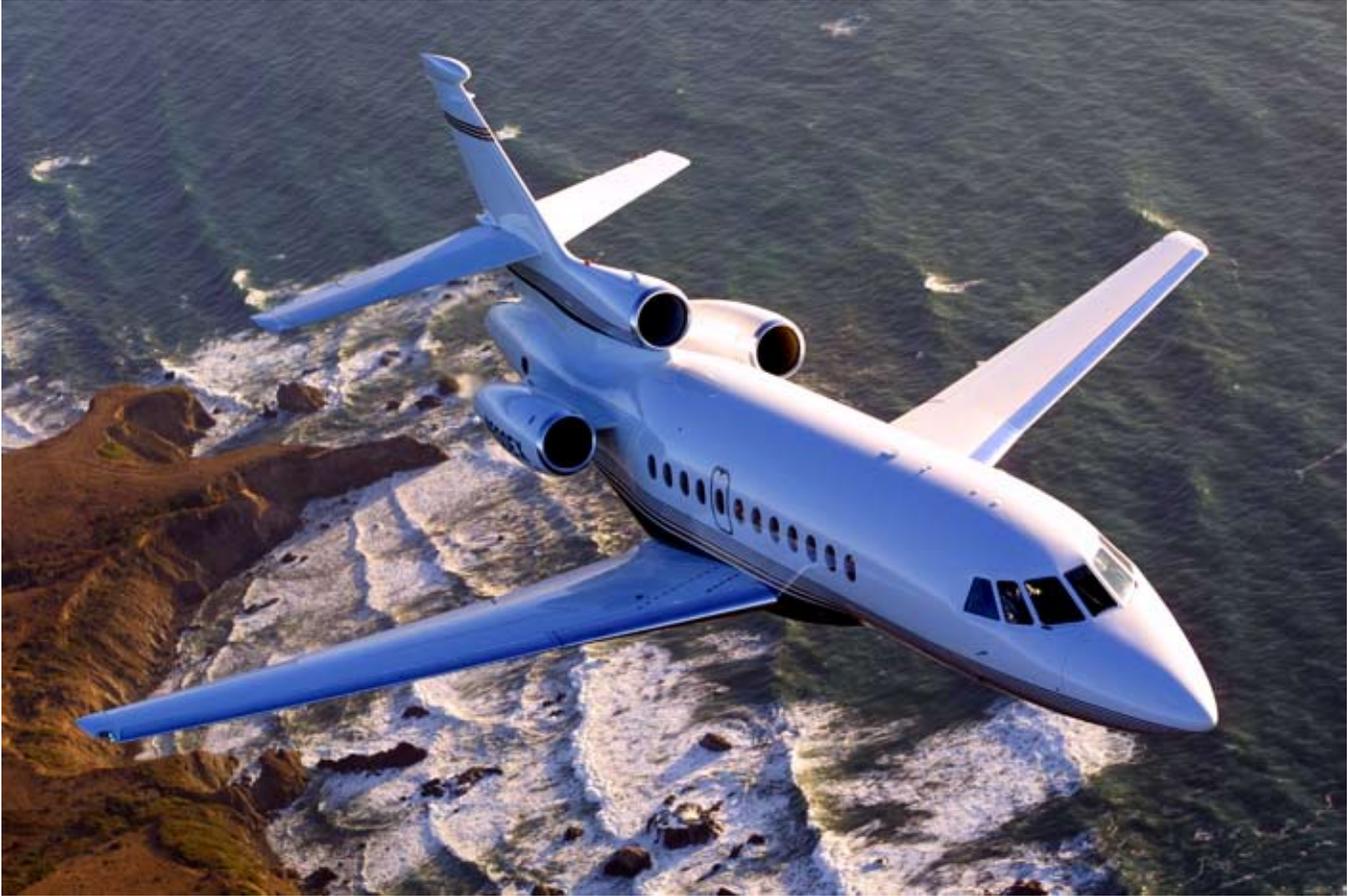
Dassault used a computer program to explore the ditching behavior of the Falcon 900.

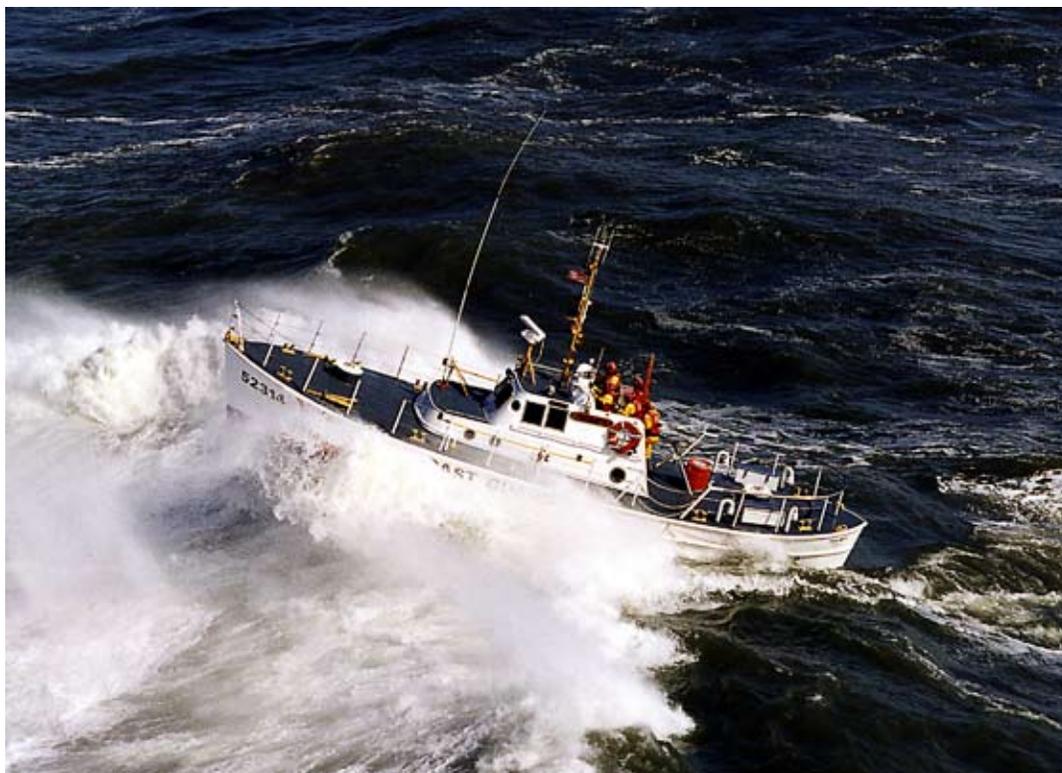
A U.S. Coast Guard 52-foot (16-meter) motor lifeboat in a wave in the northwest Pacific Ocean.

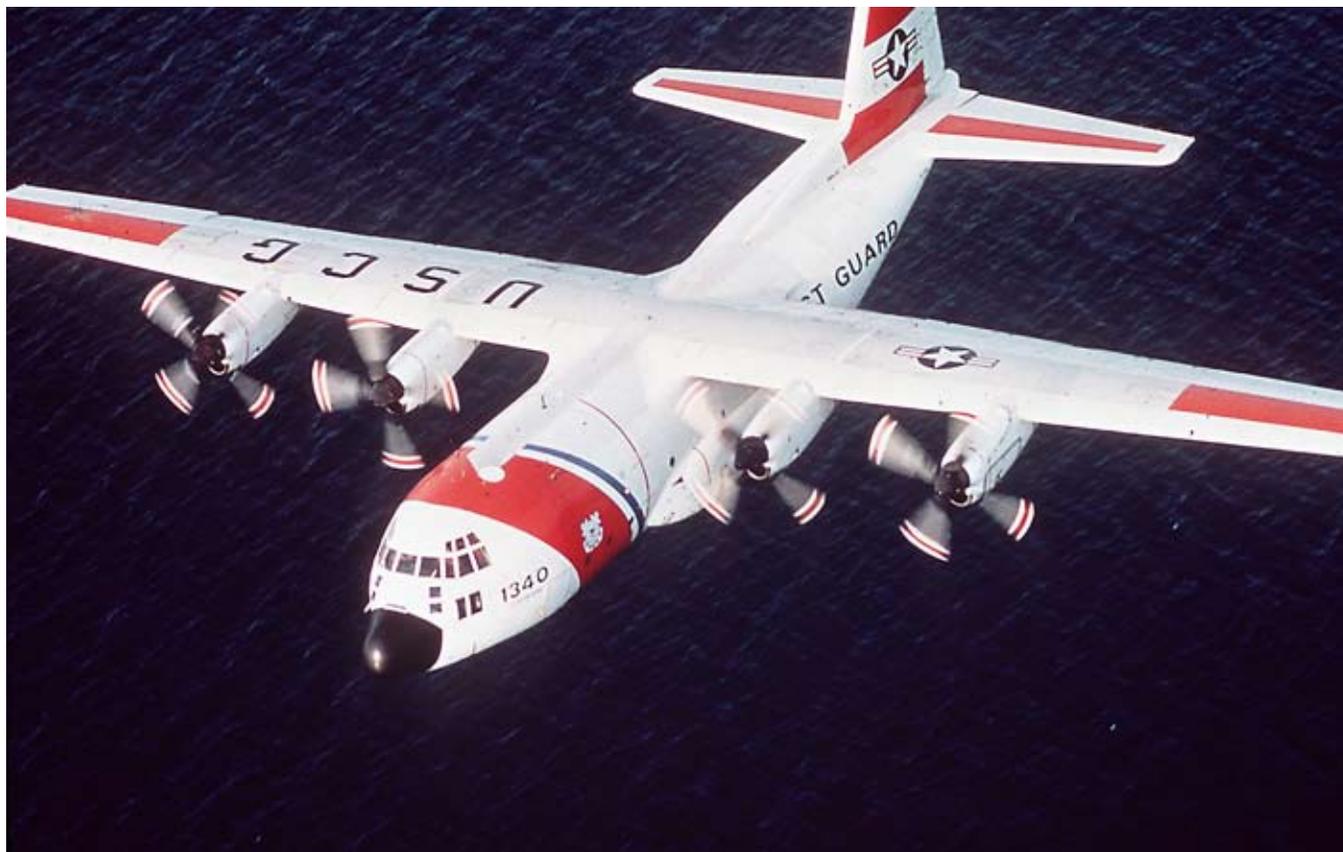
An HC-130
has the range to
conduct a search
far offshore.

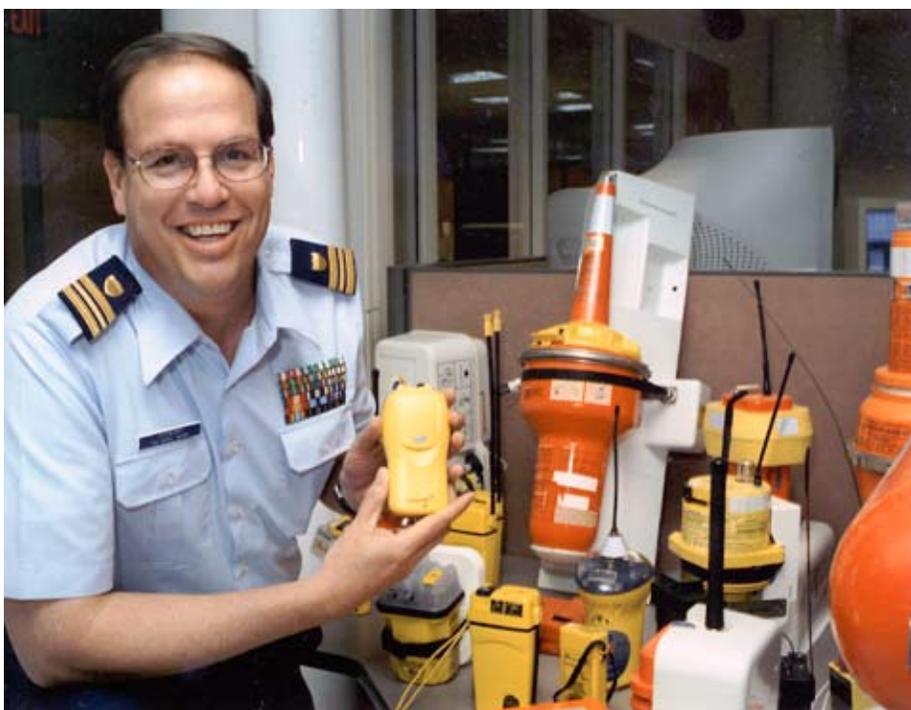
Beacons include ELTs, EPIRBs and PLBs, such as the one displayed by Lt. Cmdr. Paul Steward.

Emergency radio beacons include emergency locator transmitters (ELTs) carried on aircraft, emergency position-indicating radio beacons (EPIRBs) carried on marine vessels and personal locator beacons (PLBs), which are designed to be carried by people for use on land (but also are used on water).

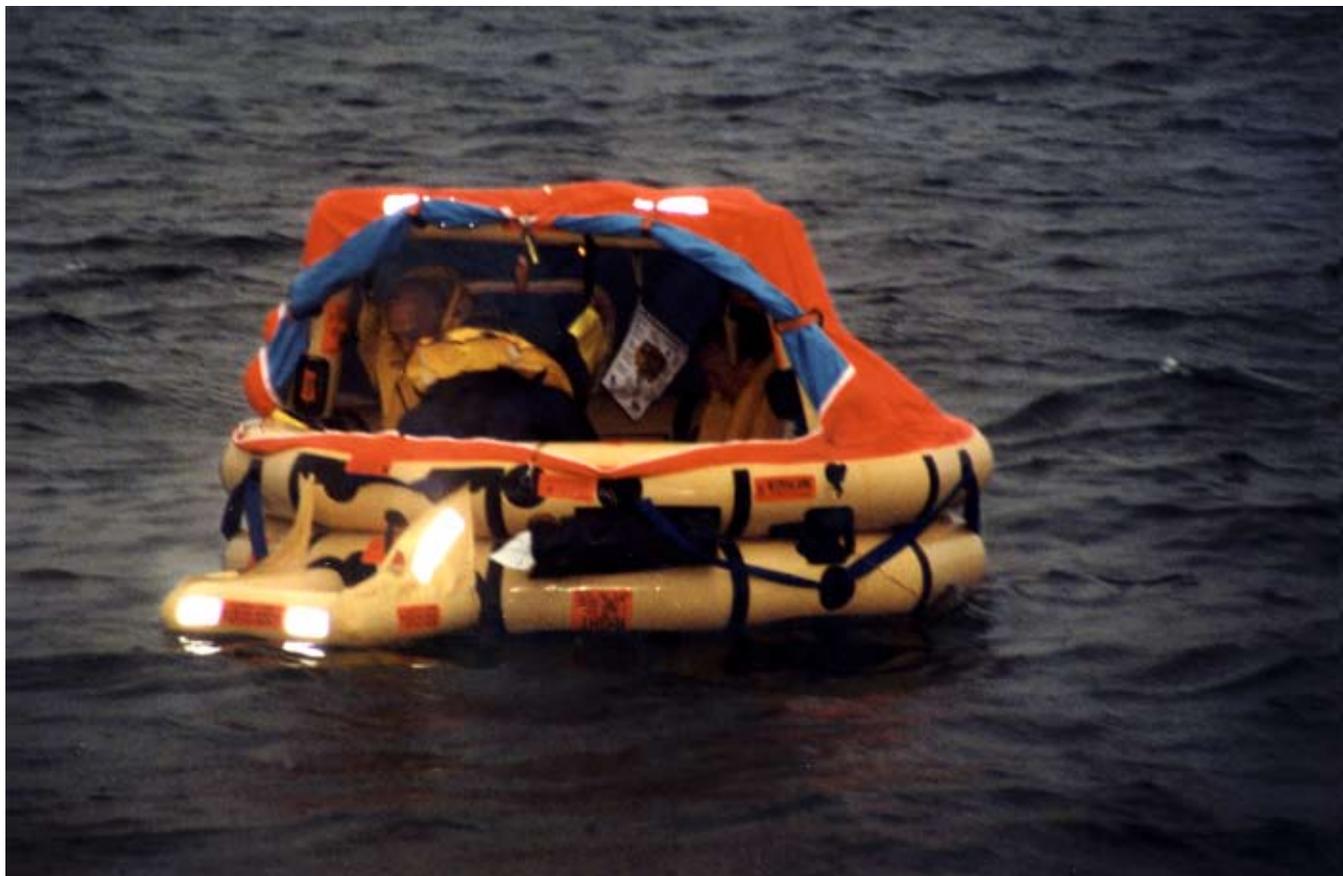
Retroreflective tape shines brightly from light directed onto its surface and makes life rafts more visible in darkness or low-level light conditions.

the water. If the life raft has retroreflective tape, a well-located survivor-locator light on the life raft canopy might reflect light from the tape, further enhancing visibility of the life raft. [Retroreflective materials are engineered to reflect light in the direction of its source and are most effective when the ambient light is low.]

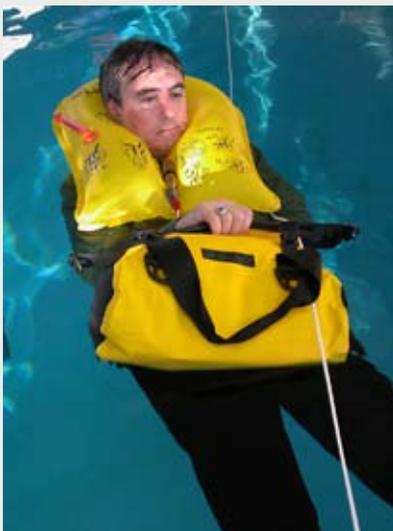
A buoyant ditch bag is buckled to the mooring/inflation line and is pushed by the survivor as he pulls himself to the life raft.

Watershed's Ultimate Ditch Bag measures 15 inches by 32 inches (38 centimeters by 81 centimeters) and is fitted with a very large, full-length, waterproof zipper and an oral-inflation tube to add air for buoyancy. The Foundation loaded this US\$250 bag with 130 pounds (59 kilograms) of weight, and it floated. This bag would be sufficient aboard corporate jets to store most supplemental survival equipment, with room

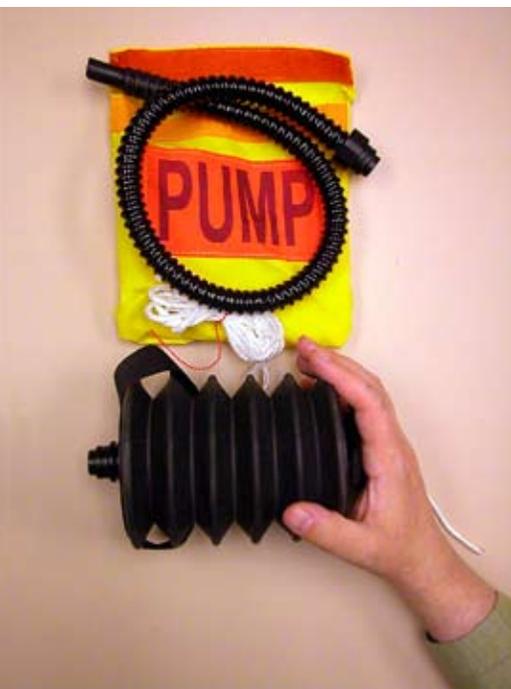
Life raft bellows pump and a backup oral inflation hose.

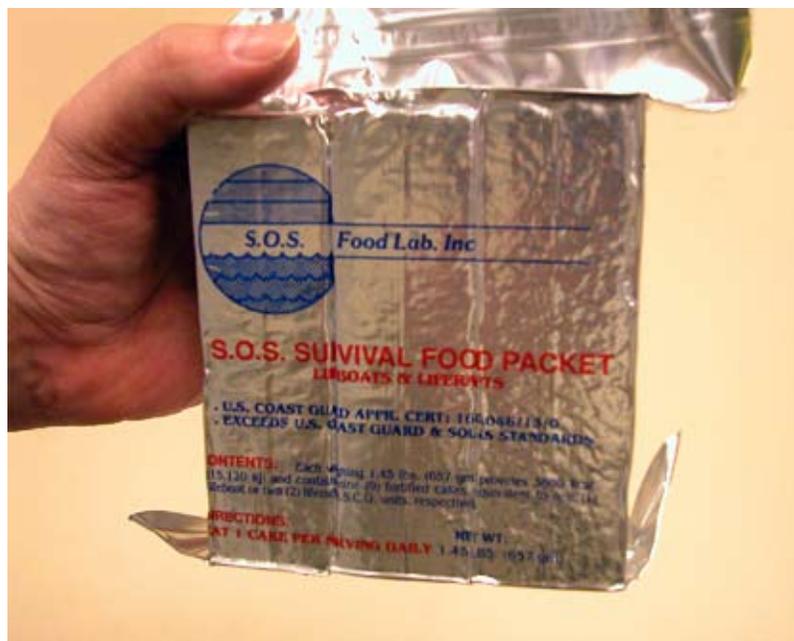
Four of these sealed packets of food would be only 500 calories short of meeting the requirements of 1,000 calories per day per person for 15 persons.

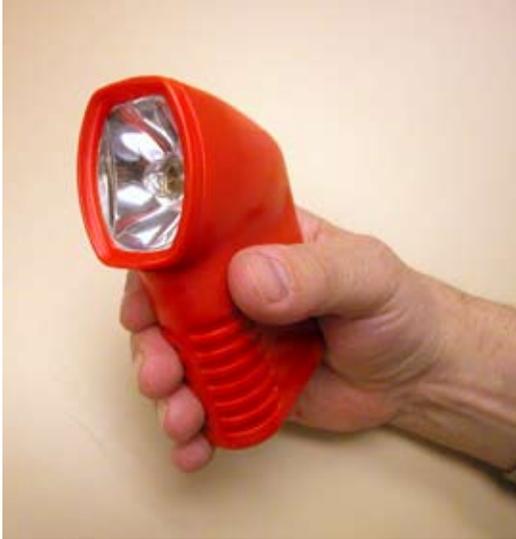
Flashlights will be essential to locate equipment and to check the condition of the life raft during darkness.

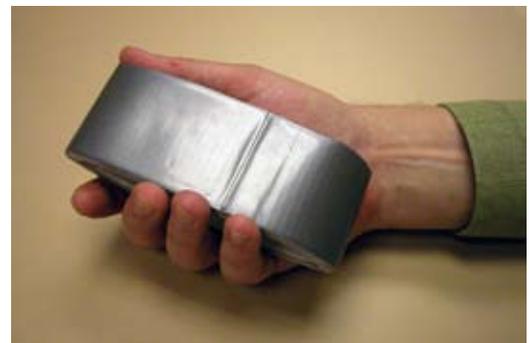
Duct tape can be used to patch air leaks in the buoyancy tubes ... and for a variety of other uses on a life raft.

"Sometimes cone-shaped and threaded rubber plugs are available, but they are generally used only as temporary plugs. And if a leak is serious, then anything at hand should be used to stem the loss of air, from clothing to a 'finger in the dike.' Losing air in a buoyancy tube will mean that the life raft's freeboard [the distance from the top of the buoyancy tube to the water] will be lowered, and that will make the life raft more susceptible to water entering the life raft. Actually, duct tape applied to a clean and dried buoyancy tube can stop leaks above the waterline."

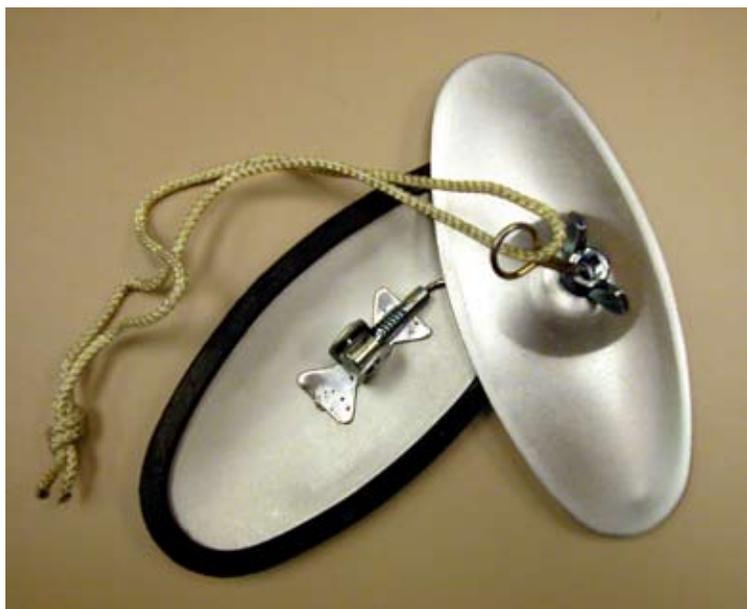
A mechanical clamp provides a leakproof repair of buoyancy tubes.

"Leaks have to be repaired," said Burton. "Most life rafts today are equipped with two or three mechanical clamps for air-holding repairs: Two oval-shaped pieces of metal face each other and are connected by a screw-down winglet on a threaded rod. The oval metal with a rubber gasket is inserted in the leak hole, which is usually made into a wider slit with a utility knife to accept the metal oval. The metal oval, now inside the buoyancy tube, is placed with the rubber gasket against the buoyancy tube fabric. The oval face on the outside is screwed tightly against the oval piece on the inside of the buoyancy

tube. The clamps come in three-inch, five-inch and eight-inch [eight-centimeter, 13-centimeter and 20-centimeter] sizes, and they provide a good long-term seal. Even so, repaired leaks should be checked by each scheduled watch.

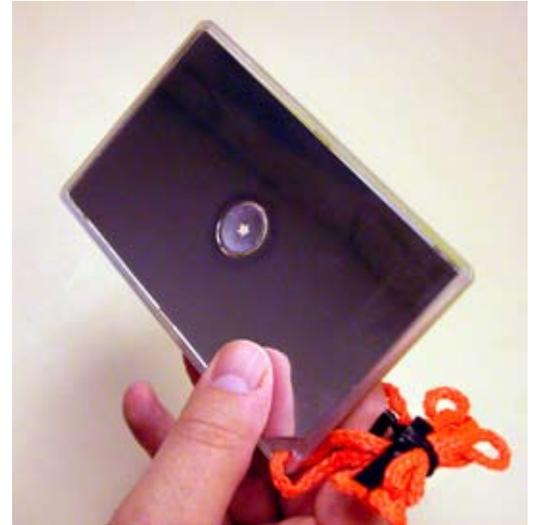
Used correctly, a signal mirror can be one of the most effective signaling devices during daylight.

“The mirror is usually packed in the SEP, and it is one of the most effective signaling devices a survivor can have,” said Burton. “Instructions are usually printed on the back of the mirror, which might be highly polished stainless steel or plastic with a metallic reflective finish. A hole usually is provided in the middle to help aim the mirror.

“Basically, the sun is reflected off the mirror, which is aimed at the target: a ship or aircraft. The survivor forms a V with two fingers with the target in the bottom of the V. Using his other hand to hold the mirror, he aims the reflected light from the mirror at the V formed by the fingers on the hand of his outstretched arm. Simple, really, and with a little practice the survivor can become very accurate with this type of device.”

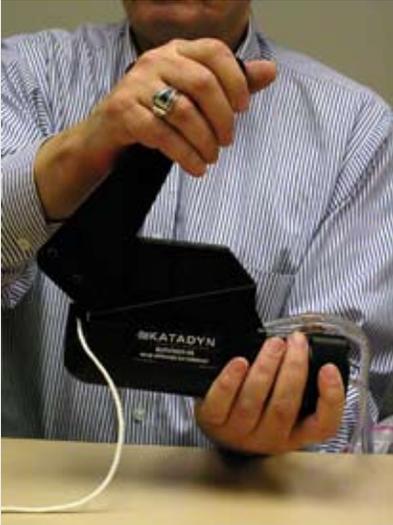
1

For a thirsty survivor in a life raft, getting water from a manual reverse-osmosis desalinator like Katadyn's Survivor-06 hand-operated water maker isn't quite as easy as turning on a faucet, but it's close (Photo 1).

Katadyn describes the Survivor-06 water maker as the smallest hand-operated water maker in the world. The stainless steel and plastic device weighs 2.5 pounds (1.1 kilograms), measures 5.0 inches by 8.0 inches by 2.5 inches (12.7 centimeters by 20.3 centimeters by 6.4 centimeters) and can produce more than six gallons (23 liters) of fresh drinking water a day, the manufacturer says. A tether sold with the water maker — when secured correctly — prevents the water maker from becoming separated from the life raft.

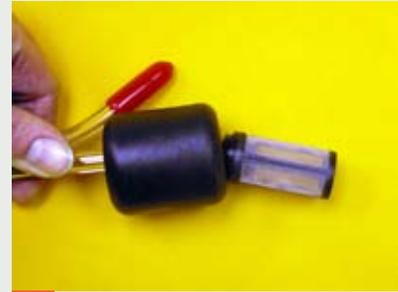
2

As instructed, the water maker's users positioned the black strainer, the accompanying weight and the attached intake/reject hoses (Photo 2) in a vase containing seawater taken from the Atlantic Ocean during a colleague's vacation in Florida; the product hose was positioned to allow fresh water to drip into a glass. (The intake/reject hoses are long enough to hang over the side of a life raft to draw water directly from the ocean. Nevertheless, if survivors prefer — because of rough seas or because large fish might mistake the plastic filter for a meal — the intake/reject

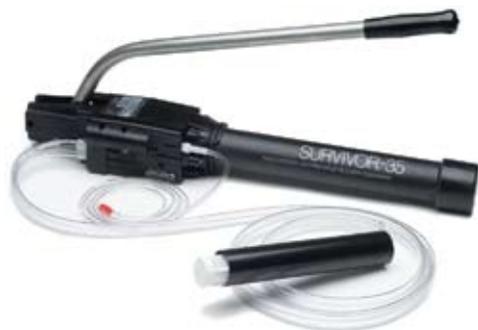
The Katadyn Survivor-35 hand-operated water maker (also known as a manual reverse-osmosis desalinator, can desalinate 1.2 gallons (4.5 liters) of water per hour.

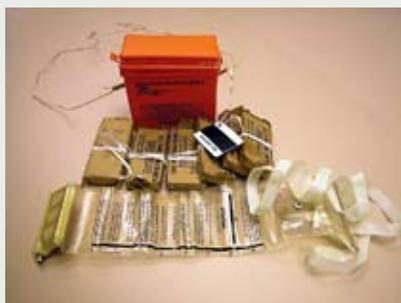
1

The kits, manufactured by Van Ben Industries, a division of Truetech of Riverhead, New York, U.S., are packaged in orange plastic boxes that weigh slightly more than 1.0 pound (0.5 kilogram) and measure 4.5 inches by 4.5 inches by 2.0 inches (11.4 centimeters by 11.4 centimeters by 5.1 centimeters). The kits contain either six packages or eight packages of desalting chemicals (clay “briquettes” containing particles of silver zeolite), one plastic bag for collecting seawater, and tape to mend the bag in the event of a tear (Photo 1). Each package of two briquettes (Photo 2) can be used to make about one pint (16

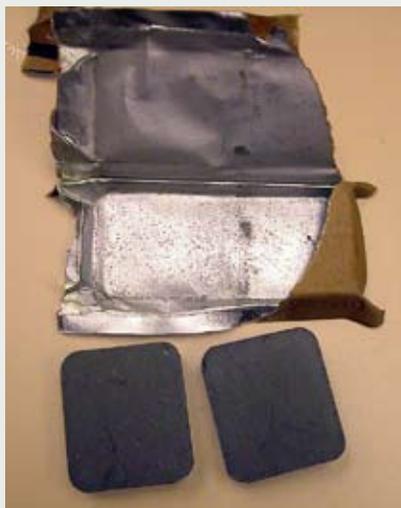
2

ounces, or one-half liter) of drinking water. The bag can be tied to the life raft with a length of attached material to prevent it from being washed overboard; an attached cord can be used to secure the box.

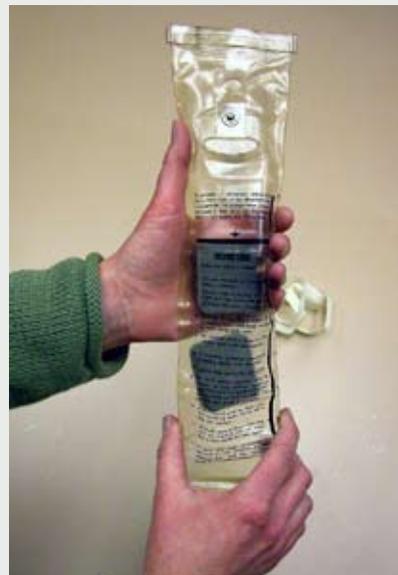
3

A package of two briquettes and slightly less than one pint of seawater (obtained from the Atlantic Ocean during a colleague’s vacation in Florida) were placed in the bag, which clearly shows — in two ounce increments — how much water it contains (Photo 3). The instructions say that the water should be in the bag before the briquettes are added, but for photographic purposes, the kit’s users reversed the order. The instructions allowed for a full pint but included an explanation that using the full amount of water would “leave a little salt in the desalted water to compensate for perspiration losses. If you desire it less salty, fill the bag to about an inch [2.5 centimeters] below the filling line [which marks about one pint.]”

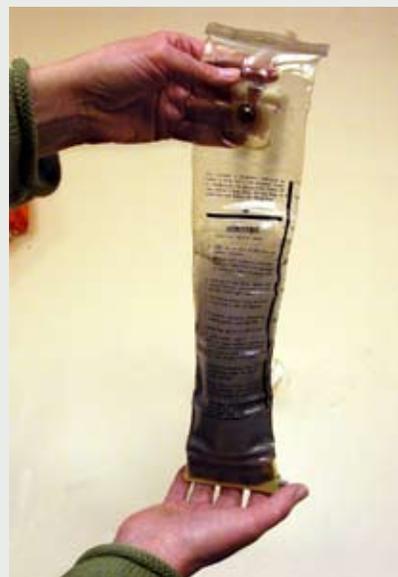
4

There was no avoiding the step that followed: “Agitate bag gently for 60 minutes.” The kit’s users took turns shaking the bag at intervals of about five minutes each — a somewhat tedious process, they agreed, but as one person said, “If you were in a

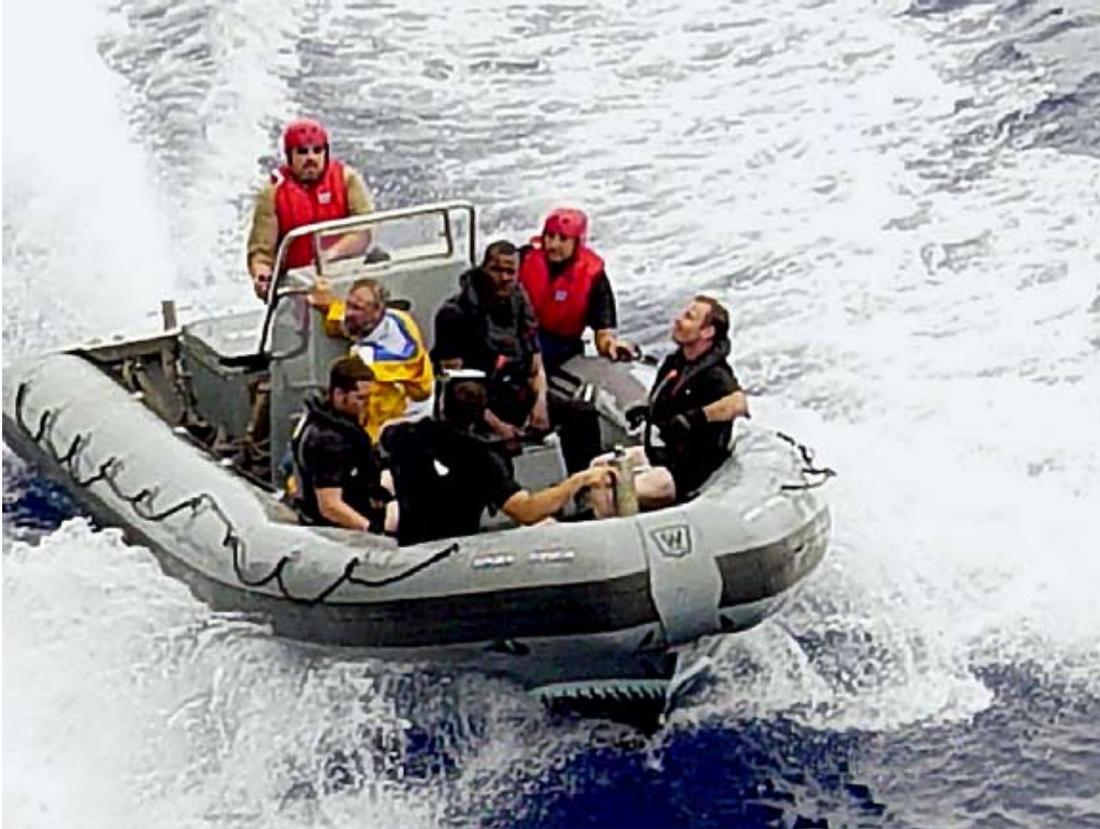
Crewmembers from the U.S. Navy ship *Spica* transferred sailor Brian King and two of their rescue swimmers from a life raft to the rigid inflatable boat, which was hoisted to the ship's deck.

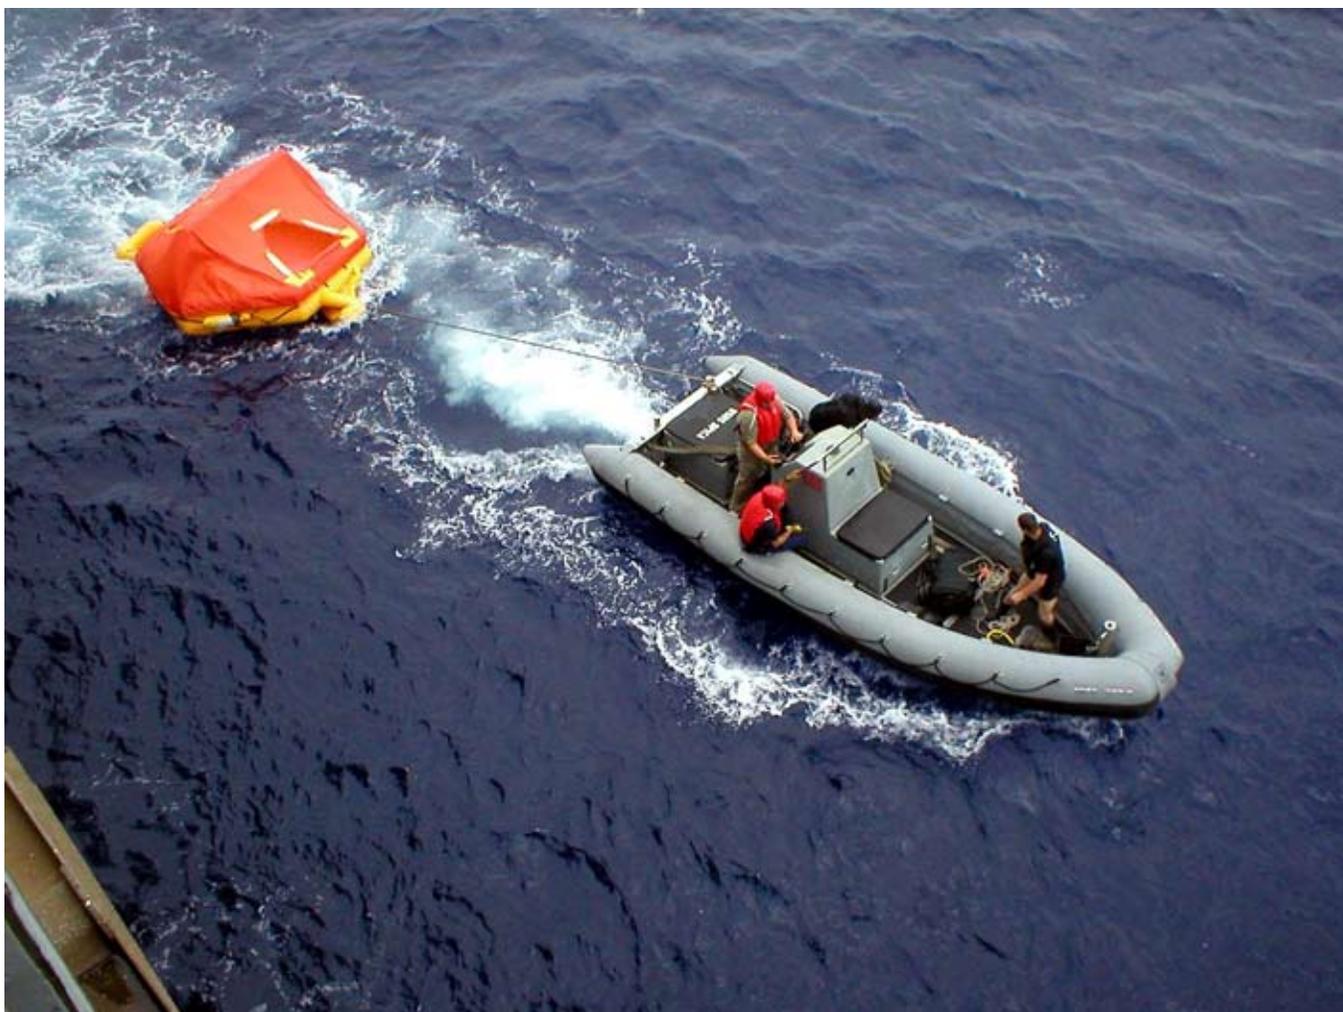
Deployed from a helicopter after the malfunction of a winch, a life raft is retrieved after it provided flotation and shelter to Brian King and two rescue swimmers from the U.S. Navy Ship *Spica*.

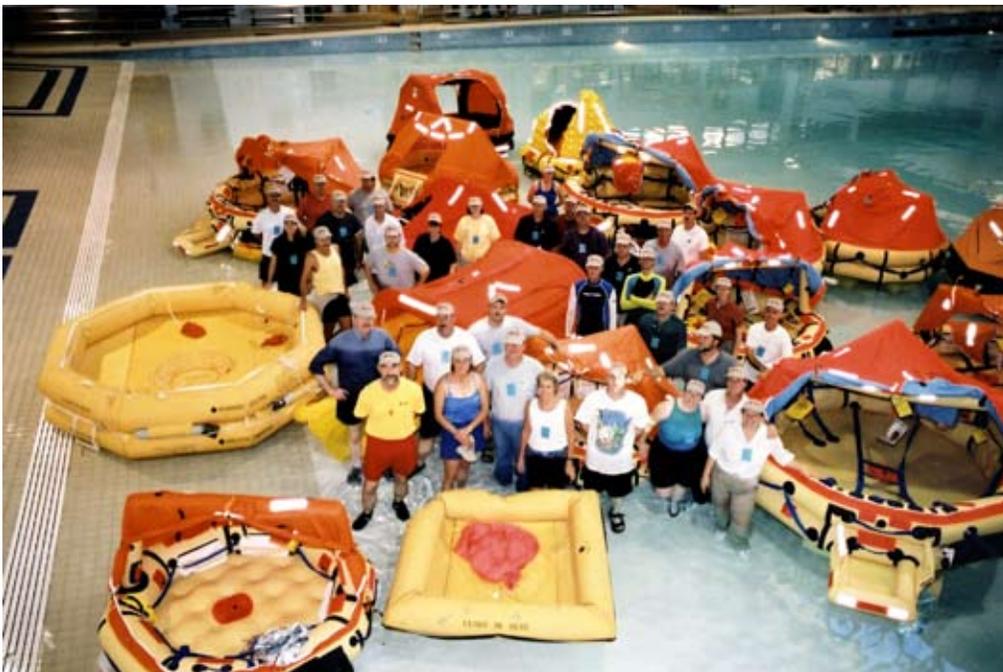
Modest simulation of heavy rain was far less than an ocean storm of heavy rain, high winds and breaking waves.

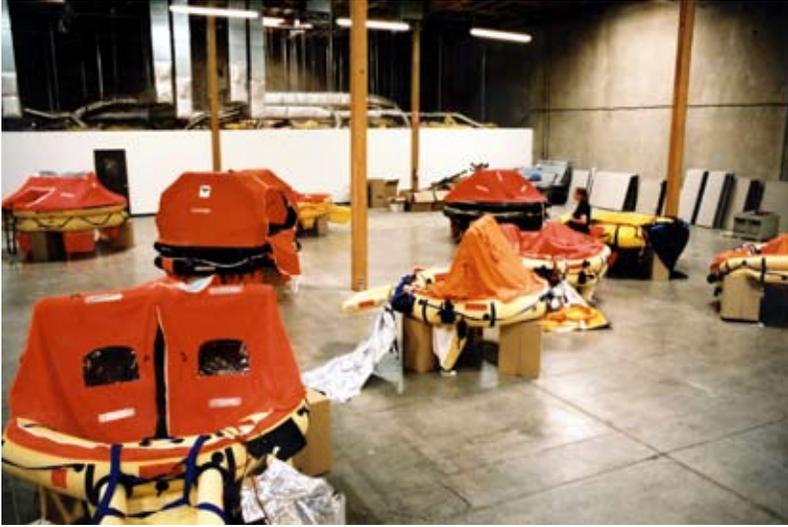
Life rafts were carefully stowed and checked for damage overnight between the daily sessions with volunteers in the wave pool.

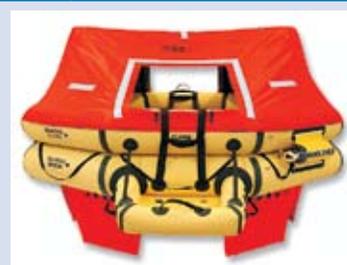
Model no.	Cost (US\$) ³	Rated/Overload Capacity	Buoyancy Tube Diameter (inches/centimeters)	Canopy	No. of Water-ballast Bags x Freshwater Capacity (pounds/kilograms)	Packed Dimensions (inches/centimeters)	Floor Insulation	Weight (pounds/kilograms)		
								Without SEP	With FARs Part 121 SEP	With FARs Part 135 SEP
VIP T10AS ⁴	5,230	10/15	11.25/29	Automatically inflatable	5 x 99.8/45.3 = Total 499/226.3	32 x 17 x 8/81 x 43 x 20	Inflatable floor (optional)	N/A	53.5/24	64.5/29
VIP Deluxe T10AS ⁴	6,050	10/15	11.25/29	Automatically inflatable	55 x 99.8/45.3 = Total 499/226.3	32 x 17 x 9.5/81 x 43 x 24	Inflatable floor	N/A	67/30	78/35

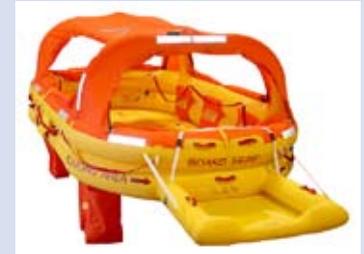
Model no.	Cost (US\$) ³	Rated/Overload Capacity	Buoyancy Tube Diameter (inches/centimeters)	Canopy	No. of Water-ballast Bags x Freshwater Capacity (pounds/kilograms)	Packed Dimensions (inches/centimeters)	Floor Insulation	Weight (pounds/kilograms)		
								Without SEP	With FARs Part 91 SEP	With FARs Part 135 SEP
10-person	8,800	10/15	9.5/24	Automatically inflatable	4 x 92.8/42.1 = Total 371.2/168.4	34 x 14 x 10/86 x 36 x 25	Inflatable floor	N/A	59/27	68/31

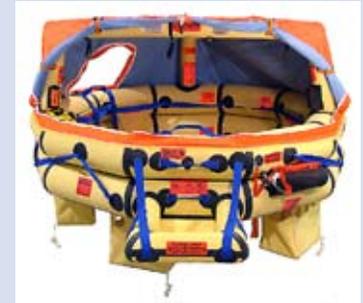
Model no.	Cost (US\$) ³	Rated/Overload Capacity	Buoyancy Tube Diameter (inches/centimeters)	Canopy	No. of Water-ballast Bags x Freshwater Capacity (pounds/kilograms)	Packed Dimensions (inches/centimeters)	Floor Insulation	Weight (pounds/kilograms)		
								Without SEP	With FARs Part 91 SEP	With FARs Part 135 SEP
Ultra-Light 1015FAUL	7,414	10/15	9/23	Automatically inflatable	5 x 79.2/36 = Total 396/180	9 x 18 x 32/ 23 x 46 x 81	Inflatable floor	N/A	54/24	64/29
Super-Light Ultima 1015FASL	7,414	10/15	11.25/28.58	Automatically inflatable	5 x 79.2/36 = Total 396/180	9 x 18 x 34/ 23 x 46 x 86	Inflatable floor	N/A	66/30	75/34

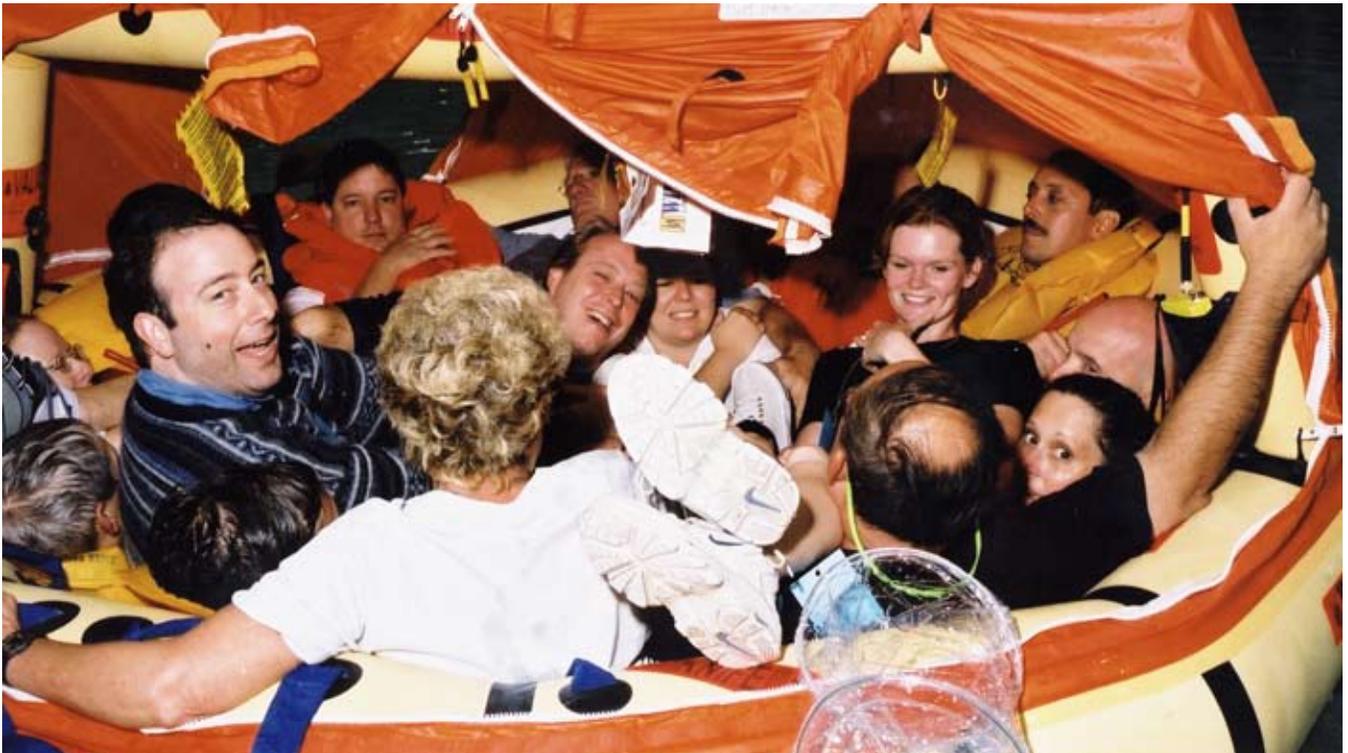
Fifteen people — the overload capacity of a 10-person aviation life raft — may be a laughing matter for some people in the pool evaluation, but when floating on an ocean everything would be focused on survival.

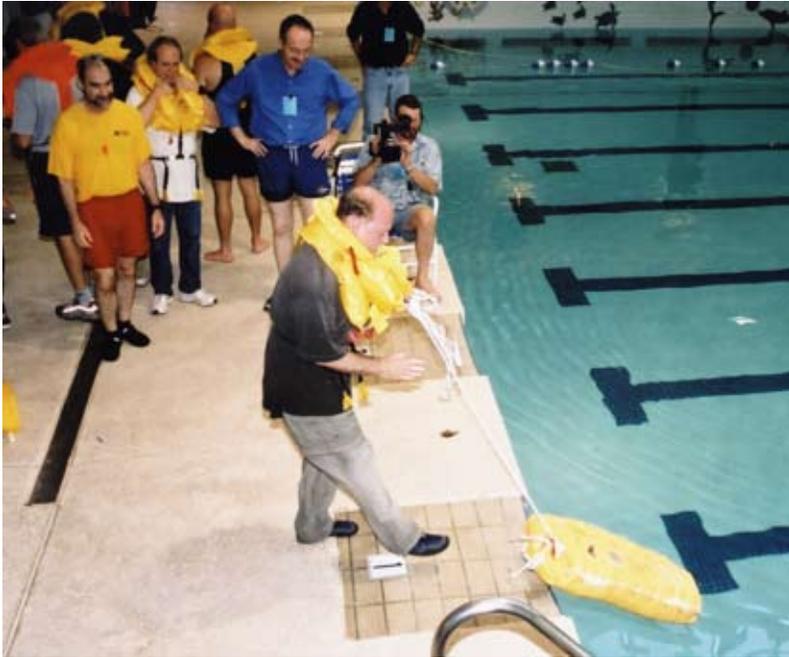
Inexperienced volunteers were selected to deploy the life rafts. They were allowed to read the directions and to deploy the life raft from the side of the pool, as if they were standing at an open cabin door.
