Flight Safety

SEPTEMBER 2003–FEBRUARY 2004

Waterproof Flight Operations

■ A comprehensive guide for corporate, fractional, on-demand and commuter operators conducting overwater flights

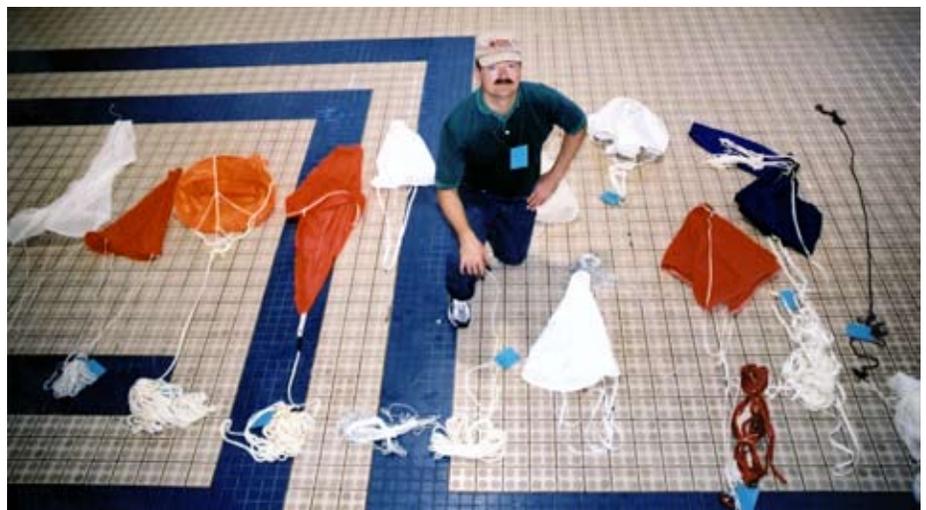
A volunteer is surrounded by the variety of sea anchors that were removed from the life rafts during the evaluation in the wave pool.

Sea anchors were evaluated independently from the life rafts. The sea anchors were towed through the water in the wave pool to allow underwater observation and underwater photography. With the assistance of the U.S. Coast Guard Auxiliary, Division 10, the sea anchors were deployed and were towed slowly behind a powerboat in calm weather conditions on Saguaro Lake in Arizona. In turn, each line was attached to a spring scale to measure its relative drag and the effect of increasing and decreasing the length of the sea anchor line.

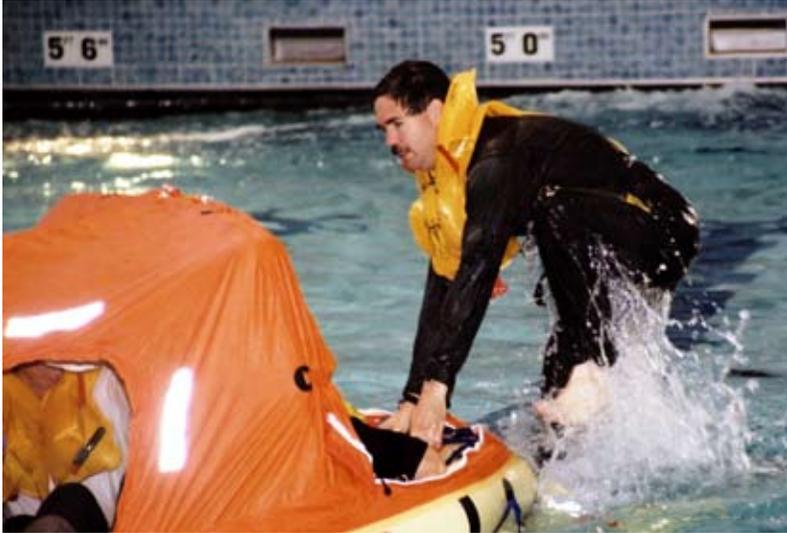
This Type II four-person aviation life raft is at overload capacity with six persons; the U.S. Federal Aviation Administration has determined that it meets the minimum requirements.

Aviation life rafts have an “overload capacity.” Generally, this amounts to half again more than the rated capacity: six people, for example, in a four-person life raft and nine people in a six-person life raft. Nevertheless, the overload capacity must provide no less than 2.4 square feet (0.2 square meter) per person. If the volunteers complain of a tight fit at rated capacity, at overload capacity they were packed so tightly that they experienced physical pain; movement was impractical and difficult.

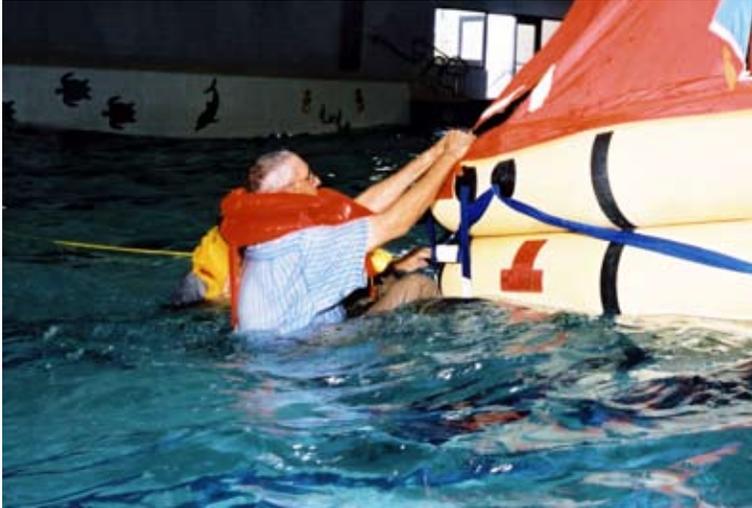
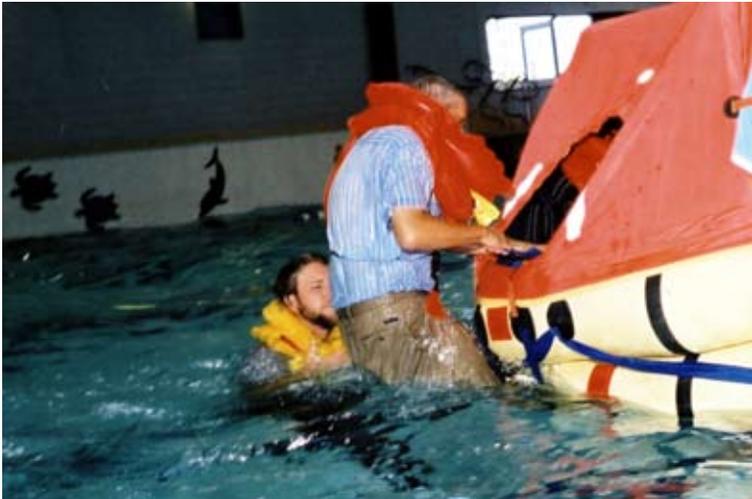
A ladder of nylon webbing will be on most life rafts, either as an alternate means of boarding or as a primary means of boarding, but boarding by a ladder is usually more difficult than by an inflatable boarding ramp.

In recent years, inflatable boarding aids have become more common and when properly designed,

they can make boarding much easier for survivors, compared with a traditional entry, such as a ladder. Some life rafts are equipped with inflatable entry aids at all entries (typically two entries), a design that could create problems. For example, if a lower buoyancy tube fails because of a puncture on a Type I life raft and each inflatable entry aid is not equipped with a check valve to prevent the boarding aid from deflating, all such entry aids will be useless. Even with a check valve to prevent deflation of the boarding aid, the entry aid may not function adequately because it is attached to a deflated buoyancy tube. When a secondary entry is equipped with a boarding ladder or similar non-inflatable entry aid, this second aid will not be affected by such a failure. When an inflatable entry aid is the primary means of boarding, redundancy is best achieved by a different means of boarding the life raft. Primary entry aids and auxiliary entry aids were evaluated for ease of use, as well as construction and susceptibility to damage.

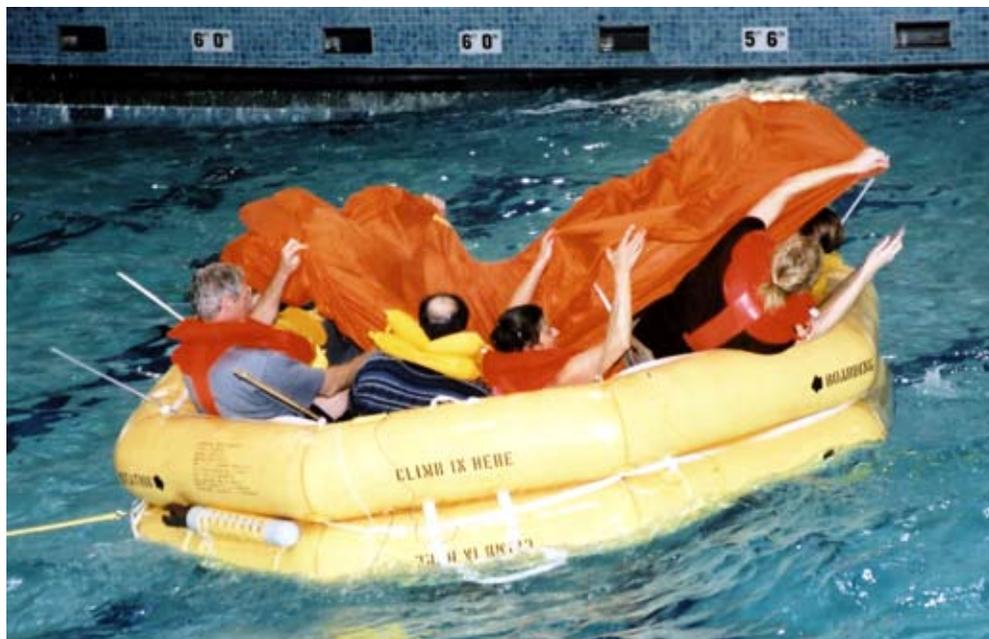
Manually erected canopies demand training and coordination to erect them quickly and correctly.

Time and effort required by inexperienced life raft volunteers to assemble and to erect canopies that were not designed to erect automatically was evaluated. This included the consideration of instructions, the functionality of the equipment and the practicality of the task. Of special interest was determining if manually assembled and erected canopies met the TSO requirement that the canopy “must be capable of being erected by one occupant of an otherwise empty [life] raft.”

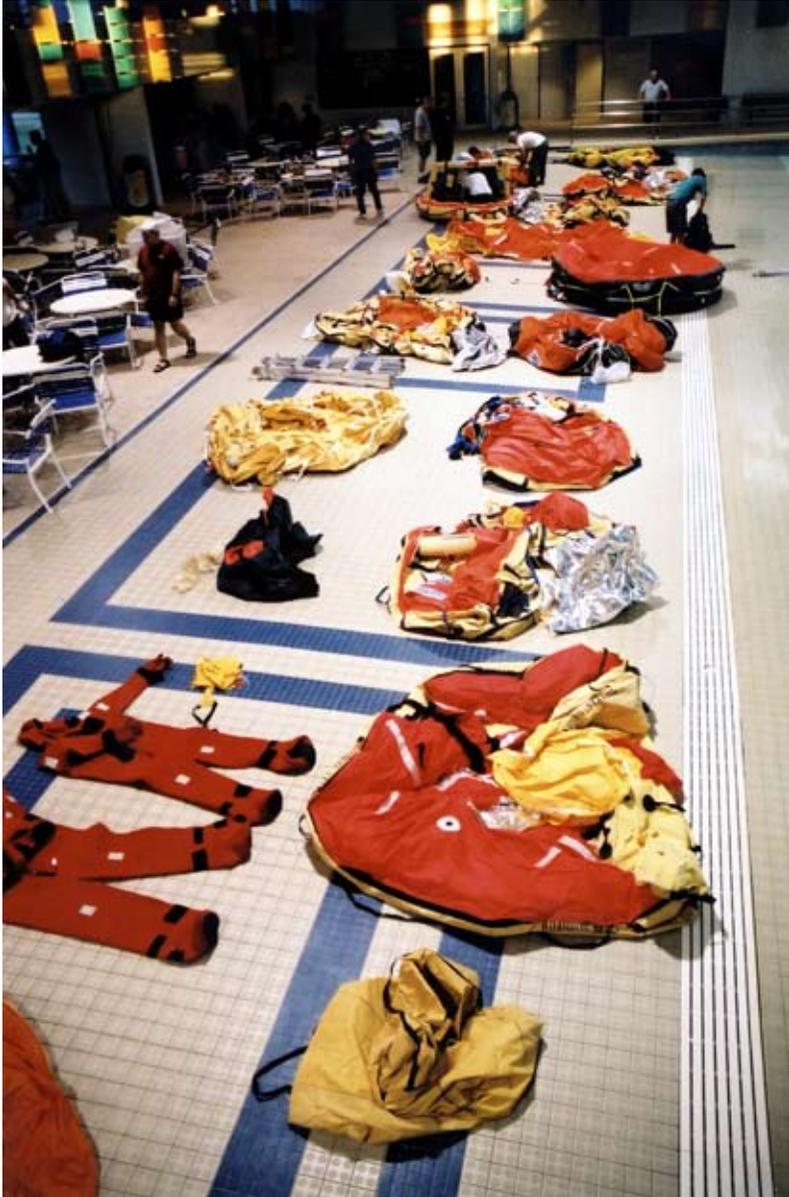
Each life raft
includes auxiliary
equipment ... generally,
this equipment has
no backup.

Equipment is arranged at the entrance to the wave pool at the close of each day's evaluation.

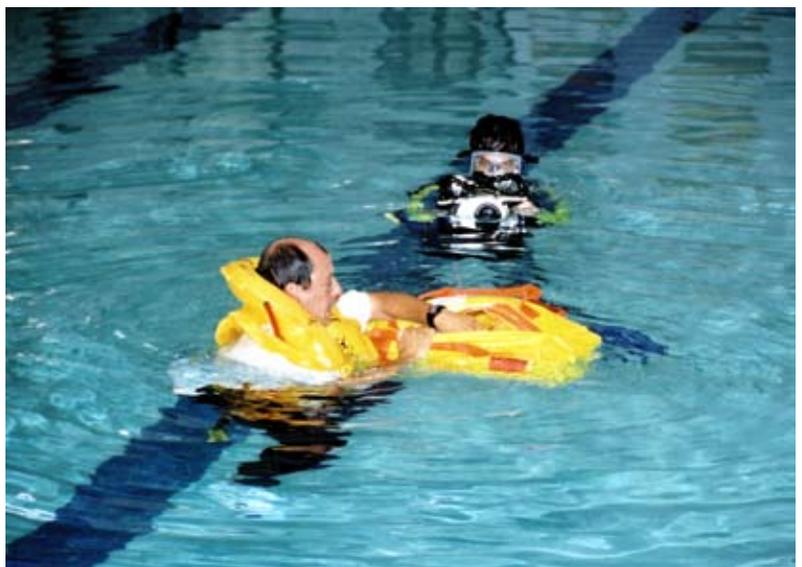
After throwing the raft pack into the pool, the volunteer leaped into the pool and used his hands to pry open the life raft pack, which is not the correct method of deploying any life raft.

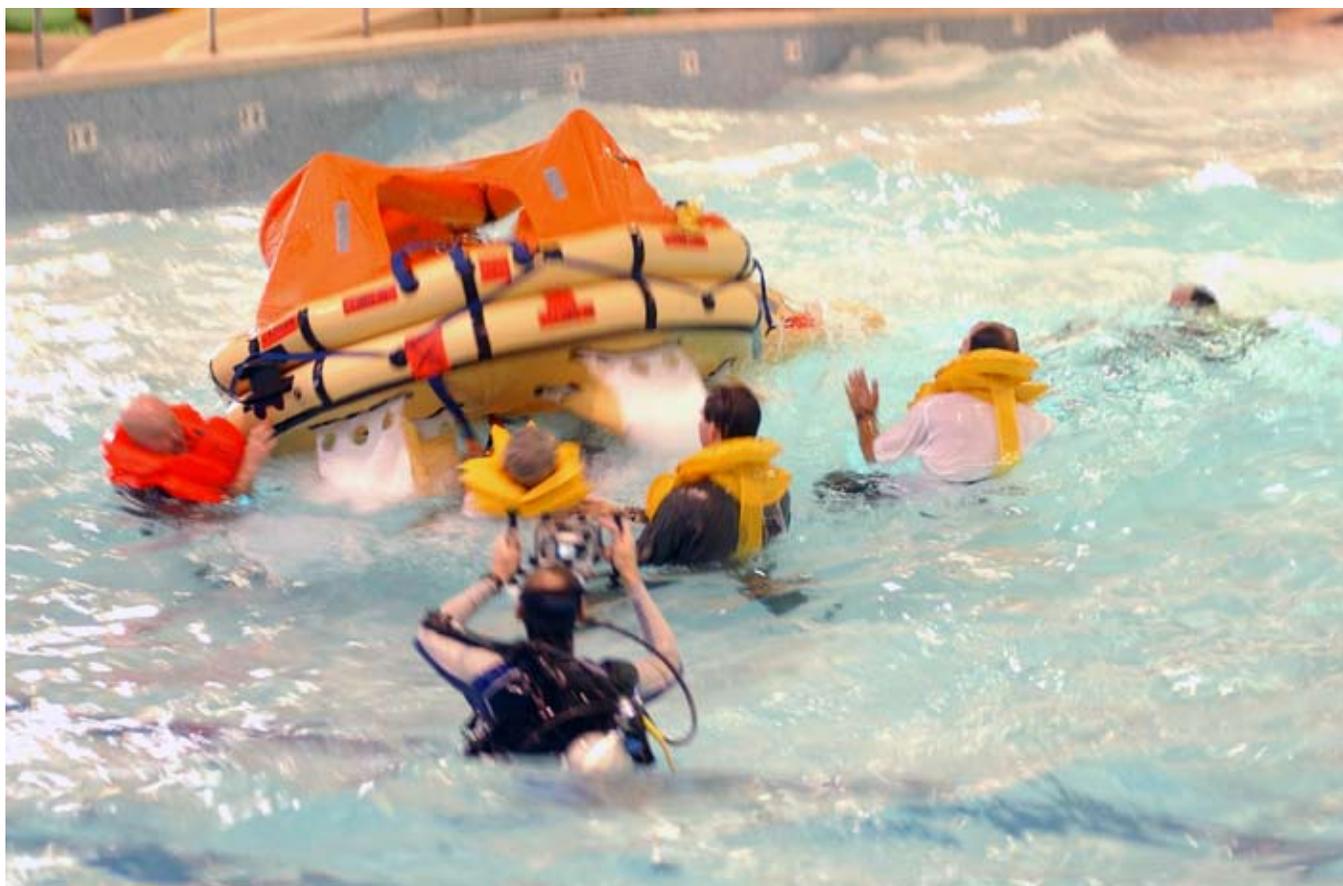
Volunteers in the life raft are attempting to capsize it.

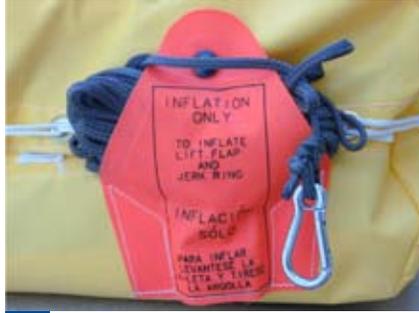
1

At one end of each valise was an orange flap (photo 1) with a single snap that retained the mooring/inflation line, but there was no immediate-inflation handle that would allow a survivor to quickly inflate the raft with a single short pull of the handle, rather than having to pull out the entire mooring/inflation line. The large snap clip on the end of the

mooring/inflation line hung loose and the mooring/inflation line was gathered under the flap and hung from each side of the flap. More-secure retention and protection of the mooring/inflation line and clip would help prevent inadvertent inflation. Under the flap was an excellent large aluminum handle that normally would be expected to be used for immediate inflation. Instead, the handle was secured to the far end of the mooring/inflation line, so that a survivor would have to pull out all the line to inflate the life raft. Instructions on the flap were in English and Spanish.

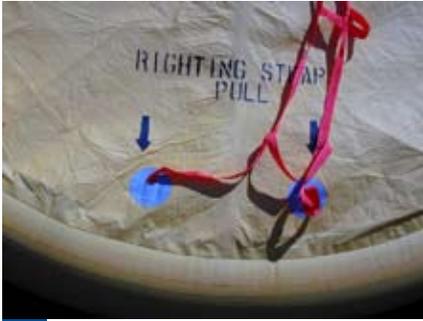
2

On the 13-person life raft, a triangular righting ladder (photo 2, page 261) was constructed of red one-inch-wide nylon webbing. A correctly implemented righting ladder was an excellent asset in righting larger life rafts, compared with a line or a line with grab handles. The righting location was to the left of the inflation cylinder (when the capsized life raft was viewed from the water). The instructions/arrows

on the exterior bottom of the life raft described how to use the righting ladder to position the life raft upright.

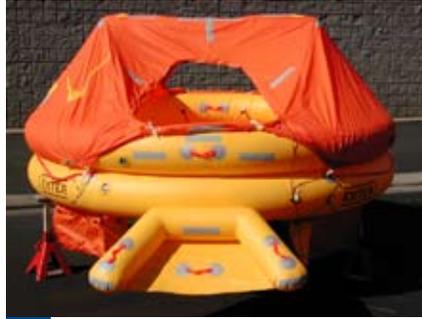
3

On the four-person life raft, the boarding ramp (photo 3) was located between the two buoyancy tubes, and on the 13-person life raft, which has two larger buoyancy tubes, the ramp was located below the midpoint of the lower buoyancy tube. While there were minor differences in construction, they did not seem to influence the effectiveness of the boarding ramp.

The inflatable tube support for the boarding ramp was splayed — that is, the tubes were spread apart in a U-shape on the four-person life raft, and in a truncated V-shape, in which a straight tube replaced the apex, on the 13-person life raft; both boarding ramps were about the same size. Buoyancy-tube fabric was attached across the bottom of each boarding

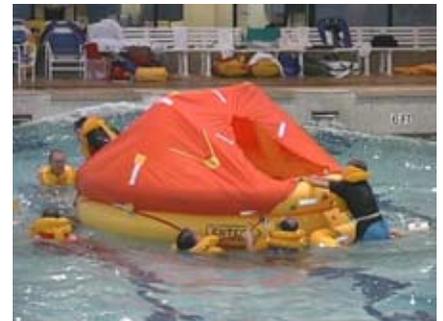
4

When wet, the floor became slick and contributed to the difficulty some volunteers had in boarding the life rafts. Some volunteers reported that the slickness and the slight slackness contributed to the boarding ramps collapsing into the water (photo 4) while they attempted to board the life rafts. This, in turn, led to the failure of two volunteers to board the 13-person life raft, which already was more difficult to board because of its larger buoyancy tubes and the resulting higher freeboard (distance between the water surface and the highest point on the buoyancy tubes, see Table 1).

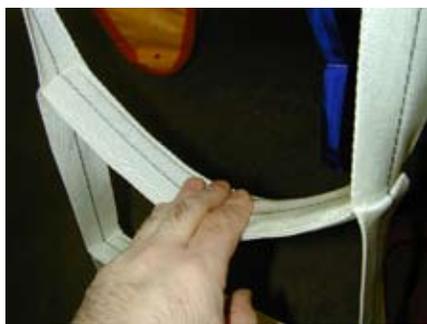
5

The alternate entry on both life rafts incorporated a three-rung ladder of white 1.75-inch-wide (4.44-centimeter-wide) nylon webbing with sewn-in flat semi-flexible rungs (photo 5). The ladder extended well below the bottom of the life raft, making it easy to climb, although its presence was not immediately apparent to some volunteers. Within reach of the ladder, a grab handle was midway on the exterior side of the upper buoyancy tube and another grab handle was on top of the upper buoyancy tube.

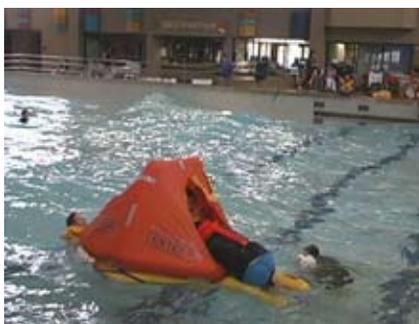
6

A means was provided to assist pulling oneself into the life raft. On the four-person life raft, one end of blue one-inch-wide nylon webbing was attached to the midpoint interior side of the upper buoyancy tube and the opposite end was attached to a plastic snap buckle, which was then attached to an anchor point in the middle of the floor. Two staggered handhold loops were sewn onto each side of the webbing. The webbing was useful to pull oneself into the life raft (photo 6) but the effectiveness of the handhold loops was diminished because they were not easily grasped. The loops were constructed of flat webbing, and they tended to lie flat together, rather than in an easy-to-grasp open loop. Grasping a handhold loop would require first spreading the webbing apart, but that could be difficult with cold, wet, numbed hands. This was a deficiency, in our opinion.

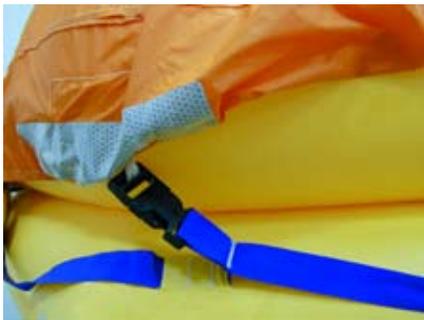
7

The bottom edge of the canopy was secured with an elastic hem, which stretched over the upper buoyancy tube, and plastic quick-release buckles (photo 7) were used to attach the canopy to anchor points on the four-person life raft; nylon ties were used to tie the canopy to anchor points on the 13-person life raft. This type of design allowed relatively easy removal of the canopy.

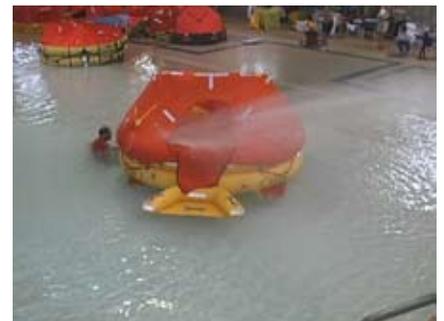
10

Because of the canopy problems, the life rafts were deficient in the rain simulation (photo 10). The rainwater collector appeared to function adequately. The canopy was equipped with a V-shaped diverter (photo 11) of semi-rigid fabric design that channeled water into a reservoir at the rainwater-collector tube (photo 12, page 264). This was necessary when the canopy slope was so steep that water would not naturally pool to the tube.

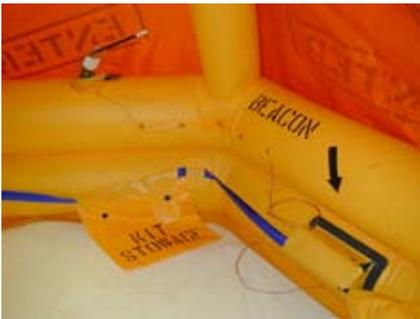
13

The grasp line was strung along the interior side of the lower buoyancy tube. The grasp line was difficult for some volunteers to use because the line was too low. Storage bags were attached to the grasp line (photo 13), which compromised its usefulness because survivors would have to compete with the storage bags for space on the line.

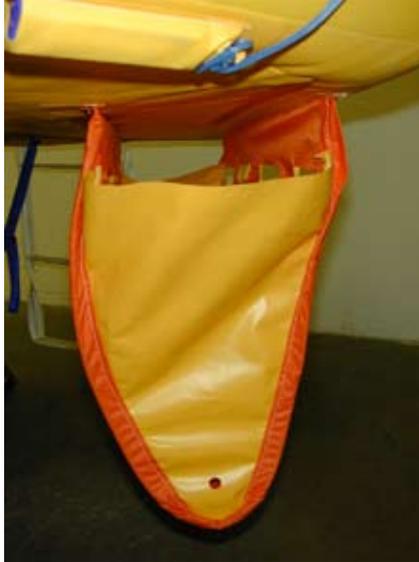
14

The water-ballast bags were unusual in both shape and construction. The bags were a truncated V-shape with rounded bottoms, and each bag (photo 14) held approximately 63 pounds (29 kilograms) of fresh water. A small 3/8-inch (0.95-centimeter) drain hole was in each end of the bag. A spring wire was fitted inside the rim at either end, helping to maintain the bag's shape. This had been expected to

The water-ballast bags were constructed of lightweight canopy fabric with buoyancy-tube fabric used only on the ends. The half-round inflow holes at the top had reinforcing trim sewn onto the rounded lower portion of the hole. We found tears in the fabric of the water-ballast bags of the 13-person raft during our evaluation (photo 15). The tears originated in the inflow holes at the top of the bags, where some essentially square corners in the cutouts would invite propagation of tears.

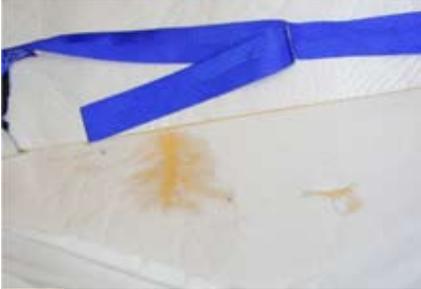
16

The foam proved to be vulnerable to damage (photo 16, page 265) during the evaluation. Sections of the insulation were

separated from the floor, and the surface of the floor was abraded. This was a deficiency, in our opinion. Air Cruisers said that it had added a layer of fabric that will withstand better the rigors of life raft use.

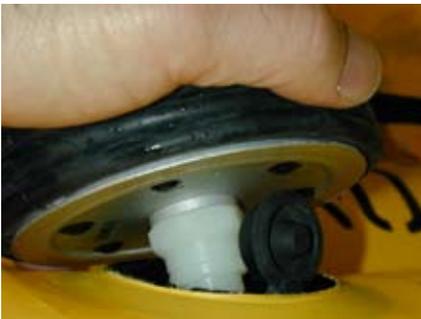
17

Volunteers had difficulty using the manual inflation pump on the four-person life raft because the cap interfered with positioning the pump (photo 17), even when the cap lay flat, by preventing insertion of the pump into the valve.

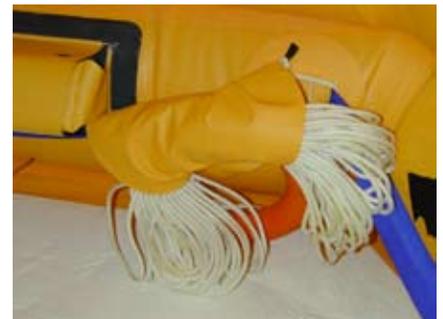
18

A heaving/trailing line (also called a “rescue line”) of mil-spec parachute cord was attached to a traditional round-ring rubber quoit. This was secured inside the life raft with a fabric clasp wrapped around an interior grasp line (photo 18) and secured with a metal snap. This location could interfere with the primary use for the grasp line. We were unable to throw the quoit without the line tangling. This was a deficiency, in our opinion. Moreover, the parachute cord was nylon, was not inherently buoyant and apparently did not comply with the TSO-C70a (paragraph 5.4) requirement for a “floating heaving/trailing line.”

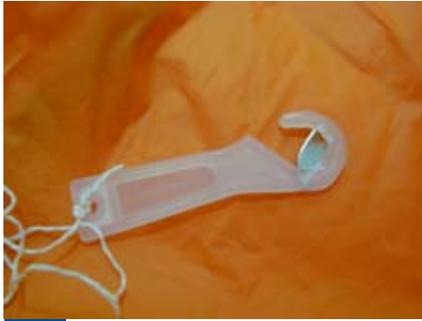
19

A tethered raft knife (photo 19, page 266), intended to be used to cut the mooring/inflation line, was retained inside a yellow sheath attached to a silver piece of fabric glued to the upper buoyancy tube. The contrast between the yellow and silver helped to make the sheath more noticeable. A long Velcro-secured flap, upon which was stenciled “KNIFE” in black, retained the knife. A hook-shaped guard

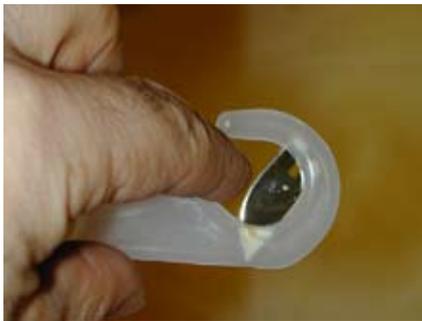
20

(photo 20) helped to prevent contact with the knife blade. On the four-person life raft, the sheath was on top of the buoyancy tube to the left of the entry (while boarding), tucked under the canopy, where it was less visible and subject to being overlooked.

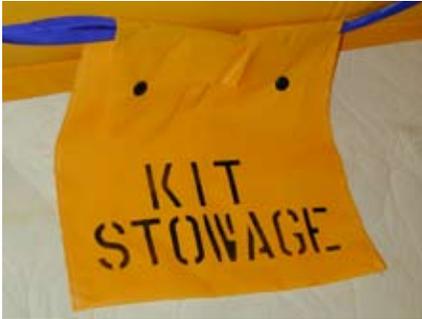
21

Two stowage bags were provided on the four-person life raft, and three larger bags were provided on the 13-person life raft. They were stenciled with “KIT STOWAGE” on the four-person life raft; a stencil on the buoyancy tube, “SURVIVAL KIT STORAGE,” identified the stowage bags on the 13-person life raft. The stowage bags were constructed of buoyancy-tube fabric in an envelope-like manner, 12.0 inches by 11.0 inches (30.5 centimeters by 27.9 centimeters) on the four-person life raft and 23.0 inches by 11.5 inches (58.4 centimeters by 29.2 centimeters) on the 13-person life raft. The flap was secured with two metal snaps (photo 21, page 267) or four metal snaps, respectively. The flap was folded over the interior grasp line and then snapped closed, which attached the bag to the interior grasp lines. This attachment was viewed as unsatisfactory by volunteers because the bags got in the way of grasping the lines, and unsnapping

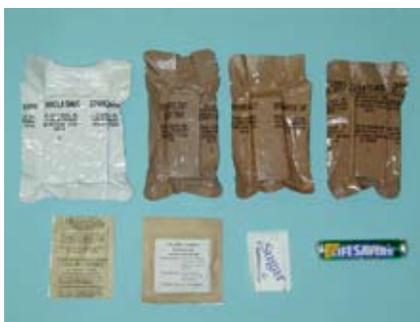
22

Air Cruisers included mil-spec survival rations containing 1,447 kilocalories. The contents of each sealed pouch (photo 22) included a pair of vacuum-packed granola bars, a corn-flake bar, a shortbread bar and a chocolate-chip dessert bar, along with a roll of Life Savers (a hard candy) and a packet each of sugar, instant lemon tea and chicken-flavored soup with a gravy base. The instructions on the package cautioned that the soup base should not be used if the user is exposed to, or has swallowed, salt water. Moreover, while the tea and soup packets could be consumed without any water, their directions required reconstitution with 14 ounces of water. This was not appropriate for a life raft, in our opinion. Volunteers said that the food bars were extremely dry and thirst provoking; again, not a desirable attribute for a life raft ration.

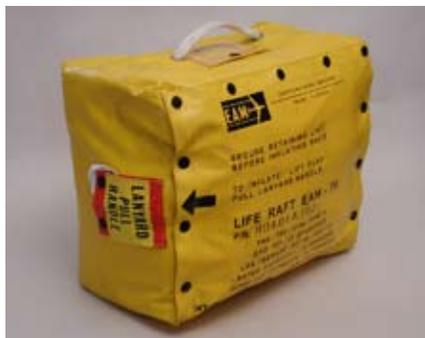
1

Classic life raft valises incorporated a separate valise for the SEP enclosed inside the primary valise and attached to the life raft with a nylon tether. The valise and SEP closures on the smaller Classic life rafts utilized metal snaps (photo 1, page 270) on three sides to close a top flap of the box-shaped valise. Based on the evaluations, this was not as secure as the slip-loop lacing used on EAM’s larger life raft valises, and we found smaller Classic life rafts with one or more of these snaps unfastened.

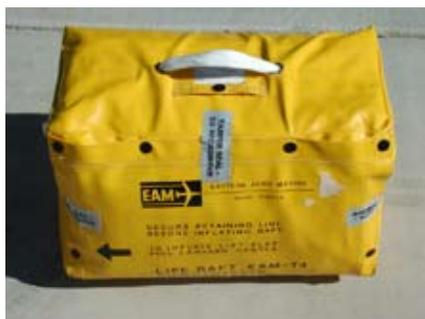
2

A single white nylon-webbing handle was attached to one side on smaller valises (photo 2); two or four white nylon-webbing handles (photo 3) were provided on the side and one on each end of the larger valises.

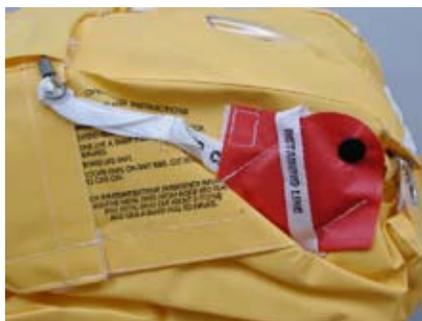
4

The VIP life raft had inflation instructions printed in small text on the end of the valise next to the mooring/inflation line. The text was partially covered by flaps and folds in the valise fabric (photo 4) and the mooring/inflation line.

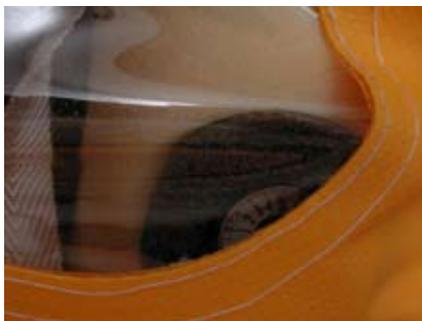
5

The VIP life raft also incorporated a clear round plastic window (photo 5) to view a pressure gauge for the inflation cylinder. By checking this gauge, the cylinder

pressure could be confirmed without conventional methods, such as weighing the life raft. The valise had a placard (photo 6) next to the gauge window that provided an "AMBIENT TEMPERATURE VS. MIN. CYLINDER PRESSURE" chart to determine if the pressure read on the gauge was satisfactory. While this is an innovative concept, there is a disadvantage: A pressure gauge can fail and cause a gas leak. The relatively fragile connection on the pressurized cylinder would be subject to damage if the life raft were mishandled. The gauge itself could be damaged in a ditching. Thus, this seems an unnecessary weak link in an otherwise robust inflation system. For example, the gauge was not aligned correctly in the life raft in the evaluation. Only by pulling the tight valise fabric aside did a portion of the gauge become visible.

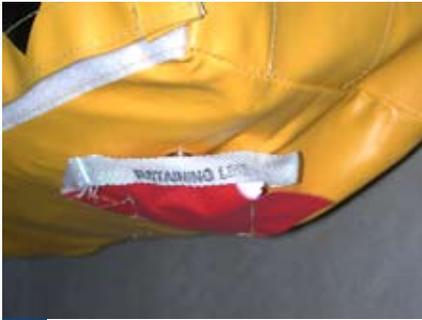
7

black on yellow fabric and affixed to the orange flap. The VIP life rafts had no information on the flap, but the mooring/inflation line was imprinted with small black indistinct lettering (photo 7) directly on the thin 0.5-inch (1.3-centimeter-wide) white nylon webbing, “RETAINING LINE,” and the end loop affixed around the flap so it was visible.

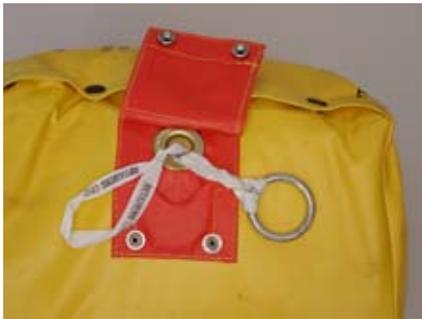
8

The 0.5-inch-wide nylon-webbing mooring/inflation line (photo 8) on all EAM rafts was terminated by a loop sewn back onto the webbing, creating a 4.0-inch (10.2-centimeter) handhold

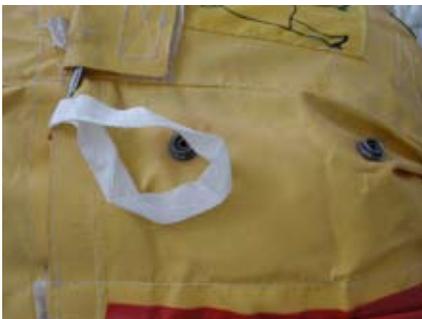
9

(photo 9). The only means to secure the life raft to the aircraft would be to use the webbing; this method requires a person to tie a knot that won't fail. This appears to be inconsistent with TSO-C70a (paragraph 5.2): “The ripcord grip or the attached static mooring line must be provided with means for attachment to the aircraft.” This was a deficiency, in our opinion. A snap clip would offer a readily usable means to secure the mooring/inflation line to the aircraft.

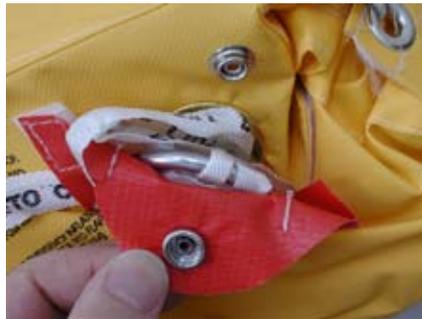
10

On the life rafts so equipped, the immediate-inflation handle was a 2.0-inch-diameter plated-steel ring, providing a narrower grip area than the ripcord grip required in TSO-C70a (paragraph 5.2). A survivor would be able to grip the ring (photo 10, photo 11) with only two fingers or three fingers (average male or female, respectively). This was a deficiency, in our opinion. The 12-person Type I life raft was not equipped with the aforementioned ring or any other similar device to serve as the “primary inflation control” required in TSO-C70a (paragraph 5.2), which was a deficiency, in our opinion.

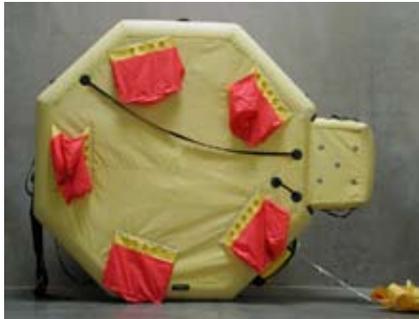
12

The VIP life raft was equipped with a black one-inch-wide nylon-webbing righting line that crossed the bottom of the life raft off-center (photo 12), and a single black nylon-webbing grab handle adjacent to the line at the righting point. The righting aids functioned satisfactorily,

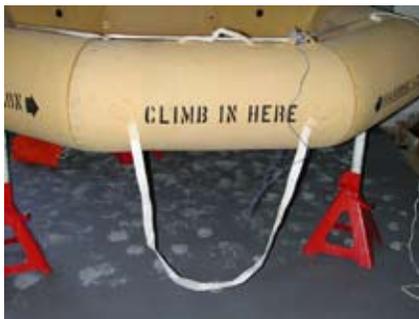
13

The EAM Classic Type II life rafts had a single boarding location (photo 13) with a single long loop of one-inch-wide white nylon webbing hanging down at the

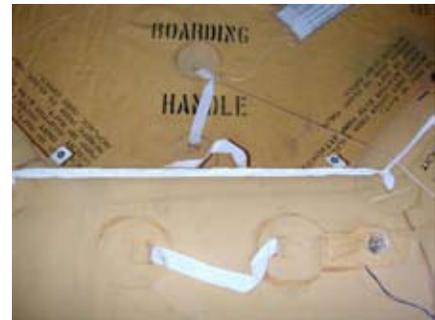
14

boarding position to be used as a foothold, which volunteers often overlooked. Three white nylon-webbing grab handles (photo 14) were provided, one on top of the buoyancy tube, one midway down on the interior side of the buoyancy tube and one on the floor, as well as the interior grasp line. The foothold was not much help, even for volunteers who recognized it and used it; the foothold would swing under or away from the life raft after any

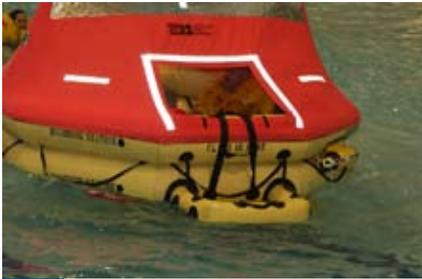
16

The VIP life raft (seven-person and larger) was equipped with an inflatable boarding platform (photo 16) and an interior boarding ladder of black two-inch-wide nylon webbing at the primary entry. The boarding platform had a fabric bottom with five drainage holes (photo 17). There were black two-inch-wide nylon-webbing grab handles on the top of the

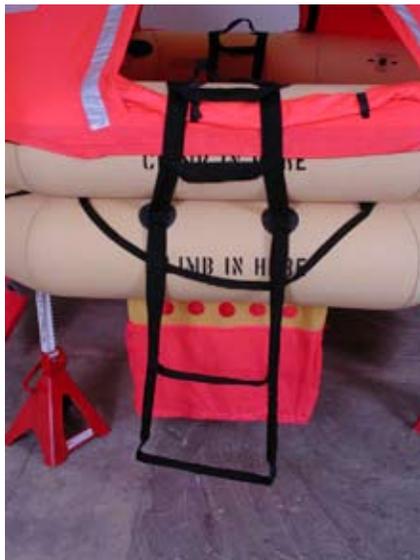
19

The two-inch-wide black nylon-webbing beams of the boarding ladder (photo 19) encased a two-part telescoping, spring-loaded tube that was compressed for packing and which was supposed to extend automatically upon inflation of the life raft. The two rungs were attached

to the lower section of the beams, both rungs hanging below the lower buoyancy tube. The ladder beams were attached to and hung from the upper portion of the lower buoyancy tube. The telescoping upper section of the rigid beams was forced against the exterior side of the lower buoyancy tube when weight was applied to the ladder, thus preventing the ladder from swinging under the life raft, as occurs with webbing-only ladders.

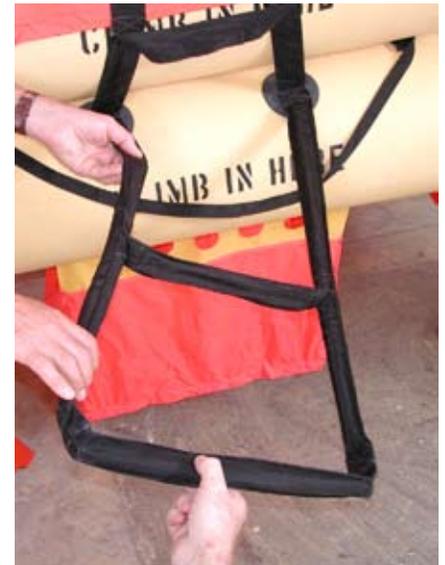
20

The result was a secondary boarding aid that all volunteers found to be effective, even though on the evaluation life raft, the left-hand beam failed to extend (photo 20), so only one beam was working as designed. This was a deficiency, in

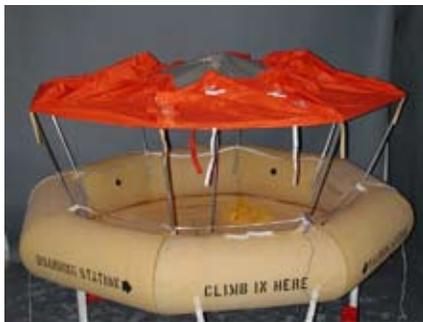
21

The EAM Classic life raft canopy was a manually erected stick-built design using lightweight translucent orange rip-stop nylon fabric (photo 21). The canopy option provided a section of metalized polyester fabric (photo 22), which is radar reflective but too small to be effective. Moreover, is not retroreflective, so it is

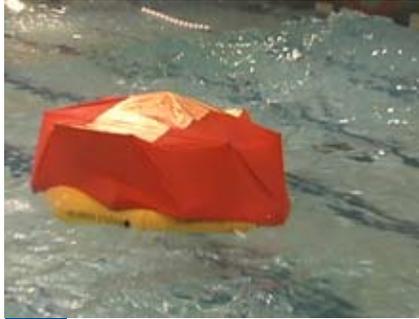
22

ineffective in reflecting light, nor will it reflect radar signals effectively. (The U.S. Coast Guard has suspended the SOLAS requirement that *marine* life rafts in the United States be equipped with a radar reflector until one is proven effective for this application.)

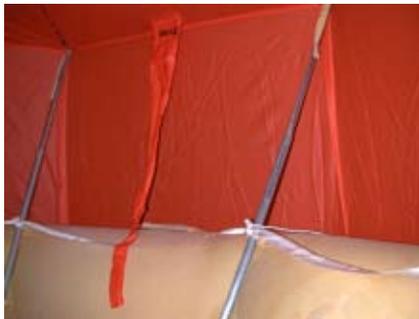
23

A water-collection tube was sewn into the canopy top surface (photo 23), approximately at the midpoint between the center mast and the periphery. Water pooling on the top surface naturally flows to the tube.

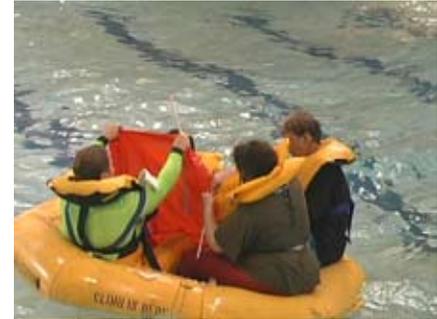
24

The telescoping canopy-support rods often were the source of considerable frustration for volunteers (photo 24). Problems manifested themselves during the installation of the canopy, and demonstrated that previous training would be required to erect this canopy.

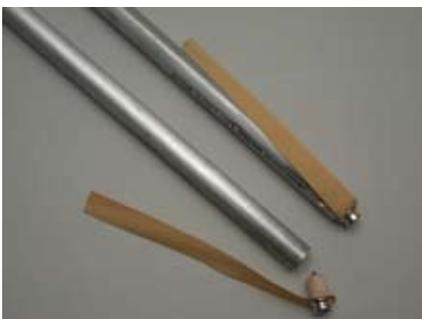
26

The male snaps at the ends of the canopy-support rods (photo 26), which connected to the canopy and life raft, were screwed into wooden plugs that were then press-fitted into the ends of the tubing. Many of these wooden plugs fell out easily or were pulled out by the volunteers while assembling the canopy; then the small plugs had to be found — which would be difficult to accomplish in a crowded raft or if lost overboard — and reinserted in the rod. Only by soaking them in water for about 10 minutes to 15 minutes would these wooden plugs expand and remain in place. No information was provided about this problem, which was a deficiency, in our opinion.

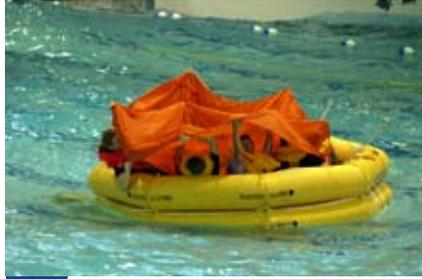
27

Despite instructions stenciled on the interior side of the buoyancy tube, the volunteers improperly installed the periphery canopy-support-rod base in three of four evaluations (photo 27).

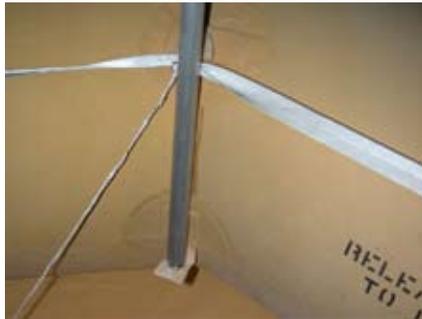
28

The canopy-support rod had to pass through a loop of nylon webbing and then be snapped onto a small retainer tab equipped with a female snap (photo 28). Volunteers consistently failed to insert the canopy-support rod through the loop.

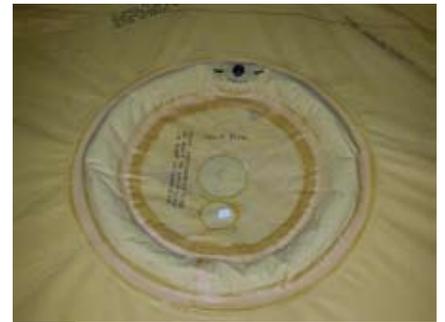
29

The Classic Type I life raft had a manually inflatable “donut” (photo 29) surrounding the center mast (or a pillow under the mast on the six-person life raft). This provided added support for the center of the life raft floor, preventing the center mast from depressing the floor too far into the water.

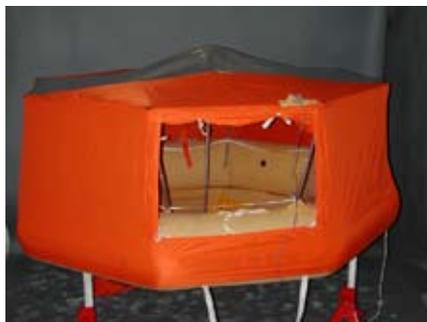
30

The Classic Type I life rafts had a pair of openings on opposite sides of the canopy; the Classic Type II life rafts had a single opening. These were equipped with closure flaps that could be secured with cloth ties along the two sides, but there were gaps between the ties; the closure flap was not weathertight. The closure flap could be rolled up and secured in the open position with cloth ties (photo 30, page 276).

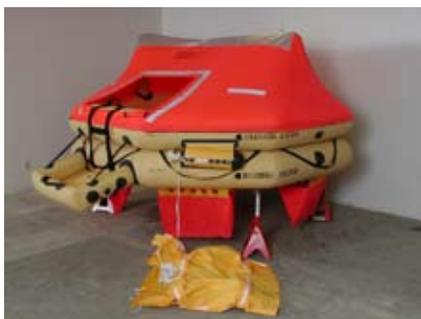
31

The VIP life raft had a single square-arch self-erecting canopy (photo 31) with a 5.0-inch-diameter (12.7-centimeter)-diameter inflatable canopy-support tube. The lightweight translucent rip-stop nylon fabric was orange, with much greater conspicuity than the traditional lightweight orange canopy fabric. The ridge of the canopy was covered with a metallic-coated (or metalized) fabric. Effective radar reflectivity was no more likely than with any other nonreflective radar reflector. Because this fabric covered only a small portion of the upper surface of the canopy, there was little likelihood that ELT signals would be affected.

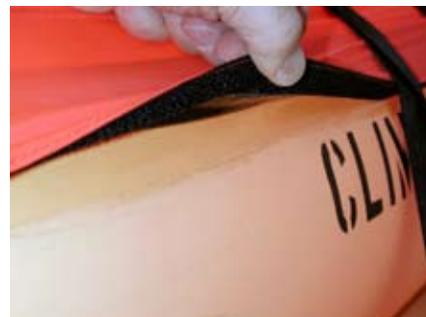
32

The canopy was attached to the buoyancy tube with a two-inch-wide Velcro strip. After the second inflation of this raft, it was thoroughly rinsed and left overnight indoors to dry. The next morning, we discovered that the Velcro strips used to secure the canopy to the upper tube had come unglued along one section of

the raft (photo 32). The Velcro also was coming unglued on two other sections. The tension of the tightly stretched canopy was pulling up the Velcro. Temperature was approximately 95 degrees F (35 degrees C). In addition, the Velcro attachment of the canopy to the tube was not even and, in some places, only 0.5-inch (1.3 centimeters) of the 2.0-inch (five-centimeter) Velcro was attached.

As to the Velcro failures, EAM said that the Velcro had been removed from the tube sections of the life raft to determine if it had been applied correctly. EAM reported that "adhesion application was found to be uneven in the few, small areas (approximately 18.0 linear inches [45.7 linear centimeters]) where you saw the Velcro lifting. However, in the

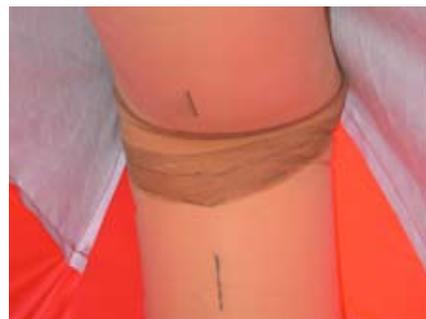
33

During the in-water evaluation, the glue on the canopy-support tube failed where the tube was folded to create an arch. There was no reinforcement of this section of the tube (photo 33). When the glue failed, the tube was retained by the

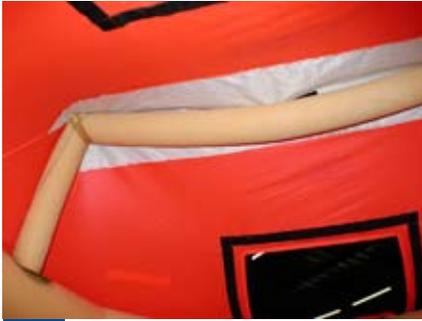
34

canopy. The canopy became elongated and created a dip in the center of the arch (photo 34, page 277), which resulted in the canopy collapsing during the rain simulation. The black fabric-reinforcing donut, where the canopy support tube was attached to the buoyancy tube, also experienced a partial glue failure (photo 35, page 277).

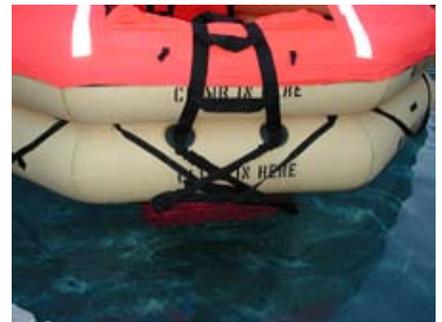
36

Both boarding-ladder beams extended fully, but the ladder became hung on the exterior lifeline (photo 36). (The primary boarding aid deployed correctly.) Upon entering the water, we made what we believed would be the natural reaction of a survivor by pulling on the ladder, which only worsened the situation. Only by lifting the ladder legs up and clear of the lifeline (photo 37) was it possible to deploy the ladder. This proved awkward to accomplish from the water. This was a deficiency, in our opinion.

EAM said that this had occurred a few times during deployment tests, and had been remedied by test subjects lifting the ladder from the lifeline.

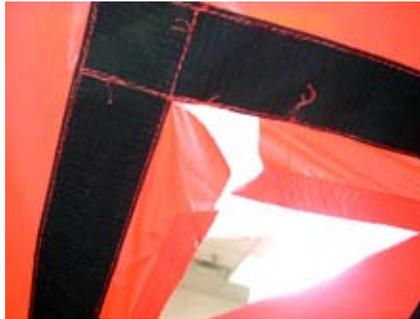
38

Both Classic Type I and Type II life rafts leaked significantly in the same areas. The flap entries were impossible to seal completely and allowed considerable water to enter through the gaps. Some flaps blew open, despite the cloth ties; others held. Tying technique apparently had a lot to do with their effectiveness. These gaps also would allow the entry of cold air and spray in windy conditions.

All the canopies allowed large quantities of water into the interior of the life raft, because the elastic skirt was pushed over the buoyancy tube by the water spray, creating a gap between the bottom edge of the canopy and the buoyancy tube. The sewn seams of the canopy fabric showed some stress and signs of parting at some stress points on some of the canopies, even after our brief evaluation. This was a deficiency, in our opinion.

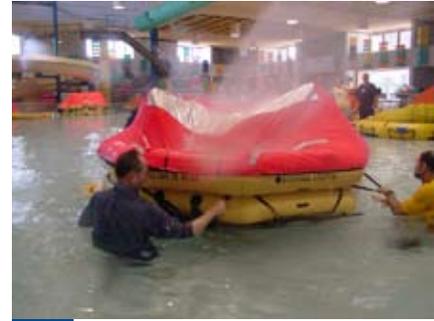
39

The VIP life raft canopy collapsed during the rain simulation (photo 39). It appeared that this was related to the earlier canopy-support-tube failure. We were not able to re-evaluate this during the second inflation after it was upgraded. This was a deficiency, in our opinion. The Velcro closure of the canopy entry

flaps held, but large quantities of water leaked through the Velcro around the entry flaps.

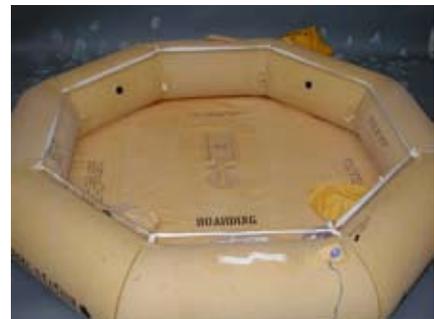
40

The Classic Type II life rafts had only a single lifeline that was located on the upper section of the interior of the buoyancy tube (photo 40). The lifeline could not be seen easily by a survivor floating in the water. It could be difficult or uncomfortable to grasp in the water by survivors, particularly those with shorter arms, who would have to reach over the tube. In our opinion, this lifeline did not meet the requirement of TSO-C70a (paragraph 4.8) that it "must encircle the life raft on the

outside periphery so that it can be easily grasped by persons in the water.” The lifeline was not visible or functional while the life raft was overturned. This was a deficiency, in our opinion.

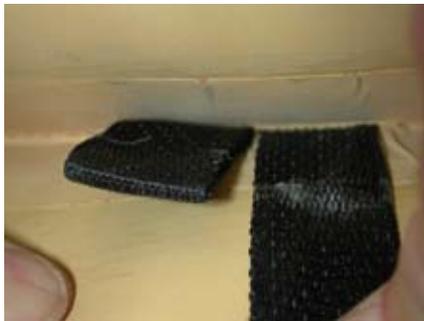
41

The VIP life raft had a lifeline and an interior grasp line of black one-inch-wide nylon webbing. A loop of webbing was provided for each section of the octagon, inside and out, secured to the life raft by passing the webbing through the joint between the two buoyancy tubes where it was sewn in place (photo 41). We had some reservations about adding any stress to this joint because it is a common life raft failure point.

EAM said that this is preferable to the method used by all other manufacturers, as well as by EAM on their other life rafts, of gluing patches to the buoyancy tube to which the lines are secured, which they said can lead to a buoyancy-tube failure if a patch is pulled off. This is not in compliance with U.K. Civil Aviation Authority (CAA) requirements, for example, “that failure or tearing off of the attachment will not damage any inflated compartment.” In other words, the glue shall fail before the integrity of the buoyancy tube fabric is compromised. The

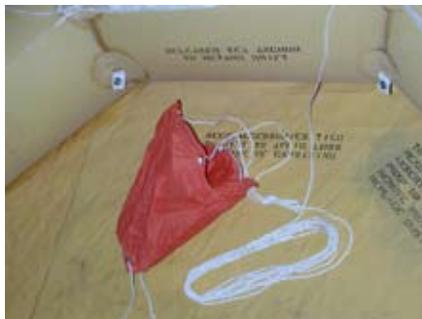
42

The Classic life rafts had no provisions for ballast. This was a deficiency, in our opinion. EAM did fit a pair of sea anchors on short (36-inch [91-centimeter]) tethers (photo 42), which they said in their brochure “improves raft stability.” Volunteers noticed no difference in raft stability with the anchors or without them. The conical anchors were 12.0 inches (30.5 centimeters) in diameter on the large end and 3.0 inches (7.6 centimeters) in diameter at the other end. They were constructed of rip-stop nylon canopy fabric with a nylon cinch line at the exit end, but it seemed to make no difference if they were open or closed.

The short sea anchors did not appear to comply with TSO-C70a (paragraph 5.3), which says, “The line must be at least 25 feet [7.6 meters] in length.” It may be that the life rafts so fitted did meet the drift requirements of this paragraph (we had no means to evaluate this), but being so small and on such short tethers they could not have any anti-capsizing effect.

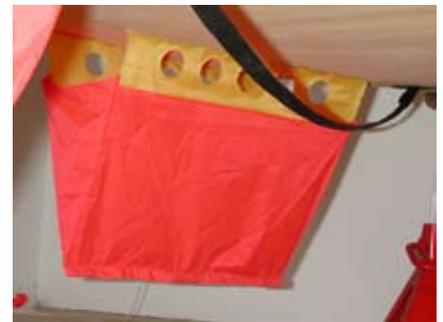
43

The VIP life raft had five V-shaped water-ballast bags (photo 43) that had an approximate capacity of 63 pounds (29 kilograms) of fresh water. The bags had polyurethane-coated nylon-fabric attachments and were constructed of rip-stop canopy fabric. We experienced no damage to the bags as a result of our evaluation. Those water-ballast bags were weighted, so we expected them to drop immediately upon inflation and to fill rapidly; they required one minute and four seconds to drop, despite induced movement of the life raft. This could be a problem in some situations and was a deficiency, in our opinion.

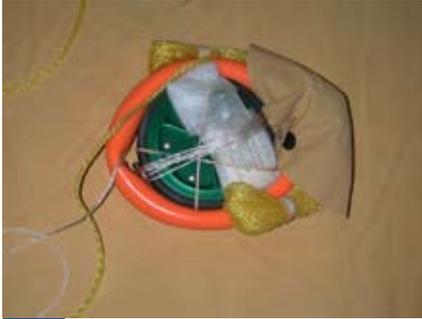
45

pump and difficult to force into the topping valve; the tether had to be cut (photo 45), which risked loss of the adapter. A 9.0-foot (2.7-meter) twisted nylon cord tether was attached to one of the pump's finger loops, but there was no attached instruction to secure the line to the life raft, potentially putting the pump at risk of loss — a deficiency, in our opinion.

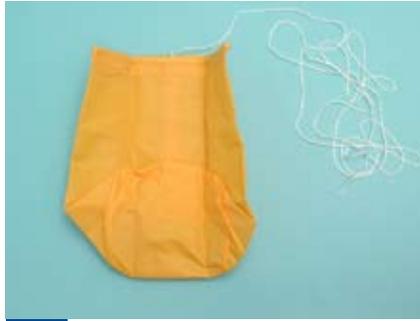
46

The VIP bailer was packed inside the SEP where it was inaccessible immediately upon boarding. The 8.0-quart (7.6-liter) capacity bailer was constructed of sewn polyurethane-coated life vest fabric. An 8.8-foot (2.7-meter) twisted nylon cord tether was attached to a metal grommet on the bailer, but no attached instruction directed the survivor to secure it to the life raft, a deficiency, in our opinion.

Neither bailer was fitted with a handle (photo 46), or had any reinforcement to the mouth that would keep it open, which makes a bailer more effective. The bailers leaked at the sewn seams. While not an issue for bailing, for other uses, such as holding fresh water or emptying collected waste, this was a deficiency, in our opinion.

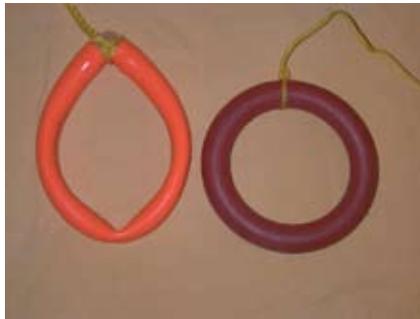
47

For the required heaving/trailing line on its Classic life rafts, EAM used mil-spec parachute cord, which was not inherently buoyant and did not appear to be in compliance with the requirements of TSO-C70a (paragraph 5.4) for at least one “floating line” and a round-rubber buoyant quoit (photo 47). It was packed inside a small pouch; on the Type I life raft, it had to be retrieved from over the side.

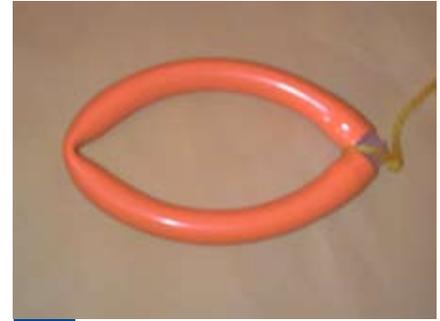
48

The VIP heaving/trailing line was inherently buoyant 3/16-inch braided-polypropylene line with a special quoit. This was constructed of a 90-degree plastic barbed hose fitting with attached orange-plastic tubing that was kinked (photo 48) to return to the other side of the plastic fitting. The line was attached to the fitting, and the result was a

somewhat elliptical-shaped device with a very narrow-angle end grip, which was uncomfortable to grasp and might be difficult with a cold hand. The line was coiled, gathered with a pair of rubber bands, and then the line and quoit were suspended from a grasp line using a fabric clasp with two metal snaps. Volunteers were unable to throw the quoit successfully because the line tangled, a deficiency, in our opinion.

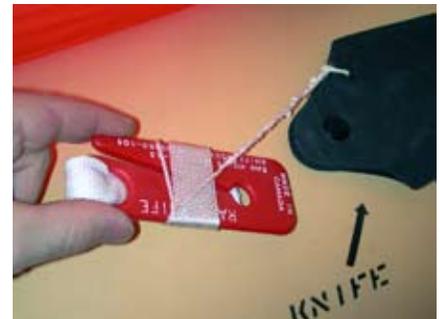
49

The tethered raft knife was stored inside a sheath with a snap closure in the Classic life rafts; the sheath was attached to the buoyancy tube at the closed end. The raft knife was placarded with a stenciled “KNIFE” on the buoyancy tube below the sheath (photo 49) with an arrow pointing to the sheath. Stenciled instructions were partially obscured by the interior boarding ladder on the VIP life raft. On the VIP Deluxe life raft, printed placards added an instructional pictorial instruction (which illustrated a life raft mooring/inflation line being cut loose from a boat).

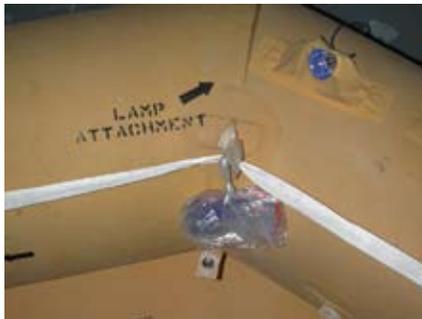
50

The TSO-approved locator light on Classic life rafts was attached to the buoyancy tube adjacent to the entry (or adjacent to an entry if there were two entries, as on both sides of the Type I life raft). Another locator light was stored in a plastic bag (photo 50) and attached to the life raft lifeline. After the canopy was erected, an attachment was provided for the light on the canopy (photo 51). With the canopy erected, the light located on the buoyancy tube near an entry became the interior light, but it was not high enough to be very effective. On the first Classic life raft that volunteers evaluated, the locator light was ripped off the buoyancy tube during boarding by one of the volunteers. Being located adjacent to the entry made such a loss possible.
