Flight Safety

SEPTEMBER 2003–FEBRUARY 2004

Waterproof Flight Operations

■ A comprehensive guide for corporate, fractional, on-demand and commuter operators conducting overwater flights

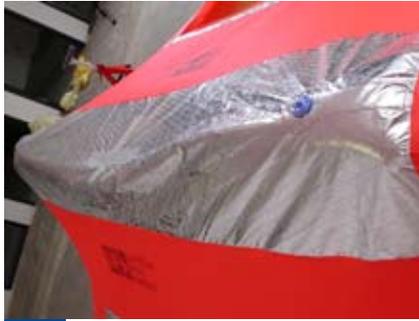
52

The VIP life raft was equipped with an exterior locator light affixed to one end of the canopy at the peak (photo 52). No interior light was fitted. The VIP Deluxe life raft was equipped with a manually switched lithium-battery-powered ACR HemiLight (photo 53), which was secured

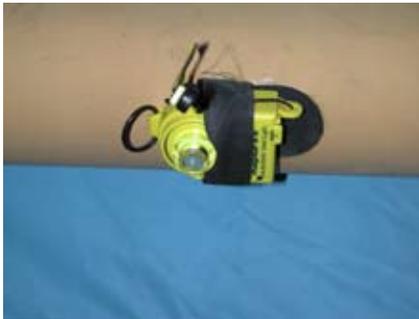
53

to the center underside of the canopy-support tube. This was a superior source of illumination for the interior, compared with using the traditional survivor-locator light, which is not designed for general area illumination. Being able to switch the light off to conserve the battery for later use was another advantage.

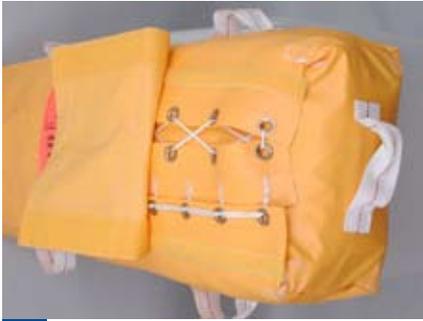
1

The standard yellow valise was of conventional box-style construction (photo 1, page 285). The valise was fastened with a Velcro seam along the middle of the top surface with yellow Velcro that matched the valise fabric. Use of a matching color would make the Velcro seam less visible

to a survivor and would make it less likely that survivors would attempt to open the valise at the seam. The valise had white nylon-webbing handles — two grab handles on the face of the smaller valises and two grab handles along each side of the larger valises — with one grab handle at the end opposite the inflation mechanisms.

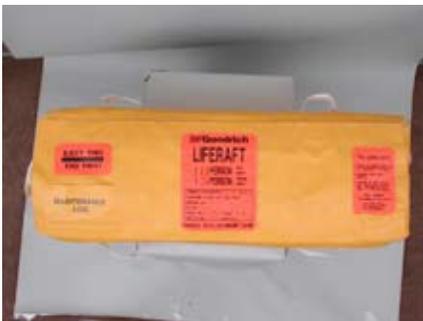
2

Orange placards were used for essential information and for nonessential information (photo 2); thus, a survivor's attention could be misdirected at a critical time. The manufacturer-and-data placard was the largest placard, and black text was printed against the orange background. A smaller orange placard was printed with the instructions "EJECT THIS END FIRST" with an arrow pointing in the correct direction.

(At an NBAA convention, a model of this life raft was exhibited, and the orange placard with nonessential information had been replaced with a silver placard, allowing the user to distinguish it from essential information on the orange placards.)

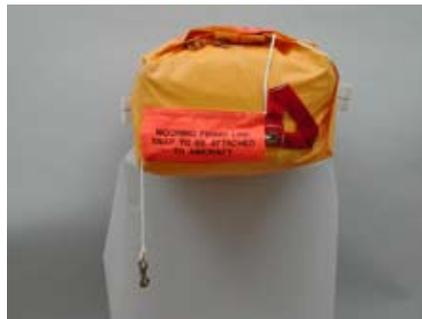
3

No adjoining instructions/identification of the immediate-inflation handle were located on one end of the hard case or the valise, although such information was located on the top surfaces of both packages. Because the immediate-inflation handle was boldly visible (photo 3), it might be selected inadvertently for inflation, in lieu of the mooring/inflation line.

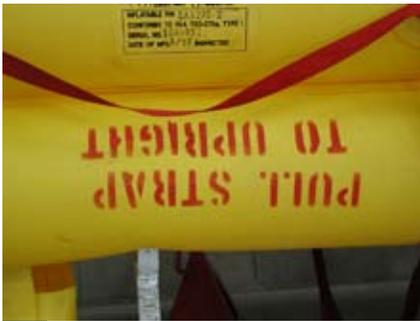
5

Goodrich stenciled explicit righting instructions on one side of the life raft; they were designed to be read when the life raft is capsized: “PULL STRAP TO UPRIGHT” (photo 5). On the opposite side of the life raft was stenciled: “RIGHT FROM OTHER SIDE.” The stenciled text was in red on the yellow fabric. (The life raft exhibited at the 2003 NBAA convention had text accompanied by pictorial righting instructions that provided very clear and unambiguous instructions. Placards and instructions were printed rather than stenciled, so readability was improved.)

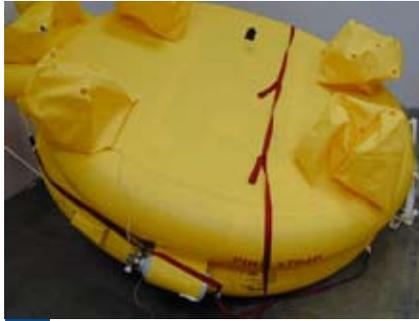
6

A single red one-inch nylon webbing with two hand loops sewn into it was attached from one side of the life raft across to the other side in the middle of the life raft (photo 6). The hand loops laid flat and were not easily grasped, but they helped to counteract slipping on the exterior bottom of the life raft. (The life raft exhibited at the 2003 NBAA convention had a righting ladder constructed of one-inch nylon-webbing rails with five two-inch nylon-webbing rungs. This would appear to address concerns about

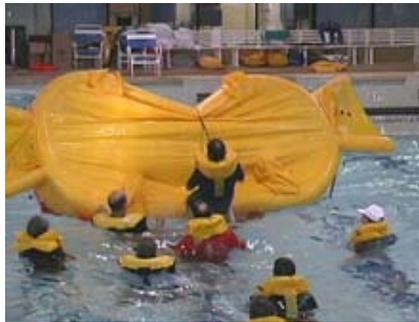
7

The inflatable canopy-support tubes were relatively narrow — four inches in diameter. When the life raft was capsized, the canopy-support tubes had insufficient buoyancy to lift the life raft off the surface of the water; the canopy support tubes were submerged and the life raft floated flat against the water on the upper buoyancy tube. When righting the 10-person life raft, the submerged canopy became a sea anchor that had to be overcome to turn it upright (photo 7); a small and lightweight person could have difficulty accomplishing the task. The canopy remained collapsed after the life

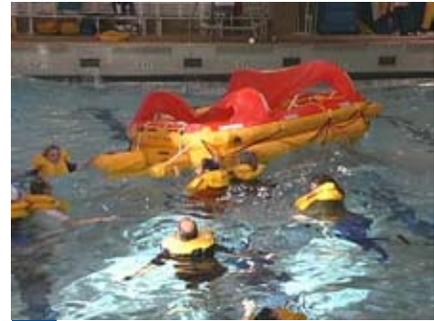
8

raft was righted (photo 8), a deficiency, in our opinion; the volunteers pushed it up after boarding.

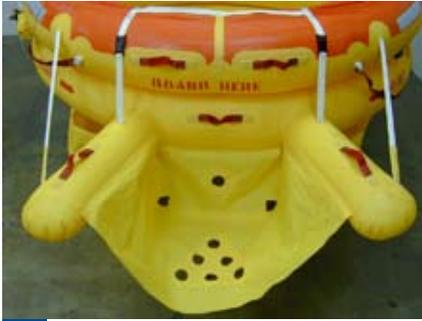
9

A pair of inflatable tubes projected from the life raft at the entries (photo 9, page 287). A pair of white one-inch nylon-webbing straps from the upper buoyancy tube attached to these tubes, near their outermost ends. They served as braces to prevent bending when weight was placed on the platform. A large section of fabric was hung between the projecting tubes and was lower; this platform satisfactorily supported the heaviest volunteers. Height to the top of the lower buoyancy tube was approximately 28.0

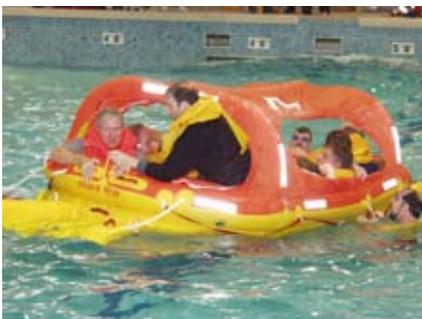
10

Despite the holes, the fabric platform tended to float upward (photo 10), and this caused some hesitation on the part of some volunteers as they stopped to assess the situation and then pushed the fabric down into the water before proceeding with boarding. Volunteers boarded with minimal difficulty, although several reported that there was room for improvement. (The life raft exhibited at the 2003 NBAA convention had a more conventional boarding platform installed with a flat fabric floor and an inflatable crosspiece at the fore

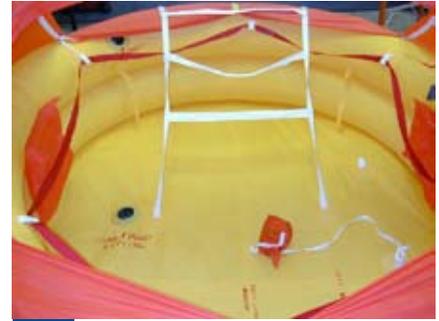
11

The interior boarding ladder, located in the midst of the volunteers, proved an annoyance even when released. One volunteer suggested using the raft knife to cut the boarding ladder loose from the floor to eliminate the annoyance. The alternate solution, used effectively on life rafts by Air Cruisers, EAM and Winslow, would be quick-release buckles at the bases of the ladder rails inside the life raft.

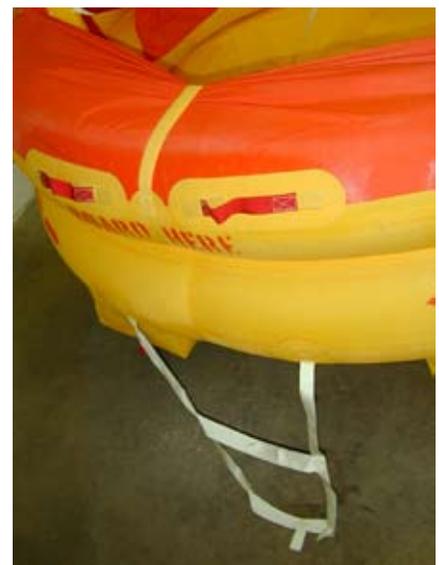
person life raft; at the second entry, a single one-inch nylon-webbing loop hung from the lower buoyancy tube approximately 12 inches and had grab handles near the top of the tube (photo 12). This entry was unsatisfactory for many volunteers, especially those who were shorter than average, had minimal upper-body strength or were mid-section heavy or bottom heavy. As with the EAM VIP four-person life raft, this type of boarding aid is deficient, in our opinion; it does not comply with the requirements of TSO-C70a (paragraph 4.6).

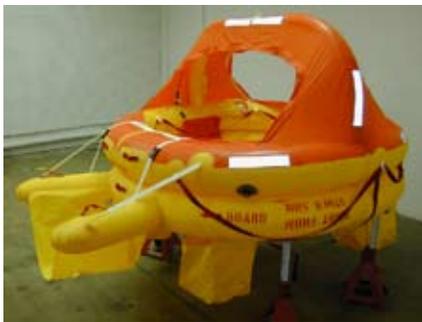
13

The four-person life raft was equipped with a four-inch-diameter auto-erecting stay-erect single-arch canopy-support tube located on the short (eight-inch) straight center section of the buoyancy tube (photo 13). The arch incorporated square corners for improved headroom. The canopy was constructed of lightweight translucent orange coated rip-stop nylon fabric. As with all the translucent fabric canopies, sun shining through it gave everything and everyone an unappealing orange tinge.

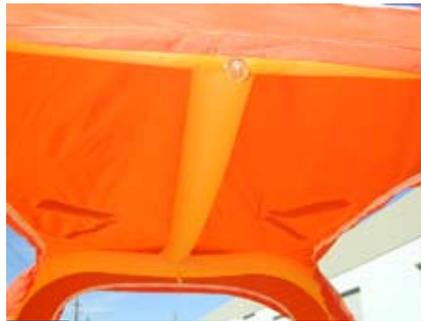
14

The larger life rafts were equipped with an auto-erecting, stay-erect canopy. A pair of four-inch canopy-support tubes were fitted at the corners of the life raft (photo 14). A central tube connected the two arches across the center of the life raft, adding rigidity to the arches. The canopy fabric was glued to the top of the canopy-support tubes and to the central

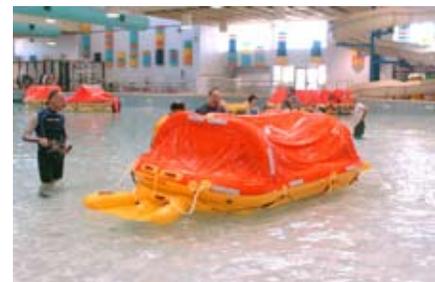
15

The canopies on the larger life rafts sagged considerably after they became wet, significantly reducing headroom (photo 15). More of a concern was the fact that the larger life raft canopy

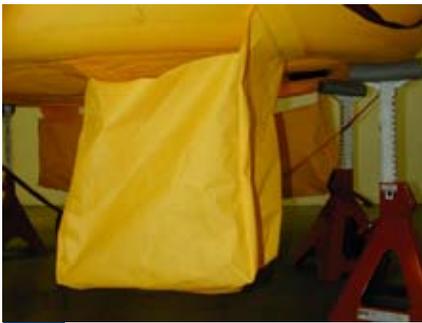
16

The Goodrich life rafts had four small ballast bags constructed of buoyancy tube material containing approximately 56.1 pounds (25.4 kilograms) of fresh water each. A bag was attached at each corner of the rectangular life rafts (photo 16) and at equidistant intervals around the four-person life raft. Five one-inch holes were in the bottom of each bag, which allowed water to escape, albeit relatively slowly (photo 17). Nevertheless, drain holes should not be in the bottom of water-ballast bags, because the ultimate

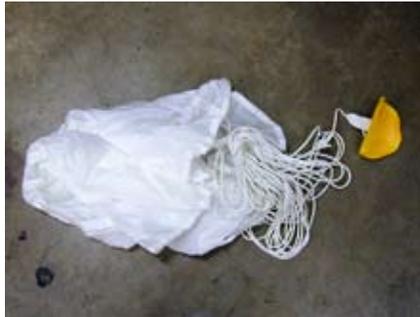
18

shape of the larger life raft, which was particularly vulnerable to capsizing if the sea anchor was lost or was deployed incorrectly. This was a deficiency, in our opinion. The yellow tab that held the sea anchor detached from one of our evaluation Goodrich life rafts (photo 18).

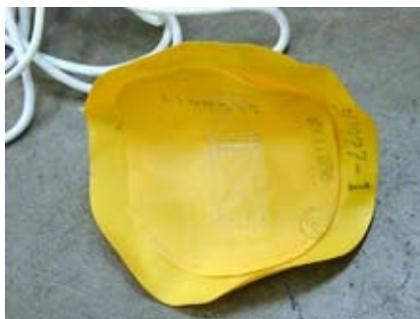
19

The sea-anchor attachment point failed on the 12-person life raft we evaluated in 2000, tearing away from the life raft during boarding (photo 19). The failed assembly was returned to Goodrich, which said that analysis showed that the failure was the result of substandard bonding, an assembly error.

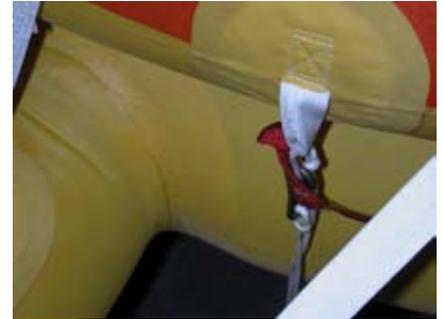
20

On the life raft (built in 2001) borrowed for the 2002 evaluation, the attachment point had been improved and was satisfactory (photo 20).

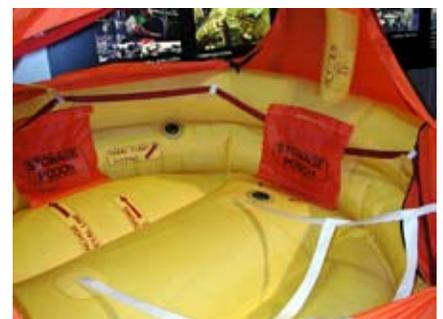
21

An inflatable floor was standard on all the Goodrich life rafts. These were equipped with long reeds that ran from one side of the life raft to the other, two in the smaller life rafts and three in the larger life rafts. This floor construction did not lend itself to being inflated "hard," it just ballooned up between the reeds; thus, its effectiveness was compromised (photo 21).

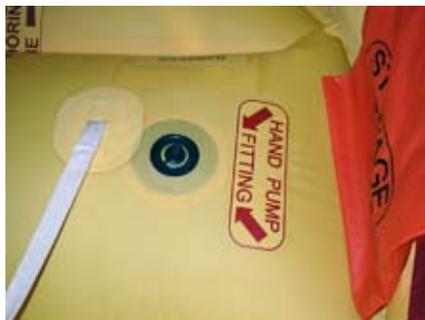
22

The inflation valve was located near the edge of the floor, rather than in its center

(photo 22). Survivors might not readily locate the inflation valve. Moreover, the valve was not comfortable to sit on, even though it was recessed; volunteers adjusted their position to avoid sitting on the valve.

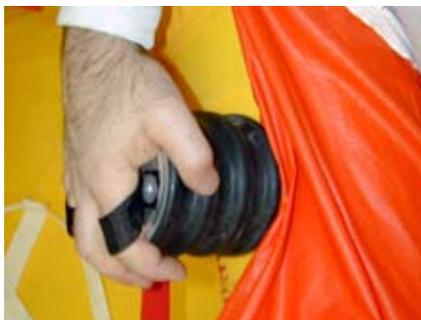
23

A recessed valve also made it more difficult to use the manual inflation pump with two hands for maximum-effort pumping (photo 23). On the larger life raft, the positioning of the topping valve on the lower buoyancy tube was too close to the upper buoyancy tube; the overhang of the upper buoyancy tube interfered with the

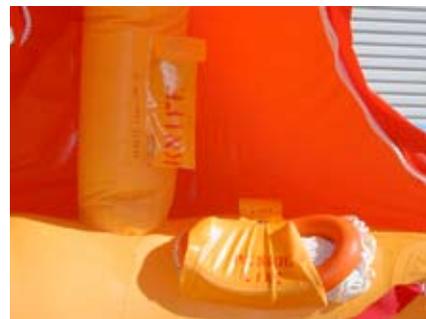
24

Goodrich used nylon parachute cord, which was not inherently buoyant, and a round-ring rubber quoit (photo 24). The line was retained on the upper buoyancy tube to the right (while boarding) of the primary entry with a yellow buoyancy tube fabric clasp. A single metal snap held it together. The clasp wrapped entirely around the line and quoit, squeezing the quoit into an oval shape. The clasp was stenciled in red with “RESCUE LINE,” and the fabric tab for the metal snap was stenciled “LIFT.” Neither was easily readable because of wrinkled fabric and inadequate stenciling. The quoit did not return to a round shape after it was released from the clasp, making the quoit more difficult to grasp from some angles (photo 25, page 291). (The four-person life raft exhibited at the 2003 NBAA convention had screen-printed text for “RESCUE LINE” that was easier to read; “LIFT” was stenciled in small text and was difficult to read. There was also a

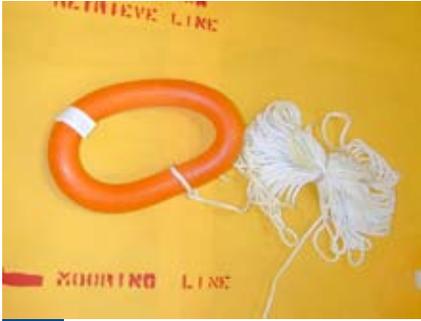
25

pictogram showing how to throw the rescue line to retrieve survivors from the water.) Volunteers were unable to throw the quoit successfully because the line tangled, a deficiency, in our opinion.

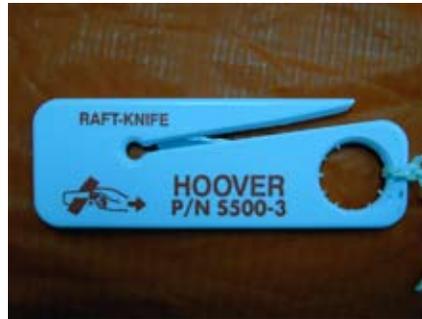
26

Goodrich used a raft knife that was made by Hoover Industries. The finger hole retained the little nibs that remained after removal of the plug that was molded originally in the hole. These nibs were sharp and painful when the raft knife was pulled from the sheath or when the knife was used to cut anything (photo 26). Hoover trimmed these nibs on the knives used in their life rafts; Goodrich did not.

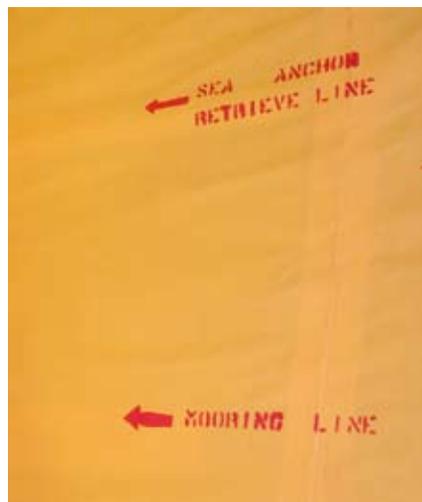
27

The mooring/inflation line and the sea-anchor line were in relatively close proximity to each other. A confused or panic-stricken survivor could cut the wrong line by mistake, a deficiency, in our opinion. On the floor of the life raft, stenciled text and a small arrow identified the lines, but the information was difficult to read or to see and might be overlooked or obscured by survivors (photo 27). (On the life raft exhibited at the 2003 NBAA convention, screen-printed text with a larger arrow made

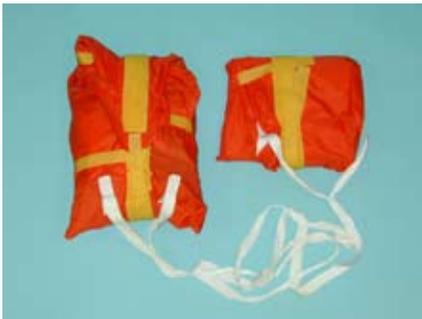
28

Goodrich secured one pouch or two pouches inside the life rafts on short tethers (photo 28). Pouches were constructed of orange canopy fabric; several strips of yellow Velcro were used to close each pouch into a compact bundle.

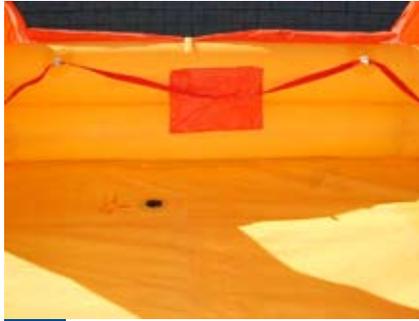
29

canopy fabric (photo 29). There was a short strip of one-inch Velcro on the flap closure, but there was a large gap at each end that allowed the contents to escape. Simply extending the Velcro all the way across the flap would improve the closure. (On the life raft exhibited at the 2003 NBAA convention, there were four stowage pouches, and the Velcro extended across the flap, a notable improvement.)

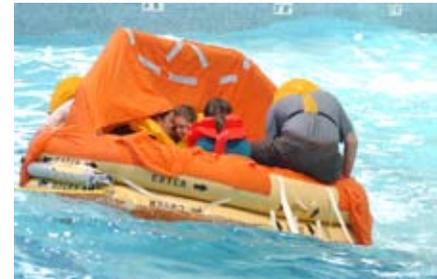
1

Hoover provided a four-person conventional Type II life raft for the first evaluation, did not participate in the second evaluation, provided a newly developed six-person conventional Type I life raft for the third evaluation and provided a six-person Type I ReadyRescue prototype (photo 1) for the 2002 evaluation.

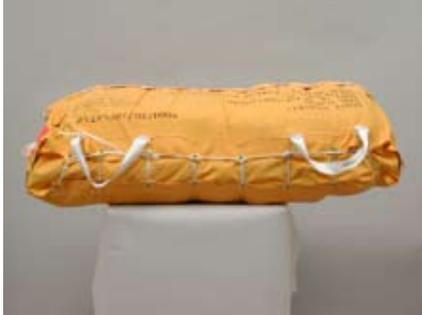
2

The six-person conventional Type I valise and the ReadyRescue valise were rectangular with nylon lacing holding the valises together (photo 2). One-inch-wide Velcro was used at the end to hold the valise flaps. The SEP was inside the valise, in its own separate pack, constructed with snaps to close it. A pair of nylon-webbing grab handles was provided on each side, but none were at the ends.

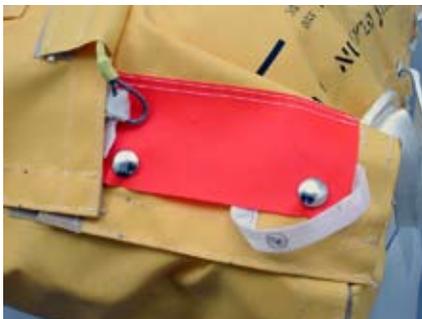
3

Instructions for inflation were stenciled in black in very small, indistinct text on the yellow valise fabric. The instructions would be difficult to read in dim light. There were no pictorial instructions. The end of the mooring/inflation line was protected under an orange — unlabeled — flap with snaps to hold it in place (photo 3).

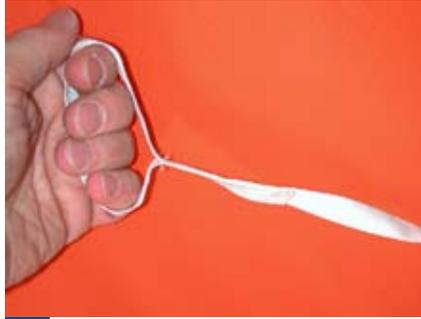
4

Like EAM, Hoover used 0.5-inch-wide white nylon tape for a mooring/inflation line, with a 3.75-inch hand loop on the end (photo 4). The absence of a handle was a deficiency, in our opinion. The line was 18.0 feet (5.5 meters) for the conventional Type II life raft, 20.75 feet

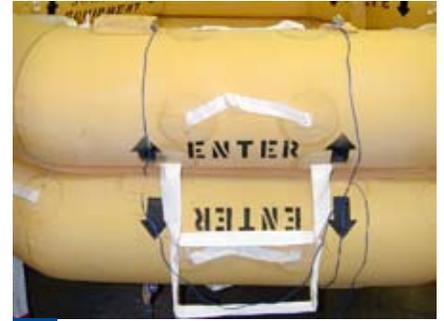
5

On the conventional life rafts, a ladder with two semi-rigid flat rungs made of two-inch wide white nylon webbing hung at the entries (photo 5). The flat

rungs were weighted — a good feature — but the ladder was too short and barely hung below the exterior bottom of the life raft, a deficiency, in our opinion. Getting a foothold, while still maintaining a grip on the grab handle(s), was very difficult for some volunteers and was impossible for a few. After our 1996 evaluation, Hoover added another rung to the larger transport category life rafts, but this improvement had not been incorporated in all the aviation life rafts.

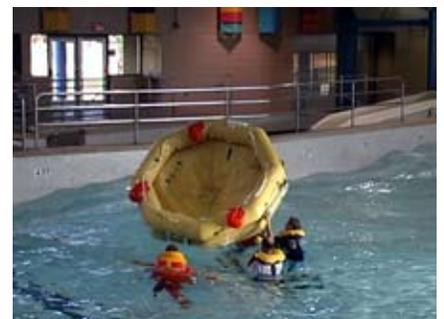
6

The Type II life raft had grab handles on top of the buoyancy tube and on the interior side of the buoyancy tube, and an interior grasp line. On the conventional Type I life raft, the grasp line did not extend across the entry, but another grab handle was added to the midpoint interior side and exterior side of the buoyancy tube (photo 6).

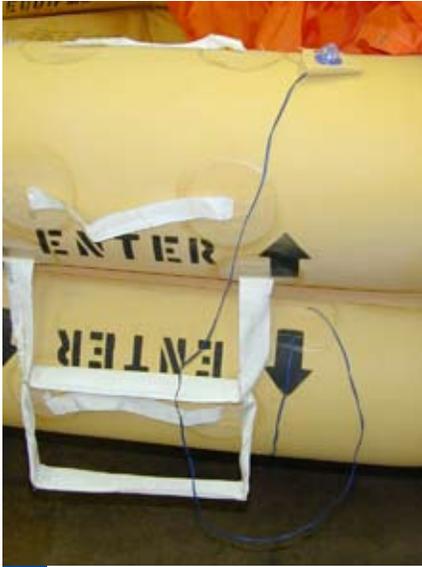
7

On the conventional Type I life raft, the entry was flanked on both sides by the blue insulated wire from the battery to the locator light attached to the top of each buoyancy tube (photo 7, page 300). The locator light inadvertently was pulled

from its location during the evaluation. The light was attached with a snap, so it could be reattached. Nevertheless, the locator light and/or the inadequately located wiring could be damaged by survivors boarding the life raft, a deficiency, in our opinion.

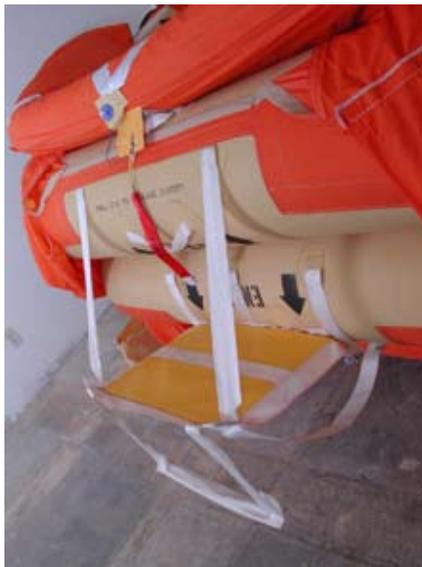
8

The ReadyRescue life raft featured a unique reversible boarding aid — part boarding ladder, part rigid boarding platform (photo 8). The rigid 20.0-inch by 16.0-inch (50.8-centimeter by 40.6-centimeter) platform was covered with

fabric; hanging at its end was a single semi-rigid flat-rung nylon-webbing ladder. The platform hung from two-inch-wide nylon webbing, and the base was located at the bottom of the lower buoyancy tube, creating a slope up from the tube to the open boarding end of the platform. No matter which side was up, the boarding aid flipped to function correctly. After volunteers boarded the platform, typically on their knees, the slope helped prevent them from slipping off the platform. One-inch-wide nylon-webbing grab handles were located at the midpoint on the exterior and interior on the upper buoyancy tube and on the top of the upper buoyancy tube. Some volunteers had difficulty boarding, but all succeeded. Volunteers suggested adding another rung to the ladder and/or stiffening the ladder, as well as adding more handholds.

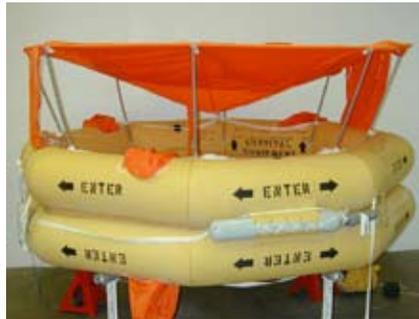
9

The canopy on the conventional life raft was a manually erected stick-built design (photo 9) similar to EAM's. It used

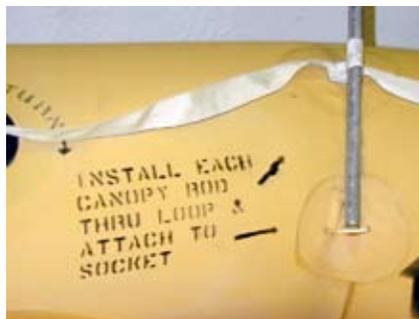
10

telescoping-aluminum canopy-support rods to hold up the edges and center of the translucent orange-coated rip-stop-nylon canopy (photo 10). There were four outer masts on smaller life rafts and eight outer masts on the six-person and larger life rafts, all spaced equidistantly around the inside periphery of the life raft.

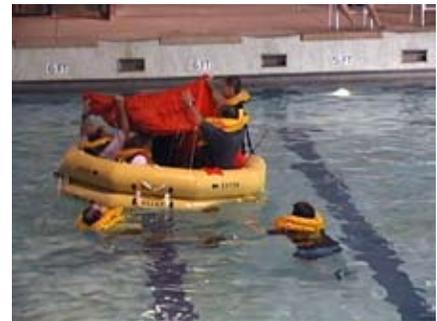
11

Volunteers had the same problems with the Hoover canopies (photo 11) that they did with the EAM canopies with one notable exception: Hoover's telescoping canopy-support rods had

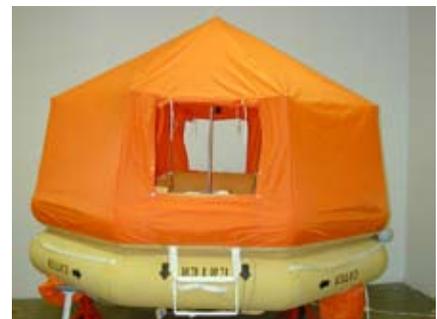
12

The Hoover canopy had two entries — which the company called “ventilation windows” — on opposite sides that were closed with metal snaps, but did not seal tightly (photo 12). They could be rolled up and secured with fabric ties. In a seating position, approximately 24 inches to 29.0 inches (73.7 centimeters)

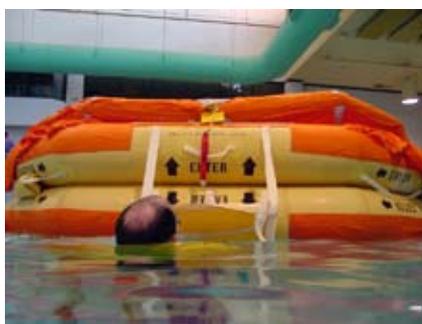
16

During inflation, the canopy-support tube inflated, but the canopy did not erect. The inflated support tube and the attached canopy were secured to the upper buoyancy tube by a tab secured with a pinned loop. Instructions — “PULL PIN TO RELEASE CANOPY”— were stenciled on the buoyancy tube below the pin at the boarding location, centered on the entry (photo 16). The same

instructions were inside the life raft, on the floor, with an arrow pointing to the exterior location of the pin. Attached to the pin with a stainless steel cable was a red one-inch-wide nylon-webbing pull tab six inches long with “PULL” stenciled in black and a piece of retroreflective tape affixed to the end.

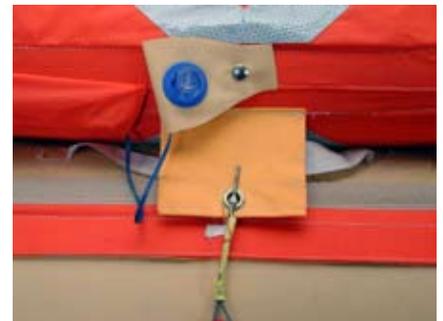
17

On the canopy-support tube was the exterior locator light, attached to the top of the canopy. Its lens, facing sideways with the canopy still pinned down, would be excessively bright for anyone looking directly at it (photo 17); however, most likely, the pin would be

pulled while survivors were in the water with their eyes below the light, so in most circumstances, it would be less of an issue. In rough weather conditions, it could become more of a factor as the life raft moved.

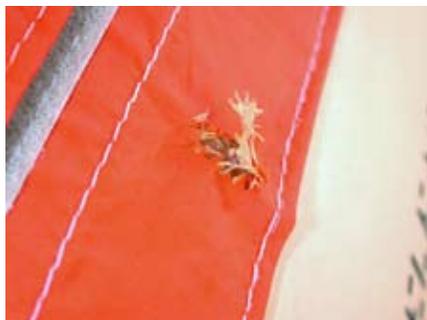
18

Thread secured the pin to prevent inadvertent release of the canopy. Pulling the pin released the canopy-support tube, which immediately erected the canopy. This worked satisfactorily on one side of the reversible life raft. On the opposite side, when the pin was pulled, the thread did not break; rather than pulling the pin, the entire pinned loop was pulled off the canopy from where it was sewn on, resulting in a small tear in the canopy (photo 18, page 302). The tear occurred in a section where no adverse effect was created, either structurally or functionally. Hoover later said that it had reinforced this attachment point to prevent a similar failure.

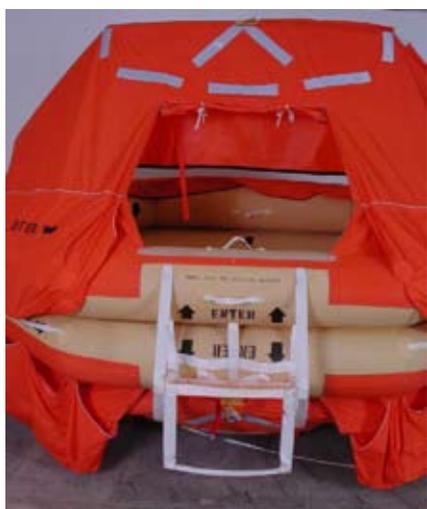
19

The ReadyRescue life raft canopy was constructed of the same lightweight rip-stop-nylon fabric as the conventional canopies. On the side where the canopy release was located, the flap closure was rolled up and tied. One-inch-wide Velcro was used to close the flap along both sides and at the buoyancy tube. The narrow Velcro and tight canopy fabric made sealing the flap difficult, and the fabric was torn on the lower corners of the canopy opening and the flap (photo 19).

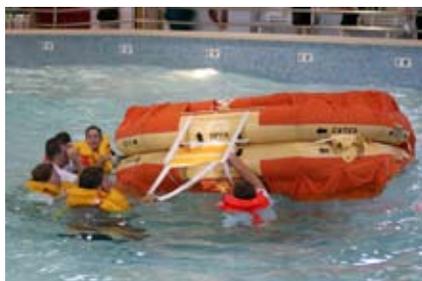
20

If the life raft were capsized and the canopy zipper were open, the arch would lay over in the same manner as when the life raft was originally deployed. If the zipper were closed, the canopy would not lay over but would remain as erected. After a capsizing, the canopy on the opposite — upright — side could be released, and the survivors would be able to reboard a life raft with a canopy (photo 20).

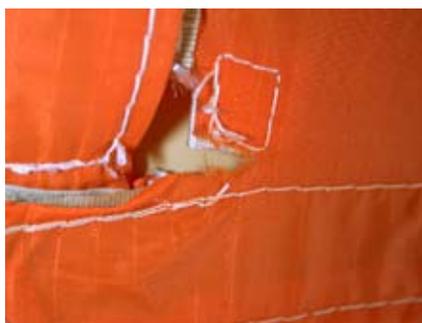
21

Large tears in the canopy fabric appeared on one side and were believed to have occurred during the capsizing evaluation (photo 21). Hoover said that it had reinforced these areas to prevent tears in production life rafts.

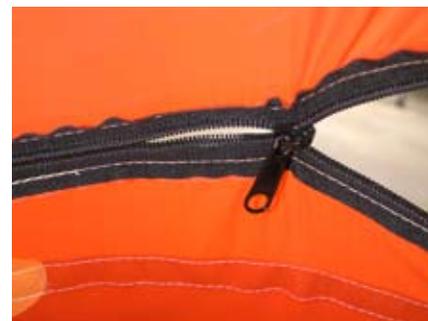
22

The canopy zipper on the undamaged side failed during the evaluation. The canopy was stretched so tightly that closing the zipper was very difficult, a deficiency, in our opinion. During examination after the in-water evaluation, the cloth pull on the zipper tore

off as the zipper was closed. When the zipper was closed, the zipper tended to part behind the zipper truck (photo 22). Hoover said that it had upgraded the zipper from the size no. 5 YKK zipper that failed on the prototype to the industry-standard heavy duty no. 10 YKK zipper for production life rafts. The company also said that the canopy was given adequate slack in the fabric to prevent this from occurring again.

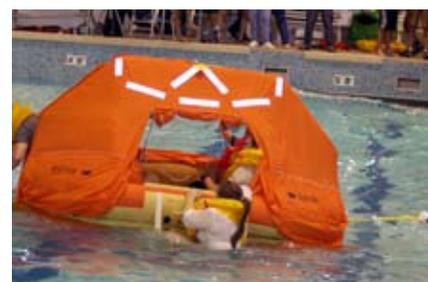
23

The canopies were fitted with retro-reflective tape in an approximation of the U.K. CAA standard pattern, with a cross of tape over the top centered on a segmented circle (photo 23), a good location for this conspicuity aid. However, there was little retroreflective tape visible from either end of the life raft, nor was much of this retroreflective tape visible when the canopy was down.

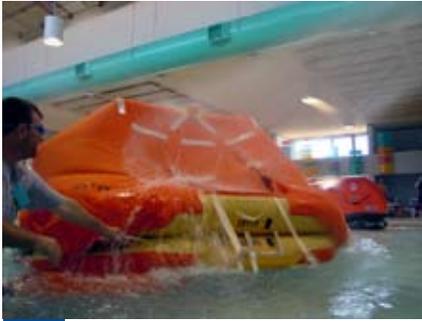
24

The ReadyRescue life raft's Velcro-secured flap-entry closure failed; it was

insufficiently secure to withstand the spray (photo 24). The long zipper on the other side, with no storm flap or protection, “leaked like a sieve,” one volunteer reported. Overall, Hoover’s canopies were deficient, in our opinion. Hoover instituted improvements to the life raft after receiving the damaged prototype from the evaluation.

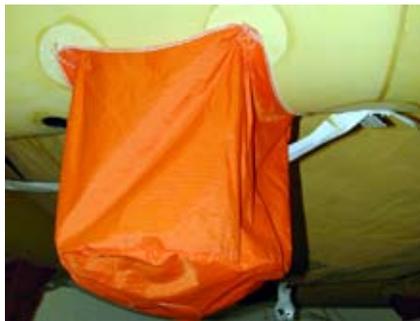
25

Four water-ballast bags (“water ballast pockets,” Hoover calls them) were suspended from the bottom of the periphery of the conventional Type II single-buoyancy-tube life rafts (photo 25). The water-ballast bags were constructed from canopy fabric and were cylindrical in shape; each held approximately 52.7 pounds (23.9 kilograms) of fresh water. The conventional reversible Type I life raft had three of the same size ballast bags on each of its two upright sides. A small weight in the bottom of each ballast bag caused the bag to drop down for immediate filling.

Water-ballast bags made the conventional Type II life raft only slightly more difficult to capsize than its EAM counterpart. On the conventional reversible Type I life raft with a higher center of gravity, the water ballast was ineffective, a deficiency, in our opinion.

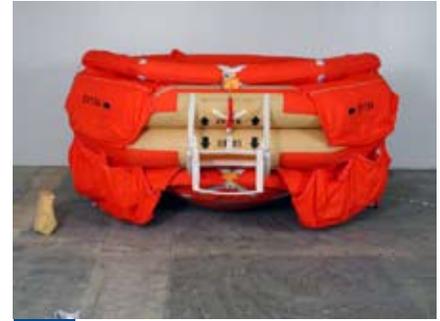
26

The ReadyRescue life raft had four large water-ballast bags on each side, constructed of canopy fabric and attached to the canopy where the canopy joined the buoyancy tube (photo 26). These hung at the outer perimeter of the life raft. They were irregularly shaped, and determining their capacity was difficult: Each held approximately 175.5 pounds (79.6 kilograms) of fresh water. They were heavily weighted and required only 42 seconds to drop down and fill after the life raft inflated.

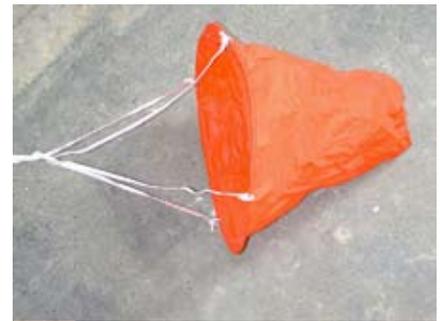
27

The sea anchor was the same on all the Hoover life rafts: a 13-inch-long

(33-centimeter-long) cone-shape construction of canopy fabric with a 12-inch wire-reinforced opening (photo 27). The 5/32-inch (0.4-centimeter) white-nylon flat-braid line was 14.0 feet (4.3 meters) long with a 10.0-inch (25.4-centimeter) bridle secured to brass grommets, considerably shorter than the TSO-C70a (paragraph 5.3) requirement of 25 feet. No swivel was fitted, a deficiency, in our opinion.

On the ReadyRescue life raft, the sea anchor was attached to the life raft off-center on one end. Given the boat-shaped life raft’s dependence upon an effective sea anchor, this was a deficiency, in our opinion.

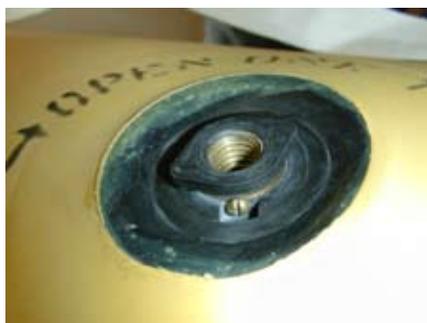
28

Hoover was the only remaining manufacturer of TSO-approved life rafts to continue to use a threaded connector (photo 28) and a manually operated rotary topping valve with no check valve, instead of a bayonet connector with an integral check valve.

To operate the manual inflation pump, the user would screw the pump into the threaded valve and open the plated-metal valve by rotating it clockwise. When pumping was completed, the valve would be turned counterclockwise to close the valve and the pump would be removed. “OPEN” and “CLOSED” text and arrows at the valve indicated clearly the required movement of the valve. Instructions stenciled on the floor of the life raft showed users the proper procedure and order of action, and included the instruction, “OPEN VALVE ONE TURN.”

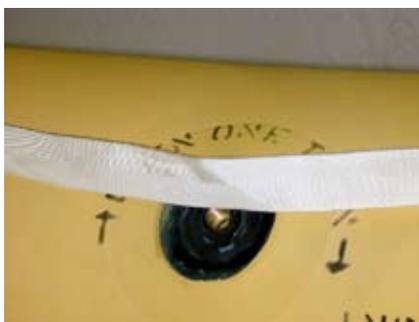
29

These instructions were not always immediately adjacent to the manual topping valve(s) and could be obscured from view under the bottoms and feet of survivors. If the valve was opened too far, as it was when some volunteers overlooked the instructions (photo 29), the valve jammed open and was difficult to close. There was no caution

about over-tightening the valve upon closure. A natural tendency to tighten the valve more than necessary could lead to over-tightening the manual topping valve. On several occasions, volunteers tightened the valve so firmly that it could not be opened again using finger strength alone.

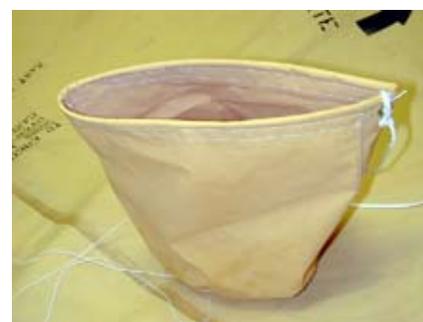
31

at the seams (photo 31). The bailer had no handle, so it was difficult to use, a deficiency, in our opinion.

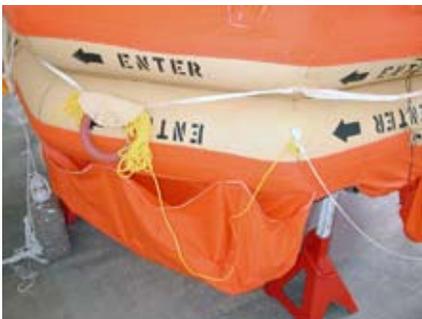
34

On the conventional Type I and ReadyRescue life rafts, the 42.3-foot (12.9-meter) heaving line and quoit were attached to the exterior lifeline with a fabric flap folded over the lifeline and secured with two snaps, and tethered to the life raft at the same point as the bailer and the SEP (photo 34). The "HEAVING LINE" was listed in smaller text under the larger "SURVIVAL EQUIPMENT" placard. The heaving line failed to meet the TSO-C70a requirement (paragraph 5.4)

of 75 feet for Type I life rafts, a deficiency, in our opinion.

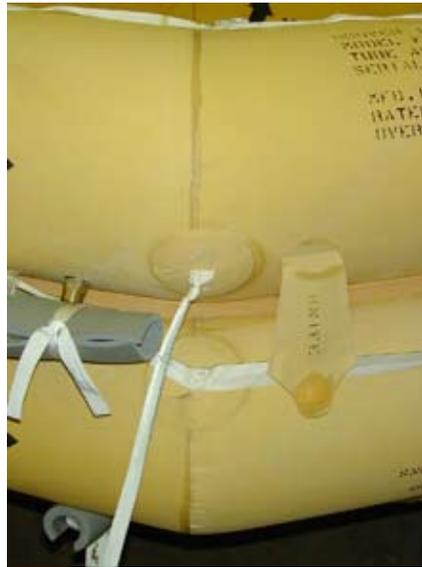
35

The tethered raft knife was stored inside a sheath of yellow buoyancy-tube fabric with a snap closure (photo 35). "KNIFE" was stenciled indistinctly in black on the sheath, but the sheath was not very noticeable, being the same color as the life raft.

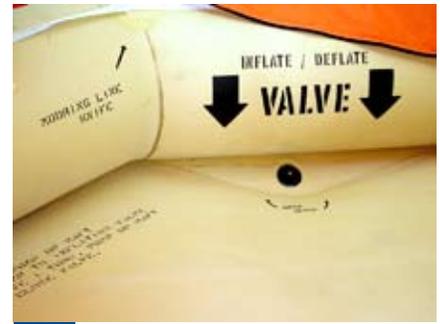
36

On the conventional Type I and ReadyRescue life rafts, the raft knife was in the sheath on the top of one buoyancy tube next to the mooring/inflation line attachment. Because the sheath was attached only at the closed end, it could be "bent" upward for access and raft knife removal. A small placard was stenciled with "MOORING LINE KNIFE" and an arrow on the interior of the upper buoyancy tube. The text was small, indistinct and easily overlooked (photo 36). This was a deficiency, in our opinion, because survivors might have an urgent requirement to sever the line attaching the life raft to a sinking aircraft.

On previously evaluated traditional Hoover life rafts, the sharp molding nibs in the life raft knife's finger hole had been removed, but the ReadyRescue life raft's knife had many nibs in place and was uncomfortable.

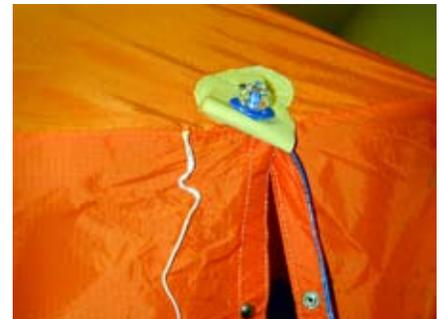
37

In our opinion, the exterior locator light on the ReadyRescue life raft did not appear to meet the requirement of TSO-C70a (paragraph 4.12), because when the canopy was pinned down to the buoyancy tube upon inflation of the life raft, the locator light was not "visible from any direction by persons in the water" (photo 37). After the canopy was erected, the light still did not meet this requirement because it was blocked by the canopy. The light was not visible to volunteers in the water when they were located on the side of the life raft opposite the light.

In a lightly loaded life raft in calm conditions, the water-activated battery for the locator light might not function. The battery, located on the midpoint of the exterior side of the lower buoyancy tube

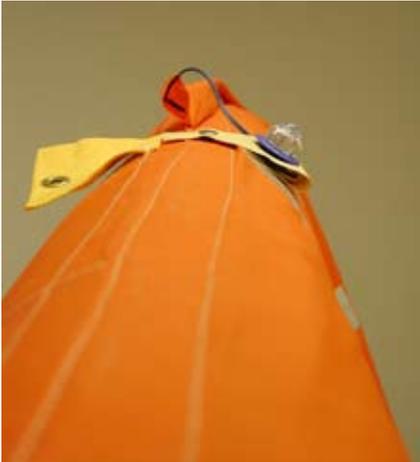
38

(there were two lights in mirrored installations, one for each side of the reversible life raft), might be above the water (photo 38), a deficiency, in our opinion. The life raft had no interior light, which was a deficiency, in our opinion.

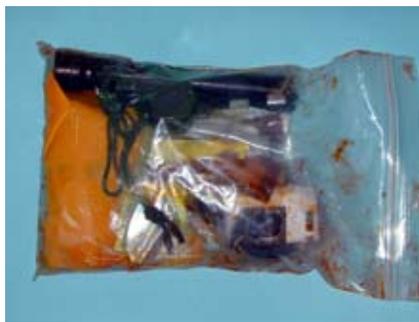
39

On the Type I life rafts, including the ReadyRescue life raft, the SEP was attached to the life raft (as noted earlier) and was contained in a heavy plastic bag (photo 39), which had been tied closed with a knotted line; the bag’s presence was not obvious. The knotted line was difficult to untie, and untying the bag would have been much more difficult with cold, wet, numbed hands. Moreover, water had leaked into the bag and had soaked the equipment.

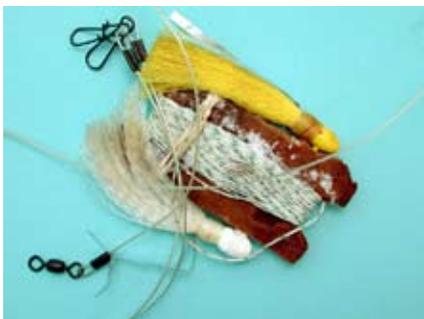
41

The Hoover fishing kit (photo 41) included only some line wrapped around a piece of cardboard, which disintegrated when wet (and it was wet), a pair of leaders

and a pair of lures. This was a deficiency, in our opinion.

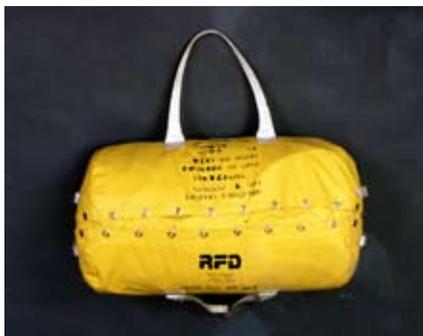
1

A pair of long handles was attached to the sides of the valise (photo 1); the handles could be grabbed at the top, or one handle each could be used by two people to carry the life raft between them. The handles were white two-inch-wide

nylon webbing, folded and sewn to create a one-inch grab handle that was easy to grasp. The webbing wrapped completely under the valise from one side to the other. The handles did not stay in place on top, but flopped at the sides, making it difficult to grab one with a single hand. Having grabbed one handle, it was impossible to also grab the other with the same hand. If placed on top to be within reach, it immediately flopped back down to the side. Volunteers found the floppy handles annoying because two hands were required to grasp the life raft. This could slow inflation because there was no way to just grab and lift the life raft with one hand. This was a deficiency, in our opinion. A break-away tie or Velcro would be useful to hold the loose handles together and to make them easier to grasp as a single handle.

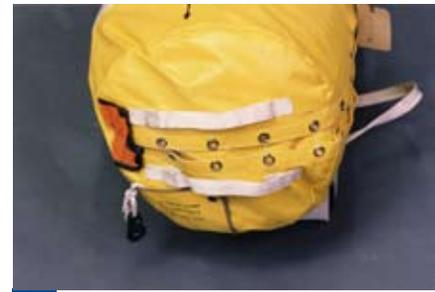
2

On one end of the valise, two flaps were located on either side of the seam at the bottom (with the main seam topmost), one orange with black trim, the other yellow with gray trim, each secured with button snaps. Instructions were stenciled on the flaps in black and were not easily read because of the small size and indistinct stenciling (photo 2). In addition, because of the slightly bulbous shape of the end of the valise, neither flap could be read without standing the valise on end, a deficiency, in our

opinion. Hanging from the yellow flap on the seam side of the flap was the mooring/inflation line with a heavy clip. This clip was not secured to prevent inadvertent snagging, which could result in an accidental inflation, a deficiency, in our opinion.

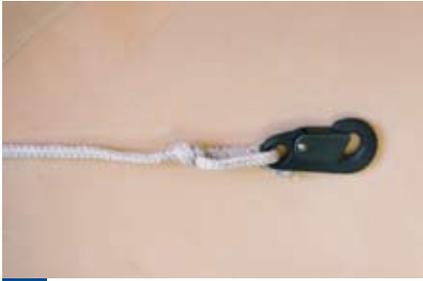
3

The mooring/inflation line was equipped with a robust heavy-duty spring clip (photo 3, page 309). The spring clip was so stiff that some volunteers were unable to use it easily; it was difficult for most of them to clip it back onto the mooring/inflation line. Sturdy fittings are benefits generally, but when an average person cannot easily operate a spring clip, it is too sturdy. This clip was a deficiency, in our opinion.

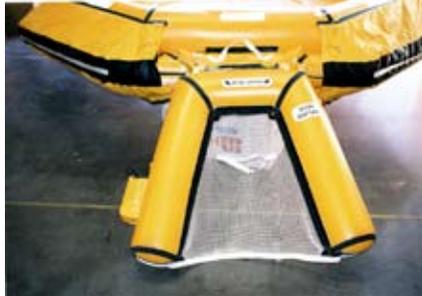
4

The Aerolite Series life rafts and R Series life rafts were fitted with a semi-rigid inflatable boarding ramp (photo 4). This entry comprised a splayed U-shaped inflated tube that protruded from the life raft. The base of the U was hinged with heavy rubber at the attachment point. Between the splayed side tubes was white open-mesh nylon netting that provided a slip-resistant surface. A one-inch-wide white nylon-tape grab handle was attached in the center of the mesh platform about two-thirds up the ramp. The white grab handle on the white mesh resulted in

little contrast, so the white grab handle was not recognized readily. Two other grab handles were fitted, one at the hinge point and one on the top of the upper buoyancy tube.

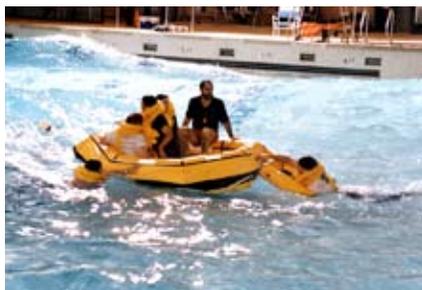
5

In general, weak or injured survivors probably could pull themselves onto the ramp and into the life raft (photo 5). For a heavy survivor, however, the ramp’s buoyancy could be difficult to overcome, leaving the survivor with little or no leverage against which to push, making boarding very difficult. Moreover, volunteers of average weight and height who tried to kneel or stand on the bottom half of the ramp found that the ramp collapsed under them. Boarding became easier as volunteers followed others who had already boarded the life raft, thus lowering the freeboard and creating a lower ramp angle.

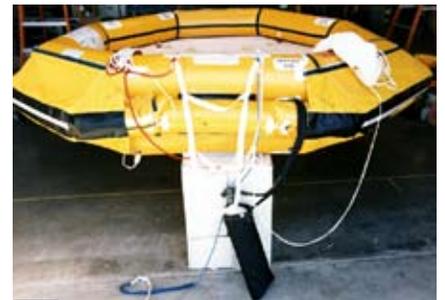
6

The seven-person R Series life raft was equipped with a white one-inch-wide nylon-webbing three-rung boarding ladder at the alternate entry (photo 6). A single grab handle was provided at the top of the ladder where it attached to the top of the upper buoyancy tube. This boarding aid’s performance was deficient, in our opinion. Larger versions of this life raft had dual boarding ramps, one attached to either tube. This would appear to provide a satisfactory alternate entry, though the steeper incline might make it more difficult to use compared with the primary entry, in our opinion.

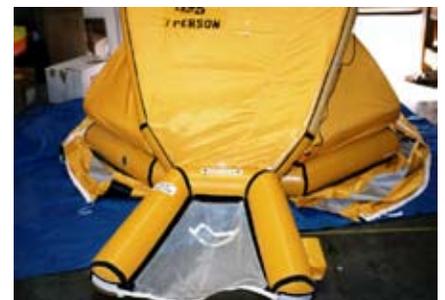
7

The canopy was spacious and weather-proof (photo 7). Although it was an auto-inflating stay-erect design, it did not erect automatically. RFD/Revere said that this

would allow survivors an unobstructed 360-degree view to search for other survivors in the water and would allow entry into the life raft from anywhere on its periphery.

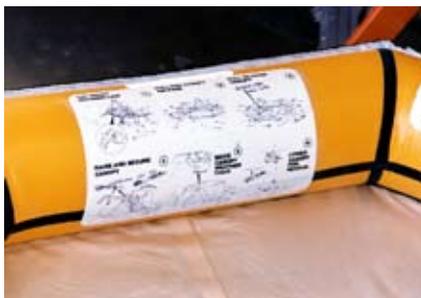
8

The first group of volunteers was unaware that a canopy was on the life raft and made no attempt to find it and erect it, although canopies were on all the other life rafts, some of which required manual erection. These volunteers had to be told to read the instructions (photo 8) so that they could erect the canopy. When all who might have to use the life raft have been trained to accomplish the task, this would not be a problem. Unfortunately, that is an ideal that should not be taken for granted.

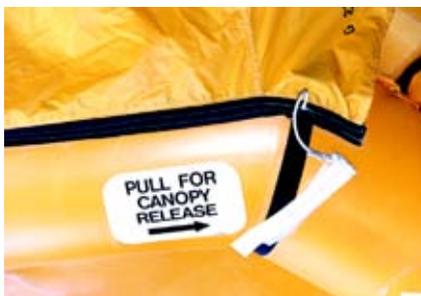
9

To erect the canopy, a survivor would have to release the protective cover over each canopy arch by pulling on a fabric tab placarded “PULL FOR CANOPY RELEASE” (photo 9) The placard was on the

interior side of the buoyancy tube for each canopy arch; the volunteers overlooked the placards. The tabs were secured with Velcro to the buoyancy tube. When pulled, the tabs ripped open the top seam on the canopy cover. There was a seam on both “top” and “bottom”; thus, a seam would be accessible regardless of which side of the reversible life raft was used. On this life raft, one of each canopy cover’s two seams was stitched (photo 10); the other was restrained with Velcro.

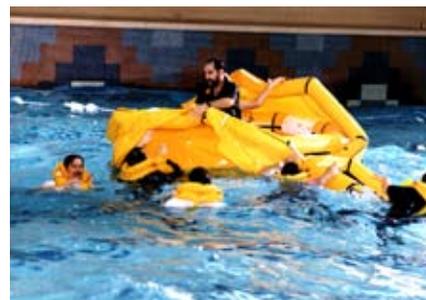
11

The canopy was yellow polyurethane-coated fabric that was somewhat translucent. The yellow interior was cause for negative comments by some volunteers; as with all the translucent fabric canopies, sun shining through it gave everything and everyone an unappealing yellow tinge. The canopy fabric was attached permanently to the arches and to the exterior of the life raft from the point outward of the canopy-arch attachment points (photo 11). The canopy arches were attached to opposite sides of the life raft, leaving two opposing segments clear for entry.

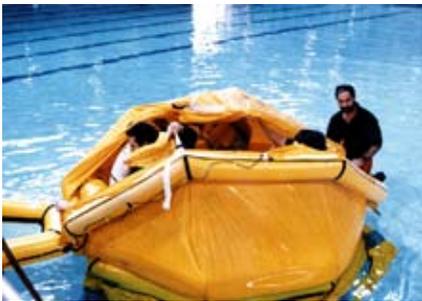
12

Having uncovered the canopy (photo 12), volunteers next had to pull one two-inch wide nylon-webbing strap from one canopy arch to the other and attach it with a plastic quick-connect buckle (photo 13). Pulling the loose end of the strap was supposed to raise the canopy. Volunteers discovered that raising the canopy-support arch by hand was easier than pulling on the strap to raise it. This expedient solution would not be possible for a survivor working alone. Volunteers had to pull very hard to raise

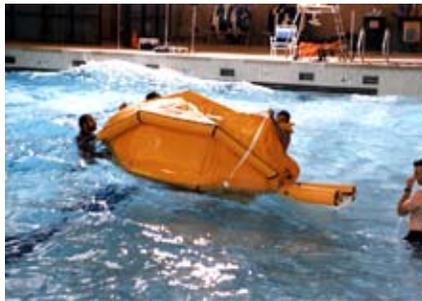
14

the canopy supports using the strap; the working leverage was initially not very effective because the canopy supports were being pulled sideways, not up at an angle. Lifting up at least one arch several inches by hand made pulling the strap much easier (photo 14). Once semi-erect, another 11 quick-connect buckles had to be connected to fully erect and secure the canopy. The final buckles required significant strength to connect.

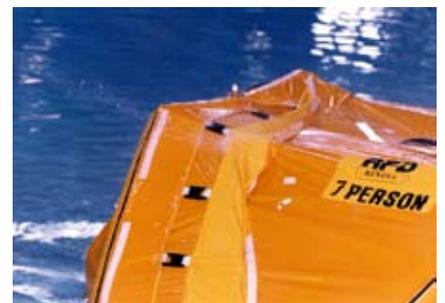
15

Two flaps of canopy fabric (photo 15), one inside and one outside, completed the seal to make the canopy weathertight. The inside flap was tucked up between the canopy tube and the canopy top with Velcro, but it provided a weathertight seal even without the Velcro. The outside flap normally would have been sealed first, but it would have been more difficult to reach. Volunteers did not even notice it; hence, our confirmation that the single flap provided a weathertight seal. The flap went over the canopy and connected to the canopy-support tube with Velcro. When both flaps were sealed, the canopy was weathertight and sturdy, with 32.0 inches (81.3 centimeters) of headroom at the center of the life raft and 22.0 inches (55.9 centimeters) at the entries and sides.

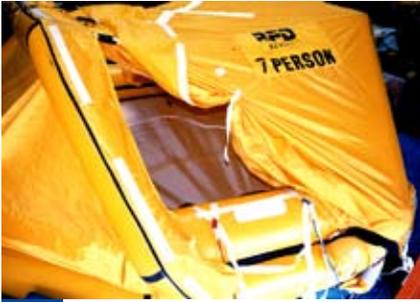
16

For providing ventilation, the canopy was not as versatile as others (photo 16, page 312). Although the canopy could provide nearly full shade, not considering the translucence of the canopy fabric,

very little ventilation would be provided by the small gap in the canopy top. The gap could be widened by releasing some of the lower buckles, but this provided only minimal ventilation because there was only one cloth tie at each entry to tie back the flap; this provided only marginally increased ventilation. Additional ventilation, not normally a concern in the North Sea, would be most welcome in more moderate conditions or tropical conditions. An improvement would be to provide a means to retain the interior flap and exterior flap so they would remain out of the flow of air when ventilation was desired. The interior flap, especially, was annoying because it hung down when the entry was open and impeded what little ventilation was provided by leaving the narrow gap open.

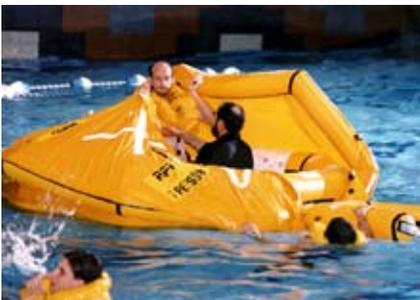
17

If the canopy were put down after erection (photo 17), it would fill with water and would be very difficult to erect again — especially by a lone and injured survivor — and would be almost impossible to erect again without soaking the interior of the life raft. Nevertheless, the problem could be avoided by ensuring that the canopy fabric was gathered on

the top of the buoyancy tube rather than just lowering the canopy support, which would tend to immerse the canopy in the water. Nevertheless, no means to keep the canopy in place was provided, so the survivor would have to improvise. This problem was not discussed in any instructions, but it should have been noted in the LRM.

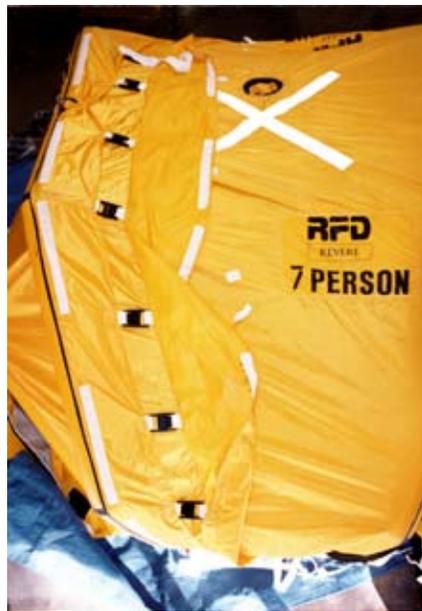
18

A single small reversible water-collection tube was installed off center in the flat top of the canopy. It had a reversible rubber plug and worked very well, although minor water leaks occurred on the seam where it was sewn to the canopy (the only leaks in the otherwise weathertight canopy). A large cross of retroreflective tape was affixed to the flat top of the canopy (photo 18); retroreflective strips also were located on the perimeter of the life raft's buoyancy tubes, providing satisfactory all-around retroreflective performance.
