Flight Safety

SEPTEMBER 2003–FEBRUARY 2004

Waterproof Flight Operations

■ A comprehensive guide for corporate, fractional, on-demand and commuter operators conducting overwater flights

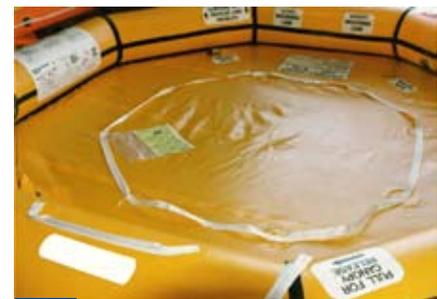
19

The interior grasp line was attached to the floor — not to a buoyancy tube — in an octagon approximately midway between the tube and the center (photo 19). Volunteers evaluated all lines and attachment points on all the life rafts as best they could, by pulling hard against them, first with arm strength, then using their legs where appropriate. The R Series life raft was the only other life raft that experienced a failure, aside from the sea anchor failure on the Goodrich life raft. The grasp line was ripped from its attachment point using only a single arm's strength, obviously less than the TSO-C70a (paragraph 4.9) requirement for 500 pounds (227 kilograms) minimum strength. This was a deficiency, in our opinion. (This was a demonstration life raft and no doubt had been subjected to abuse prior to the evaluation, which may have contributed to the failure.) The thin nylon webbing also was not as comfortable to hold as wider or more substantial webbing.

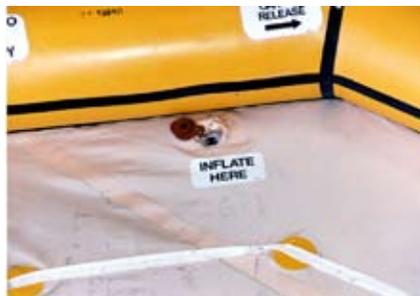
22

The life rafts had plastic topping valves, which had a friction-fit opening and a rubber butterfly-flap valve. Each valve also was equipped with a friction-fit rubber cap (photo 22) that was attached to the valve by a tether of small-diameter nylon cord. The cap for the

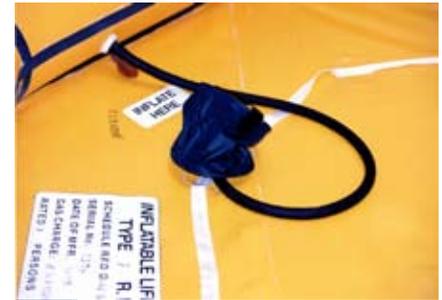
23

The RFD/Revere manual inflation pump (photo 23) was equipped with a large-diameter — approximately one-inch outside diameter — flexible rubber hose, approximately 36 inches long, with a plastic male friction fitting on the end. This fitting was inserted into the valve; it had to be inserted tightly or it would work loose. Inserting the fitting did not open the check valve; airflow under pressure of the manual inflation pump opened the check valve.

The long hose would allow survivors to position themselves for best performance and comfort, and when one survivor became tired, the manual inflation pump could be passed among the other survivors near that particular valve. The long hose was essential for the R Series life rafts because some of the manual topping valves were not inside the life raft.

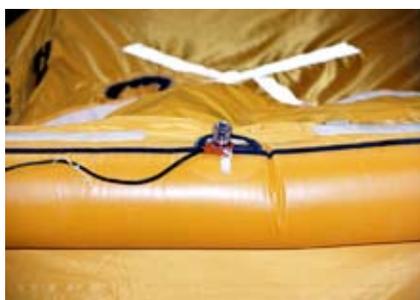
24

The approved exterior locator light (photo 24) for the R Series life raft was on the top of one canopy-support arch. Until the canopy was raised, the light was on the side of the life raft, underneath the cover that protected the canopy-support tube. A small clear plastic "window" was over the light, and the window itself was bisected by the exterior lifeline. Depending on how carefully the life raft was packed, the light might or might not be

This light was covered, partially obscured at best, and was ineffective because it was held down on one side of the life raft until the canopy was raised, which, depending on weather, might not occur and generally would not occur until all survivors were aboard. This installation did not appear to comply with the TSO-C70a (paragraph 4.12) requirement that it be "visible from any direction by persons in the water" and was a deficiency, in our opinion.

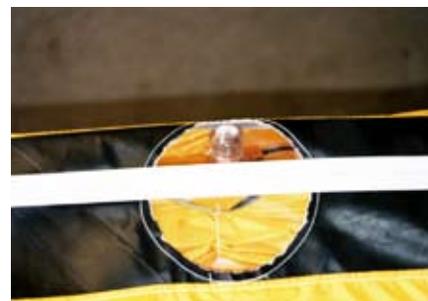
25

located directly behind the lifeline (photo 25); we saw lights that were almost not visible because they were off-center of the window.

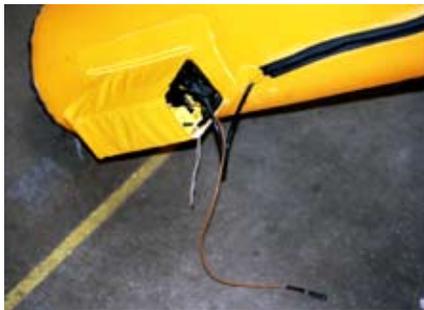
26

attached to the side of the boarding ramp in a foam-padded pocket. This allowed the water sensor, a length of flexible wire with the sensor on the end (photo 26), to function, no matter which side of the reversible life raft was up. A length of wire connected the ELT to the strip antenna that was glued to the adjoining canopy support. This canopy support was either beside the raft or, when erected, was at about a 40-degree angle from vertical. The ELT manufacturer said that with the canopy down, the ELT signal could be received by an aircraft overhead or nearby, but the manufacturer could not guarantee that the signal would be received by the Cospas-Sarsat International Search and Rescue Satellite System.

The ELT manufacturer said that unless the antenna was near vertical, the company would not guarantee that the ELT would function to specifications or be received by the satellites. The further the ELT was from vertical, the greater its loss of signal strength. With the canopy up, Artex would not guarantee that the ELT would function 100 percent of the time at the extreme angle. This was a deficiency, in our opinion.

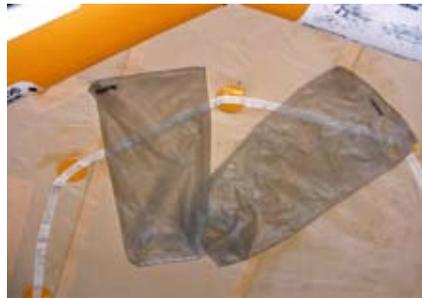
27

On the R Series life raft were two bags (photo 27), one with supplies and equipment, the other with hand paddles, a heaving line and a manual inflation pump. The ability to see inside the bag, even if not perfectly, was especially useful because there was nowhere else on the life raft to store equipment or supplies. The drawstring top was a bit difficult to use, but better than a tie closure. The bags were not waterproof.

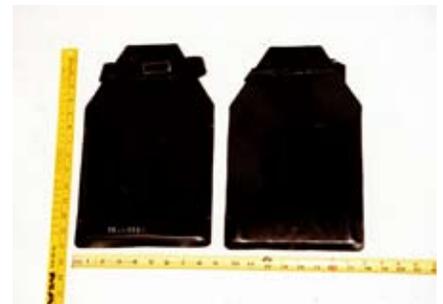
28

The R Series life raft had the worst “paddles” (photo 28) that the volunteers encountered. They were really hand paddles, not conventional paddles with handles. The wide and thin boards were covered with coated cloth and measured approximately 8.5 inches by 14.0 inches (21.6 centimeters by 35.6 centimeters). Each paddle had a one-inch strap at the top, and a hand had to be inserted under the wide strap covering most of the midsection of the paddle. A survivor would have to lean over the side of the life raft and immerse a hand and arm in the water to use a paddle. The paddles were nearly useless and difficult to operate, and would be unusable in cold water unless the survivor using them was wearing survival suit gloves/mitts that protected the hands. The paddles were a deficiency, in our opinion.

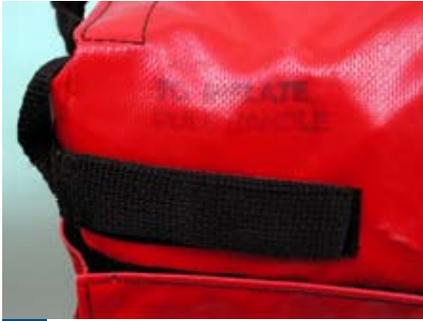
1

A black 3.5-inch (8.9-centimeter) loop of 3/4-inch-wide (1.9-centimeter-wide) nylon webbing, which was the inflation handle,

was Velcro-secured to the valise. This hand loop did not appear to comply with the requirements of TSO-C70a (paragraph 5.2), a deficiency, in our opinion.

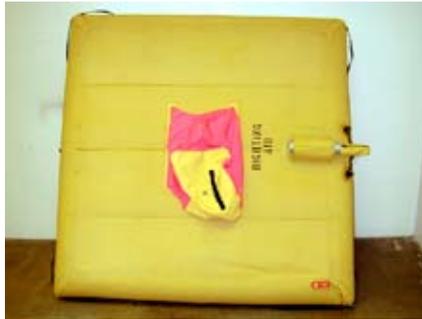
2

On the Type II life raft, a righting handle of black 3/4-inch-wide nylon webbing was attached to the bottom of the single water-ballast bag located in the center of the life raft. Stenciled next to the bag was “RIGHTING AID” (photo 2), which could be covered by the water-ballast bag,

depending upon which way it flopped, rendering the instruction useless. Even when not covered, a survivor in the water could have difficulty seeing the instructions. These are deficiencies, in our opinion.

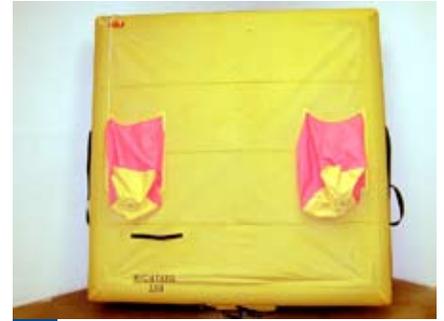
3

The righting handle on the Type I life raft was located on the bottom of the life raft to the left of the inflation cylinder (when viewed from the water), which was located conventionally on the exterior side of the buoyancy tubes. The “RIGHTING AID” stenciling (photo 3) was located on the exterior bottom at the edge of the life raft. On a capsized life raft, the exterior bottom was lifted well above the water by two buoyancy tubes; the instruction was not visible from the water.

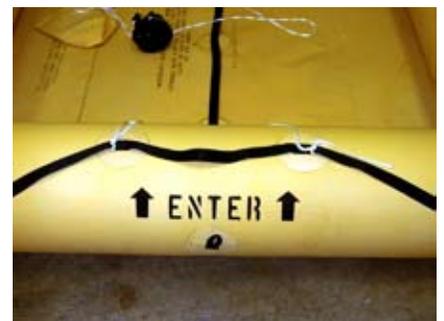
4

No foothold was provided to board the Type II life raft. The lifeline was attached above center (photo 4), high on the exterior side of the buoyancy tube on both sides of the two opposed entries. A grasp line was stretched across the floor between the two entries. Volunteers said that these lines were of little value as boarding aids. The inflation cylinder's inflation valve poked from underneath the bottom of the life raft at the center of an entry point; this was a potential source of injury and a deficiency, in our opinion. Entry was difficult for many volunteers, and the life raft easily was swamped (filled with water so that the top of the life raft was at or near water level with little — if any — freeboard) during boarding. This was undesirable because, in this situation, a large volume of water must be bailed out. This was a deficiency, in our opinion.

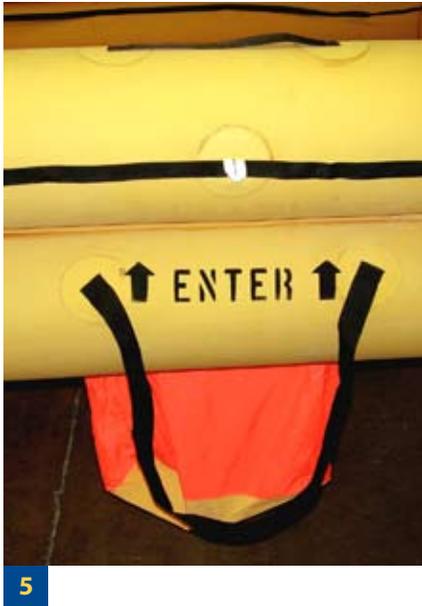
5

Type I life raft boarding aids were minimal. A black loop of one-inch-wide nylon webbing served as a foothold (photo 5, page 318), but it was easily overlooked because it hung down in the water. This

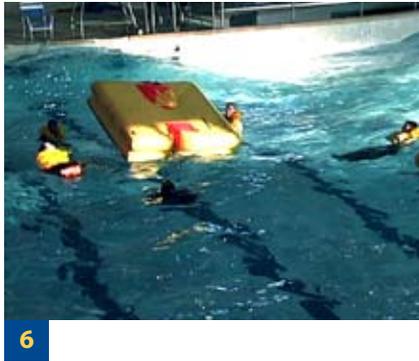
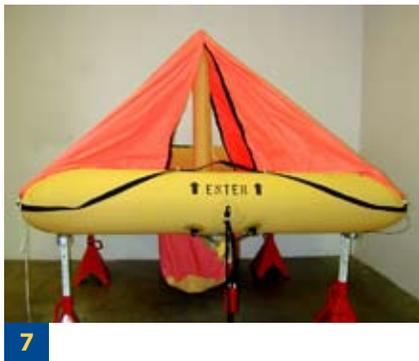
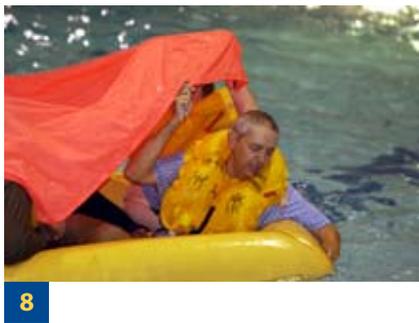
8

The TSO-approved life rafts were equipped with a unique teepee-style canopy (photo 7). After retrieving the coated rip-stop-nylon canopy and the attached orally inflatable mast from the SEP, the volunteers determined how to erect it in a few minutes; first-time erection (photo 8) required an additional 12 minutes to 15 minutes. Instructions were stenciled on the center of the life raft floor, but because the process was self-evident to the volunteers, the directions were unnecessary.

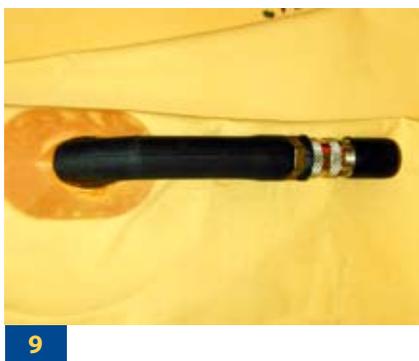
valve (photo 9). The mil-spec valve confused many volunteers because most had to discover for themselves that the valve had to be depressed manually to open it for inflation. After inflation, the loose end of the inflated mast was secured

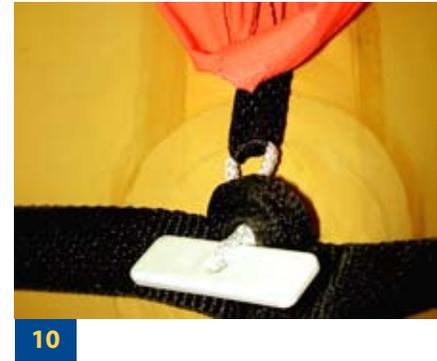
10

The bottom edges of the canopy were secured to loops (photo 10) in the lifelines on the exterior of the buoyancy tube, at the corners and middle of each side, with a plastic tab that slipped through the loops.

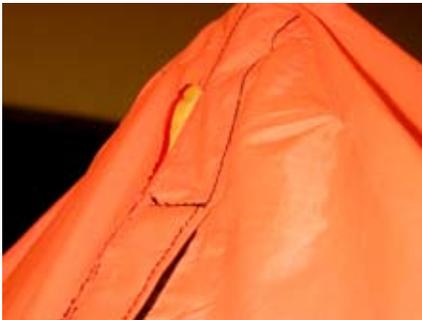
11

When the life rafts were capsized, the canopies on both life rafts tore at the peak (photo 11) where the orally inflated mast was attached, a deficiency, in our opinion. Volunteers also said that with the canopy fully closed and the tabs at the bottom of the flaps engaged, egress from the capsized raft was difficult and provoked anxiety for some volunteers, a deficiency, in our opinion.

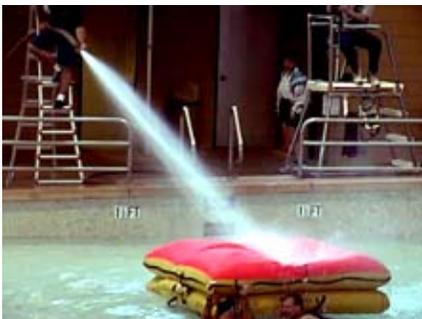
12

Canopies immediately collapsed during the rain simulation, and water poured into the life raft from under the bottom edge of the canopy and through the Velcro-secured entry slits. Volunteers complained about the chill transferred through the canopy to their bodies because they were unable to avoid contact with the collapsed canopy (photo 12). Even in a light shower, avoiding contact with the canopy side would be difficult because of the canopy design. These canopies offered only minimal shelter, inadequate to protect survivors in rough weather conditions, a deficiency, in our opinion.

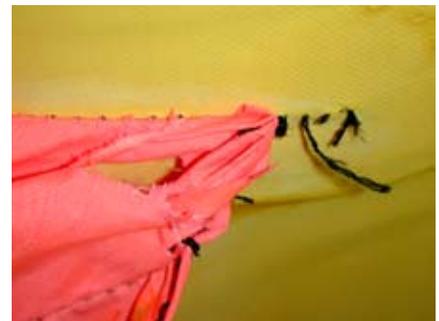
14

The water-ballast bags were constructed of lightweight canopy fabric for sides, buoyancy-tube fabric for the bottom. The lightweight canopy fabric tore at the seams near the top attachment points (photo 14), a deficiency, in our opinion. A marginal advantage of this design was that the bag became effective as the life raft lifted from the water faster than conventional designs because there was less distance between the bottom of the life raft and the effective open top of the bag, approximately three inches,

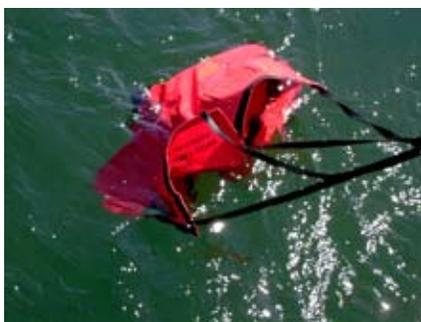
16

After the cable tie was severed and the valise was returned to the water, it was supposed to perform as a sea anchor. The sea anchor (valise) was attached to a 24.0-foot (7.3-meter), 1/4-inch-wide (0.6-centimeter-wide), flat-braided nylon line; the opposite end was attached to a corner of the life raft. This was coiled and retained by a cloth tube; the line tangled when it was deployed (photo 15). Including the length of the sea anchor's four one-foot shrouds, the total length met the requirement of 25 feet specified by TSO-C70a (paragraph 5.3). No swivel was attached to the sea anchor, a deficiency, in our opinion. The sea anchor (valise) on the Type II life raft performed satisfactorily until its Velcro seams attached to each other and the sea anchor was rendered useless (photo 16).

The longer sea anchor (valise) from the larger Type I life raft became attached immediately to its Velcro seams; despite repeated deployments, the sea anchor (valise) tended to foul itself very quickly and was rendered useless.

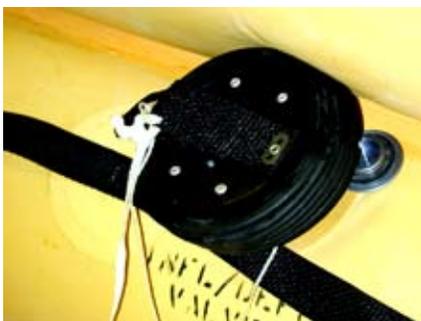
17

A Mirada bellows manual inflation pump (photo 17) provided approximately 40 percent more capacity than the TSO-C70a (paragraph 5.5) requirement. Nevertheless, some valves located between buoyancy tubes interfered with the filling and operation of the pump. The pump was tethered to a loop in the center of the life raft floor, stored inside the bailer.

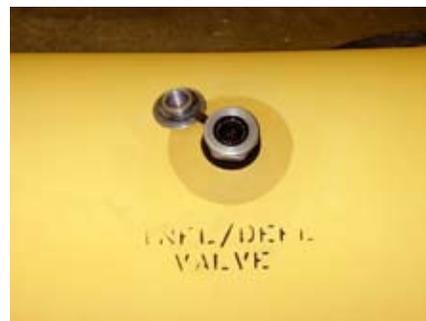
18

DEFL VALVE" (photo 18; survivors must decipher the abbreviations); no information noted the function as a PRV. This was a deficiency, in our opinion. This valve included a protective screen fitting (photo 19) that should be removed after the life raft inflates. An attached metal cap with a seal was used to plug the valve afterward. Plugging the valve is important, especially when the canopy is erected and closed; otherwise, the PRV will vent carbon-dioxide gas into the enclosed life raft, a deficiency, in our opinion. The stenciled instructions on the floor of the life raft were easily obscured and were overlooked by the volunteers.

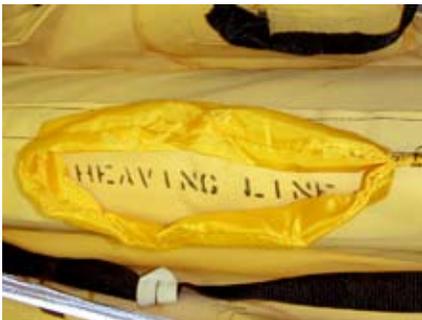
21

heaving line was a yellow nylon-fabric tube (photo 21) filled with polymer granules that expanded after being immersed in water for a few minutes, creating a flexible, sausage-like loop. This flexible loop could be difficult to hold onto with cold, wet, numbed hands while the loop is under tension, such as when it is being used to pull a survivor to the life raft. The dry quoit weighed only a few ounces and packed flat.

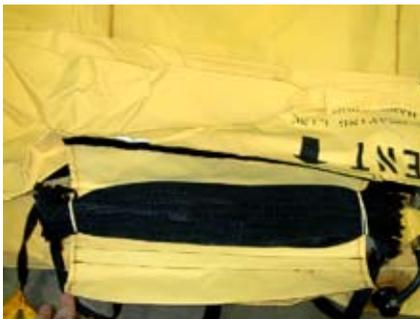
23

The heaving/trailing line, which was black 0.5-inch-wide nylon webbing (photo 23), was coiled inside a fabric Velcro-secured sleeve and retained with a pair of rubber bands, one on each end. It was attached above the inflation cylinder on the exterior of the

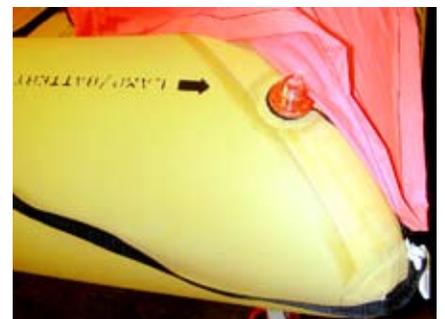
25

After the canopy was erected, the light did not function as a locator light because it was under the canopy (photo 25), located low and in a corner. In our opinion, this did not comply with the requirements of TSO-C70a (paragraph 4.12). Moreover, its location made it an ineffective interior light. The water-activated battery was secured with Velcro to the exterior bottom of the life raft. The battery was within reach, so it could be removed from the water and saved for later use. (No volunteer considered this possibility, and this action was not noted in any instructions.)

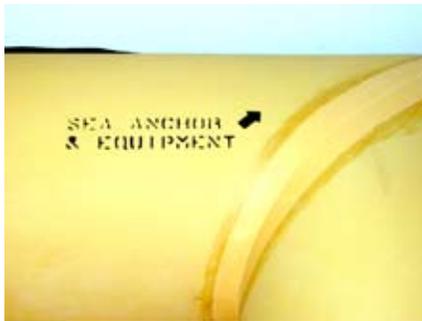
26

The SEP, with its Velcro closure system, remained secure. All the Survival Products life rafts noted the location of the SEP with a stenciled placard (photo 26) on the buoyancy tube. Even the most conspicuous of these was easily overlooked in a full life raft, and in one instance, the SEP was overlooked by the volunteers, who had to be told to retrieve it from the water. The SEP was not waterproof.

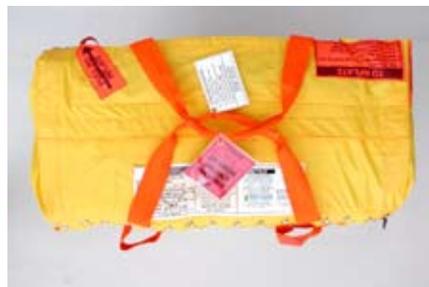
1

The life rafts shared common valise designs, and Winslow offered a wide range of custom valises and cases, numbering 500 at the end of 2003. The standard valises (photo 1) were constructed of yellow polyurethane-coated nylon with braided-nylon laces on both sides and a two-inch wide Velcro closure across the top center and across each end, like box-top flaps.

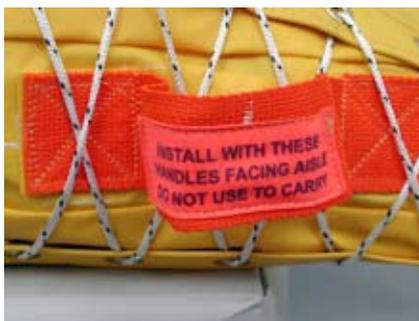
2

nylon-webbing handles was attached, one on each long side and each long enough to reach over the center seam when laid flat on top of the valise. The central portion of the grab handle was sewn around a foam core to provide a comfortable carrying handle. Smaller life rafts could be gripped by one person using one hand; larger life rafts could be gripped with separate grab handles by two people. The flat-carry method could be somewhat awkward inside an aircraft, but the life raft was easily dragged using the standard handles. There were no grab handles on either end of the standard valise; no-cost optional pairs of side grab handles were available to allow retrieval if the life raft was stored on its side or end, or if necessary to pull it from underseat stowage. We recommend that end handles (photo 2) be specified on larger life rafts for easier movement inside an aircraft.

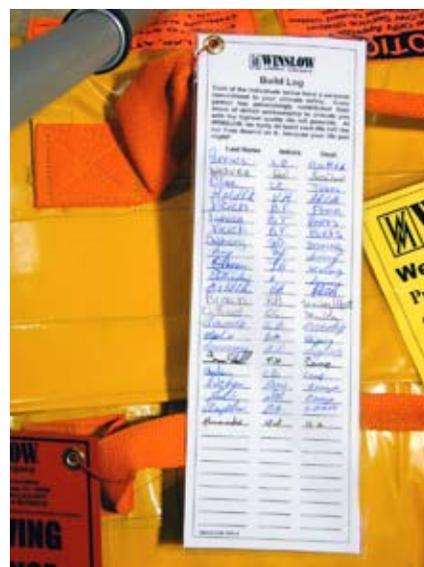
3

The life rafts were “decorated” with a variety of tags and placards. Two laminated tags were attached with thin plastic ties to the valise grab handles: a double-sided tag, with black text — “HANDLE WITH CARE” — on a red background, and a white build log tag (photo 3). (Each of the workers who had a hand in building the life raft signed the build log card, which was then laminated and attached to the life raft.) These tags were not required, so the customer could remove them.

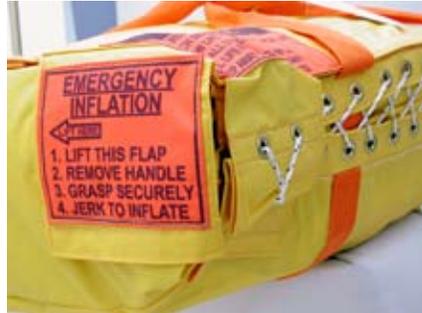
6

respectively). This did not appear to be an acceptable substitute or an “equivalent means,” and was a deficiency, in our opinion. The orange placard (photo 6) on a protective covering flap was clearly labeled

“EMERGENCY INFLATION” and provided clear instructions. Volunteers liked the caution to “GRASP SECURELY.” On occasion, we had seen volunteers using the immediate-inflation mechanism be startled by the nearly instant inflation and instinctively let go of the life raft, which could be disastrous in a survival situation. A pocket with a Velcro-secured tab retained the immediate-inflation handle under the flap (photo 7).

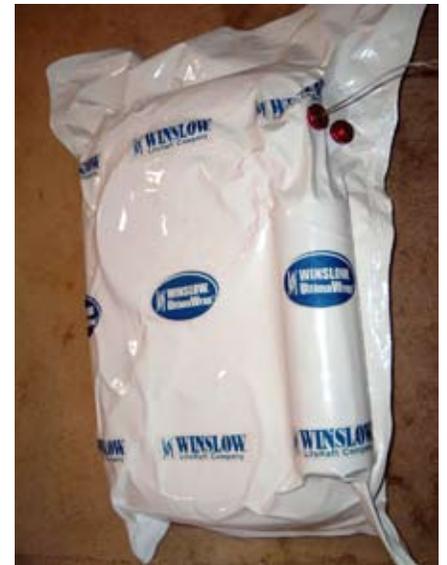
8

the packaging also contributes to smaller pack sizes. The life rafts provided for the evaluation were equipped with prototype packaging that since has been put into production with only minor cosmetic changes. Winslow’s “UltimaWrap” vacuum-packing material (photo 8) was a six-ply laminated-aluminized film that proved to be abuse-resistant and puncture-resistant.

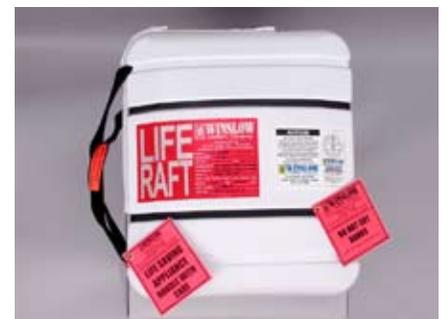
9

The life rafts could be packed in optional white molded-plastic cases (photo 9), which were usually designed to fit a particular aircraft installation. The two halves of the molded case were secured with plastic strapping bands. A laminated tag was attached that warned not to cut the bands and said that they would break during inflation. Placarding was similar to that on the valises, but on the hard cases, the identification/data plate was

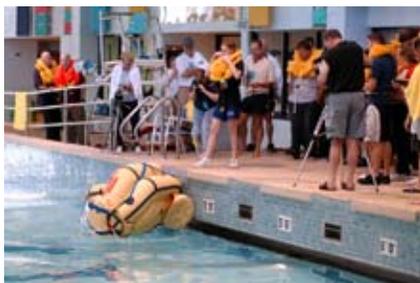
10

The life rafts inflated easily (photo 10), without noticeable difference from the inflation of other life rafts that were not vacuum packed. On one vacuum-packed life raft that we specifically measured, the force required to activate the inflation bottle was 23.0 pounds (10.4 kilograms), within the TSO-C70a (paragraph 5.2) requirement of 20 pounds to 30 pounds. Inflation time ranged from 16 seconds for the smaller life rafts to 20 seconds for the larger ones.

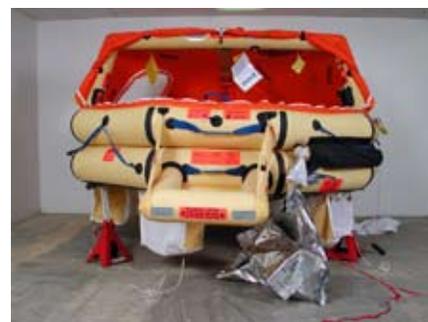
11

On larger life rafts, the large quantity of vacuum-packing material (photo 11), which remained attached to the mooring/inflation line next to the primary entry, was a minor annoyance to some volunteers gathering at the boarding platform prior to boarding, but it did not interfere with anyone boarding the life raft. One volunteer said that the attached aluminized material could be cut from the line and likely could be used in a survival situation.

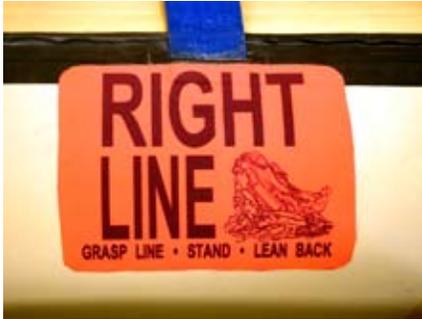
13

A unique “righting locator light” was located on the underside of the life raft at the outer edge adjacent to the righting line at the righting location. This light, the same approved-type water-activated locator light used elsewhere, guided survivors to a capsized life raft and to the righting location at night, a significant advantage, in our opinion. It provided sufficient illumination to see the righting instructions and righting aids. Inside the upright life raft, a placard instructed survivors to retrieve the light’s water-activated battery from the water (photo 12) and store it in a Velcro-secured holder provided for that purpose. This was done out of concern that the light under the life raft might attract unwanted attention from marine life. Winslow provided very noticeable and bold, easy-to-read righting instructions. At the righting location on the bottom buoyancy tube (the top buoyancy tube when the life raft was inverted) was an orange placard with a black text/pictorial instruction: “RIGHT LINE” (photo 13, page 327),

next to a pictorial instruction showing a life raft being righted, under which were instructions to “GRASP LINE – STAND – LEAN BACK.” The righting line and placard were located directly over the inflation cylinder. Some volunteers said that the terminology might be confusing to survivors for whom “right” means the opposite of “wrong” or “left,” a deficiency, in our opinion, but the pictorial instruction was clear.

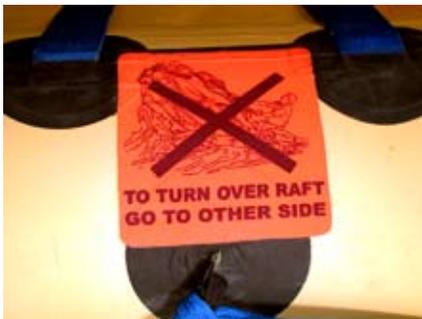
14

On the opposite side of the life raft, where the opposite end of the righting line or ladder was secured, was another bright orange placard with the same pictorial instruction: a big “X” over the pictorial instruction and the instructions “TO TURN OVER RAFT GO TO OTHER SIDE” (photo 14).

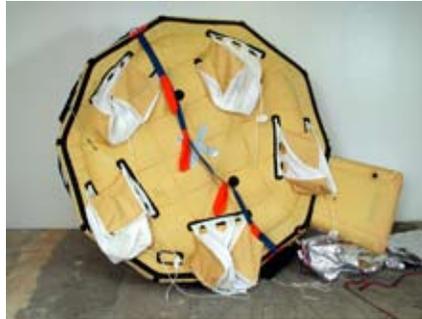
15

The blue two-inch-wide nylon-webbing righting line extended from one side to the other side with loops along its length to grasp (photo 15). These handholds were made of two-inch orange nylon webbing and contrasted with the blue nylon webbing. In addition, they were twisted, so they did not lie flat and were

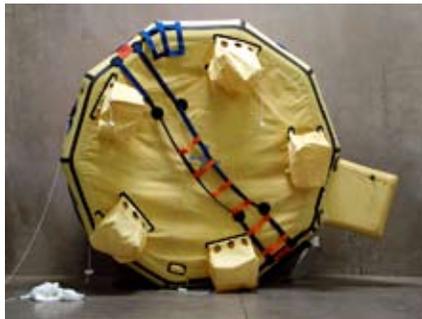
16

The 10-person Ultima life raft was equipped with an optional righting ladder, which also was constructed of blue two-inch-wide nylon webbing with orange two-inch-wide nylon-webbing rungs (photo 16), which further aided righting.

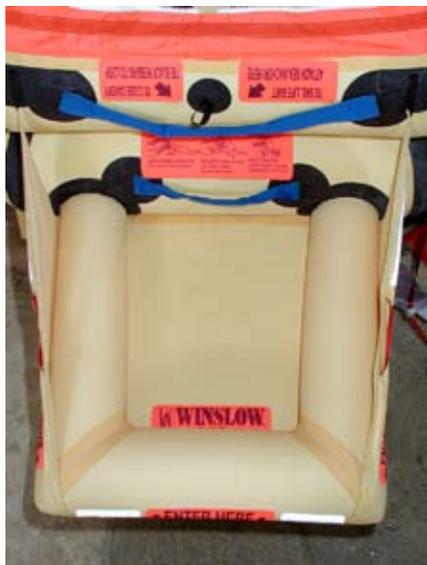
17

A grab handle was centered on the exterior lower buoyancy tube; a wider grab handle was centered on the exterior upper buoyancy tube; and another grab handle was centered on the top of the upper buoyancy tube. The boarding platform proved to be an effective boarding aid, noteworthy considering the high freeboard of some of the Winslow life rafts (photo 17, page 328).

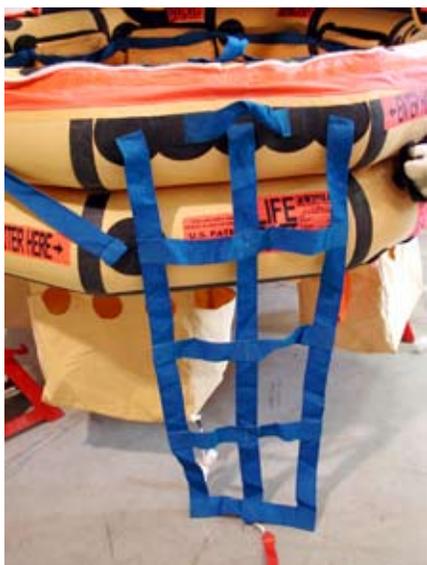
18

Winslow's original, very effective exterior boarding ladder (photo 18), in combination with the interior boarding ladder, remained a no-cost option for applications where weight or volume was critical. Attached to the exterior midpoint of the buoyancy tube (the upper buoyancy tube on two-buoyancy-tube life rafts) was a large three-rung or four-rung boarding ladder, depending on life raft size and freeboard, that hung well below the exterior

bottom of the life raft. The ladder was constructed of blue two-inch-wide nylon webbing with a center web between the rails to maintain the flexible ladder's shape during boarding. This appeared to be a satisfactory alternative to the flat rungs used by Hoover and Air Cruisers. The boarding ladder, combined with the interior boarding ladder, was a satisfactory primary boarding aid, but the inflatable boarding platforms, such as Winslow's, were preferred by the volunteers.

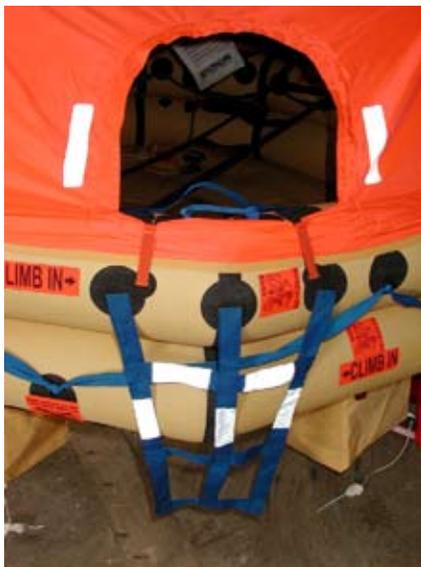
19

The alternate entry incorporated a similar exterior boarding ladder (photo 19) with a single grab handle on top of the upper buoyancy tube and a short interior boarding ladder of two-inch nylon webbing. The placards for the entry identified it as "REAR BOARDING" and included a pictorial instruction showing its use. The differentiation in placarding might help to prevent confusion about which entry is primary. The addition of the interior boarding ladder to the alternate entry made it effective enough that all the volunteers were able to use it to board.

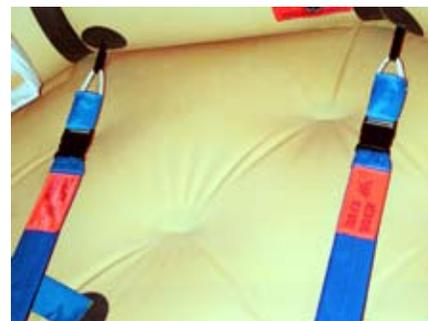
20

the bottom end of the rails. Placards on the two-inch nylon webbing instructed survivors "ONCE ON BOARD UNCLIP BUCKLES," apparently an instruction added after an evaluation in which the boarders did not realize that the interior ladder could be disconnected. The interior boarding ladder for the auxiliary entry was fixed to the floor and was equipped with quick-release buckles (photo 20) to allow it to be stowed after use.

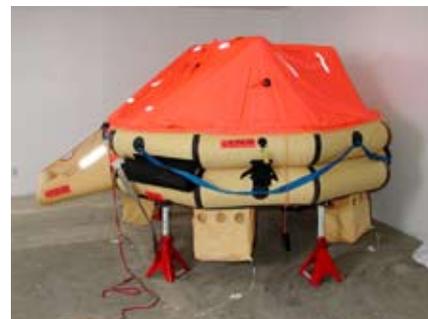
21

The standard canopy (photo 21) on the Type I life rafts was a self-erecting, stay-erect tri-arch design with a 5.0-inch-diameter (12.7-centimeter) canopy-support tube. The primary arch was located forward of the life raft centerline so that the canopy covered approximately 60 percent of the life raft when open. The other square arch extended at a right angle to the primary arch, from the center of the arch down to the upper-buoyancy tube in the rear. The stay-erect tri-arch tube included its own topping valve (photo 22, page 329). The closed rear section of the convertible canopy was attached to the

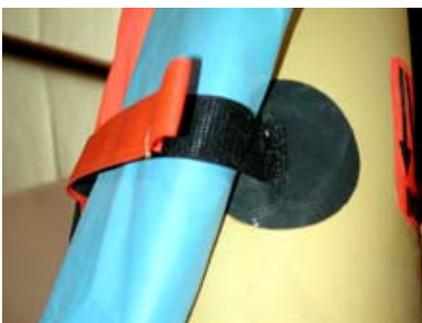
23

The open half of the canopy was split in two, and the flaps were rolled up to the arch tube, secured by two-piece Velcro straps, three for each flap (photo 23). A tab on the end of each flap facilitated release of the Velcro. The tabs ensured that in cold weather or with gloves, these straps could be grasped easily to release the flaps.

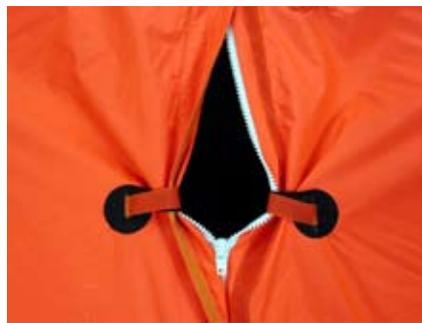
24

Ventilation was provided with the canopy closed via the double-action center zipper, which could be zipped open at the top. Velcro tie-backs allowed the two edges to be pulled back to form a diamond-shaped opening for increased ventilation (photo 24).

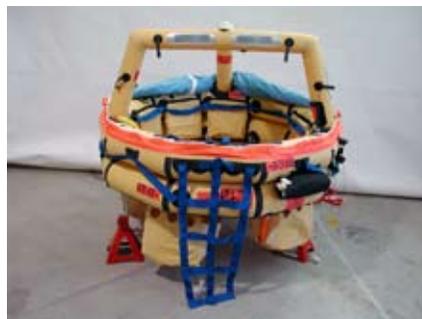
25

The bottom zippers extended back past the canopy-arch tubes and could be unzipped completely; the convertible canopy could be pulled off the arch tubes and then rolled up on the main tube at the rear of the life raft. The third support arch leg and alternate entry prevented the canopy from being rolled up and secured in place, as on Winslow's Type II life rafts. The canopy tended to crush the bottom of the rear arch (photo 25), which served to secure the canopy in the open position. While this was satisfactory, a Velcro strap on either side to hold down and collect

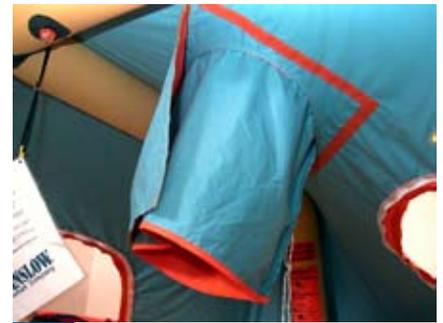
26

A combination observation port and water collector was fitted in one section of the rear of the canopy. This canopy-fabric duct (photo 26), 12 inches in diameter, was sufficiently large to allow a volunteer to put her head through the canopy (photo 27) and would be useful in inclement weather while protecting the interior of the life raft. The duct also would ventilate the life raft in cold, but

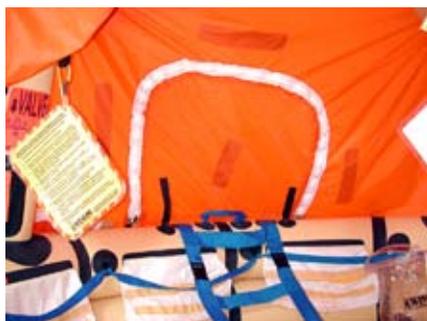
28

The required second entry was located in the left rear quarter (opposite the one with the observation port). This was a zippered arched entry door that was rolled down and secured by a pair of Velcro straps on the upper buoyancy tube upon inflation. The single large plastic double-action zipper went completely around the sides and top of the entry (photo 28). A Velcro-secured storm flap was fitted.

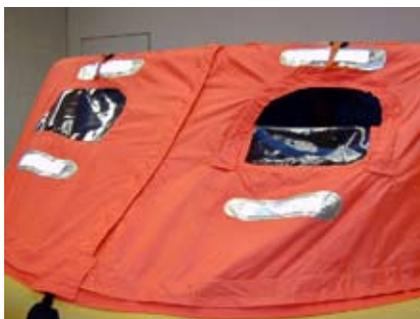
29

A unique Winslow innovation was the optional view ports (photo 29) added to the standard canopy. These clear plastic semicircular ports were a feature that contributed to a more comfortable environment in a closed-up life raft and as a potential antidote to seasickness, always a serious problem for survivors in a closed-up life raft. Two were fitted to the entry, one on either side, and one was fitted to the rear; they were expensive — US\$470 —

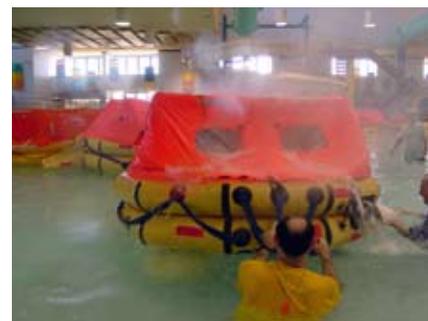
30

In the 2002 evaluation, the canopy on the larger life raft tended to collapse under the full impact of the fire-hose spray (photo 30,), something not experienced in previous evaluations. Investigation revealed that the canopy-support tube was

not fully inflated after the life raft had been manually re-inflated by volunteers. After topping off, in a second dousing, there were no problems. This shows that the inflation of the life raft must be maintained for maximum performance.

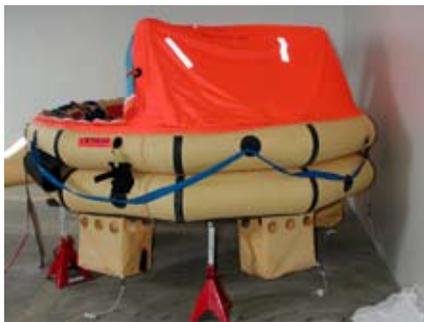
31

life raft. Blue one-inch webbing was used on Ultra-Light and Super-Light life rafts. The lifelines were staggered up and down (photo 31), from the midpoint of the upper buoyancy tube to the midpoint of the lower buoyancy tube on the double-buoyancy-tube life rafts. This pattern made the lifeline easier to grab, no matter what the position of the life raft. Subsequently, the lifeline was extended from beside the entry platform and attached to the sides of the boarding platform for improved security as survivors pulled themselves to the front of the platform.

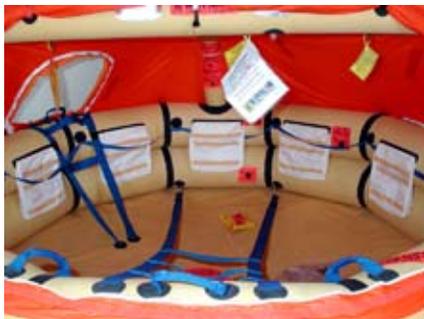
32

The interior grasp lines were located on the upper buoyancy tube on the Type I life rafts with sufficient slack to be easily grasped (photo 32).

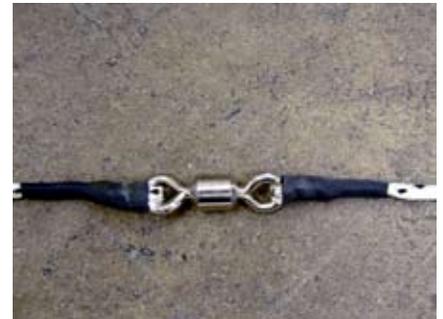
33

were fitted with spreaders to prevent tangling. The sea anchor was deployed automatically upon inflation and was attached at the rear of the life raft. The sea-anchor line was coiled and was contained within a fabric tube to aid inflation without tangling. A stainless-steel swivel (photo 33) was fitted at each end of the 30.0-foot (9.1-meter) long parachute-cord line.

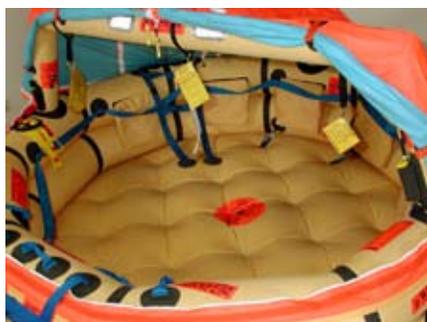
34

Winslow upgraded its integral inflatable insulated floor in 2002. Standard on the Type I life rafts, the upgraded floor had 21 reeds, more than any other similar floor among the life rafts that were evaluated. The result was something akin to tufted upholstery and provided more comfortable seating and more even insulation while reducing the total volume of air required to inflate the floor to an equalized air space (photo 34, page 332). The inflated floor was reasonably firm, like an air mattress, and it was impossible to feel someone punching the bottom, even with just a single person in the life raft. Only EAM's optional floor in its VIP line appeared to be similar, although with fewer reeds;

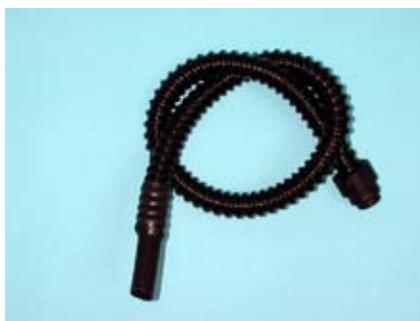
35

An oral inflation tube was included as a backup to the manual inflation pump. A rubber mouthpiece was on one end and a bayonet fitting for the valve was on the other end. A yellow laminated placard with instructions in black text was attached to the oral inflation tube. During the manual inflation pump comparison, we determined that the oral inflation tube (photo 35) could be very effective, providing more than six times the volume of the

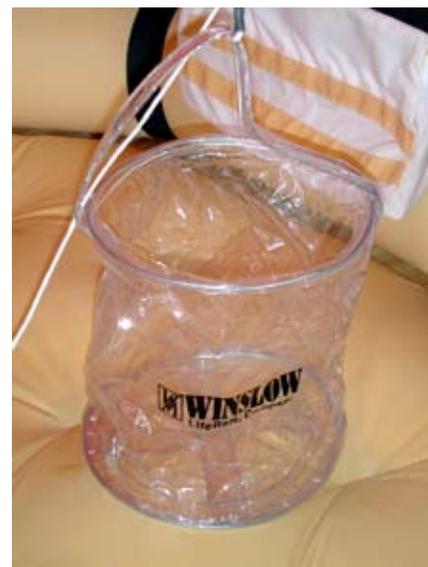
36

The bailer was a collapsible bucket (photo 36) with a handle, rigid wire-reinforced rims — top and bottom — and a reinforced bottom. It was constructed of clear flexible vinyl with welded seams that did not leak. While a bit on the large size (nine quarts [eight liters]), making it somewhat unwieldy in the tight confines of a smaller life raft, volunteers believed

that it was the best bailer. The wide bottom and moderately stiff material allowed the bailer to stand upright. It was secured by a parachute cord tether inside the life raft and was immediately available upon boarding.

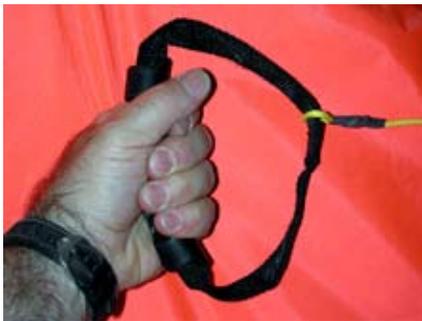
37

Winslow used an inherently buoyant yellow 3/16-inch braided polypropylene line attached to a single-handed water-skiing tow-rope handle (photo 37). This was a buoyant and slightly flexible black plastic handle through which was passed a loop of black 3/4-inch-wide nylon webbing that was then secured to the polypropylene line.

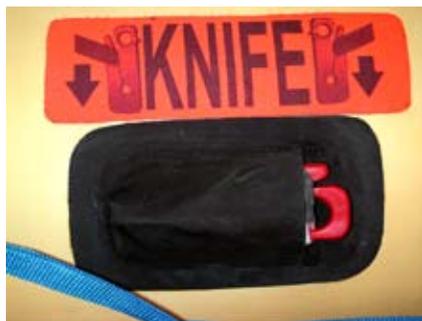
38

The raft knife was stowed inside a black fabric sheath on the interior side of the upper buoyancy tube (the single buoyancy tube on the Type II), adjacent to the primary entry on the right (as survivors board). Next to it were two orange placards labeled in black "KNIFE," with pictorial instructions affixed next to them (photo 38). One placard was oriented to the interior of the life raft above the sheath, and the other placard was angled toward survivors who would be boarding at the primary entry. Volunteers cited this as an excellent presentation, but said that on smaller life rafts, the placard facing the boarding survivors might be covered by the lower edge of the canopy.

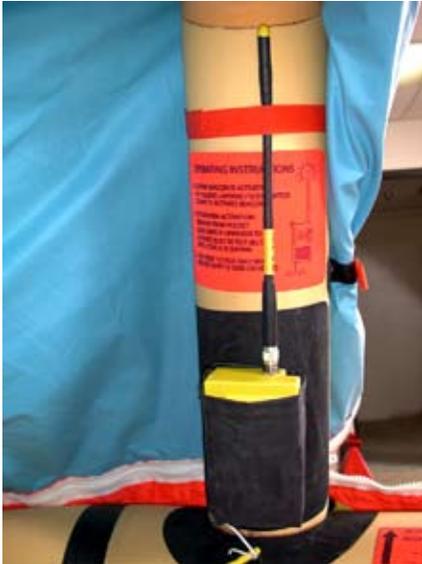
39

Winslow offered a range of ELTs as options, including the auto-deploying DME 121.5-MHz ELT and 406-MHz ELT (photo 39, page 334), which were secured in the life raft interior with the whip antenna on top of the buoyancy tube next to the leg of the canopy-support arch. Another option was a Techttest 121.5-MHz ELT that was available for manual deployment or automatic deployment, in which case it was located on the canopy-support arch-tube leg with an integral whip antenna. A wrist tether was attached to the ELT for security when it was used as a 121.5-MHz transceiver. A third option was a Kannad 406-MHz ELT, which was included in the SEP and was deployed manually into a pocket on the canopy-support tube arch leg. A fourth option was a manually deployed

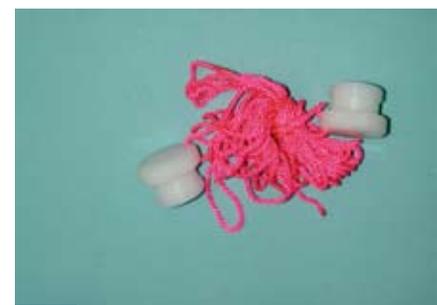
40

A pair of three-inch repair clamps and a pair of Mirada PRV plugs (photo 40) were included. The plugs did not float, but each was equipped with a six-foot orange nylon tether to prevent loss. Adding a tag to suggest that the tethers should be secured before use might prevent them from being lost overboard.

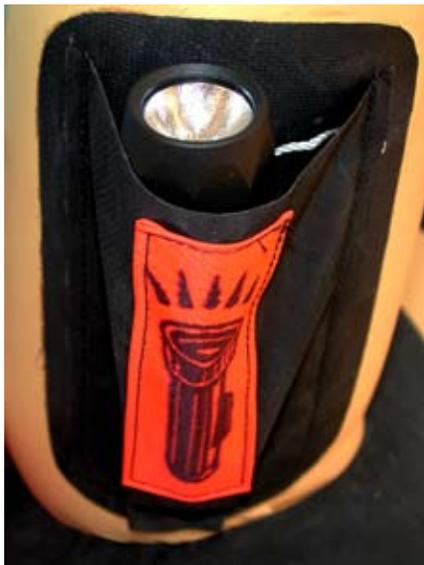
41

Winslow life rafts were first to be equipped with a flashlight available immediately upon boarding. Called the “Quick Grab” flashlight, it was a high-quality waterproof Pelican Products Magnum two AA-cell flashlight with a xenon bulb. The flashlight was stored in a vertical sheath (photo 41) in plain view on the canopy-support arch leg with an orange placard that showed a flashlight pictorial instruction. The flashlight was tethered to the life raft; a second Pelican Products Magnum with a tether was in the SEP.

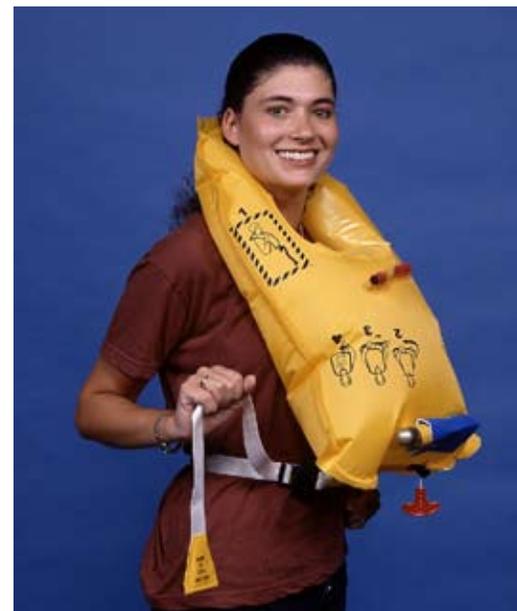
The newest U.S. standards for aviation life vests permit designs with a single buoyancy chamber.

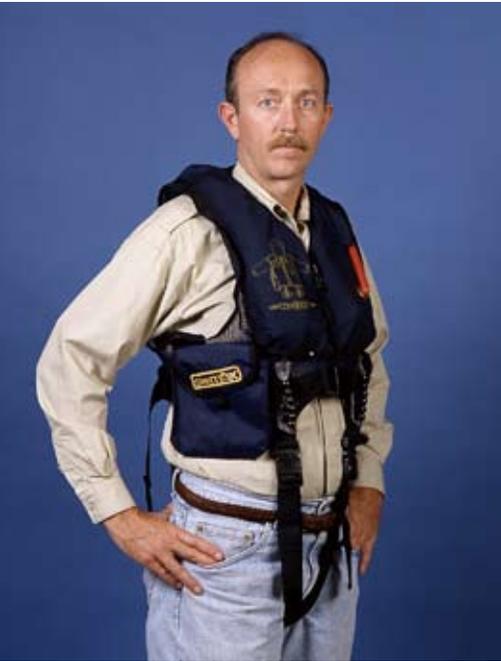
Unlike most aviation life vests designed for adults, this constant-wear design incorporates crotch straps to enable helicopter crewmembers to adjust their flotation attitude in the water.

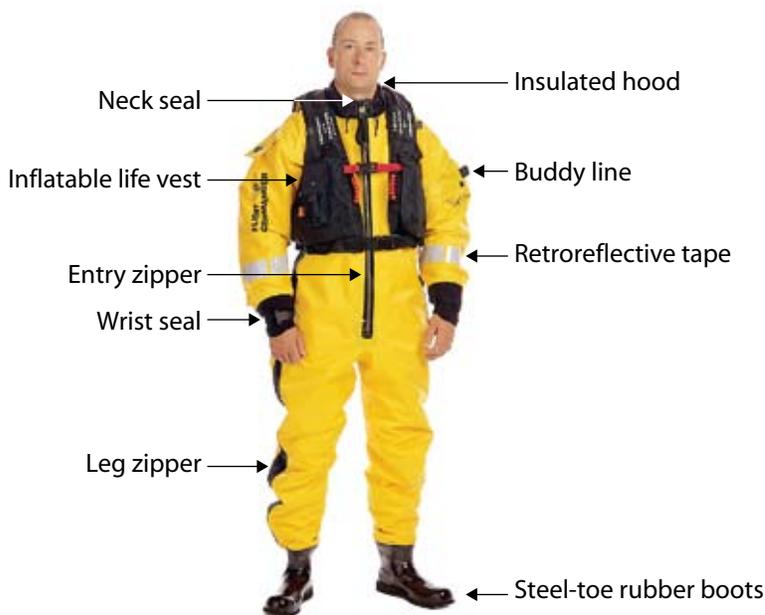
Immersion-suit systems are designed to ensure compatibility of life vests and other components.

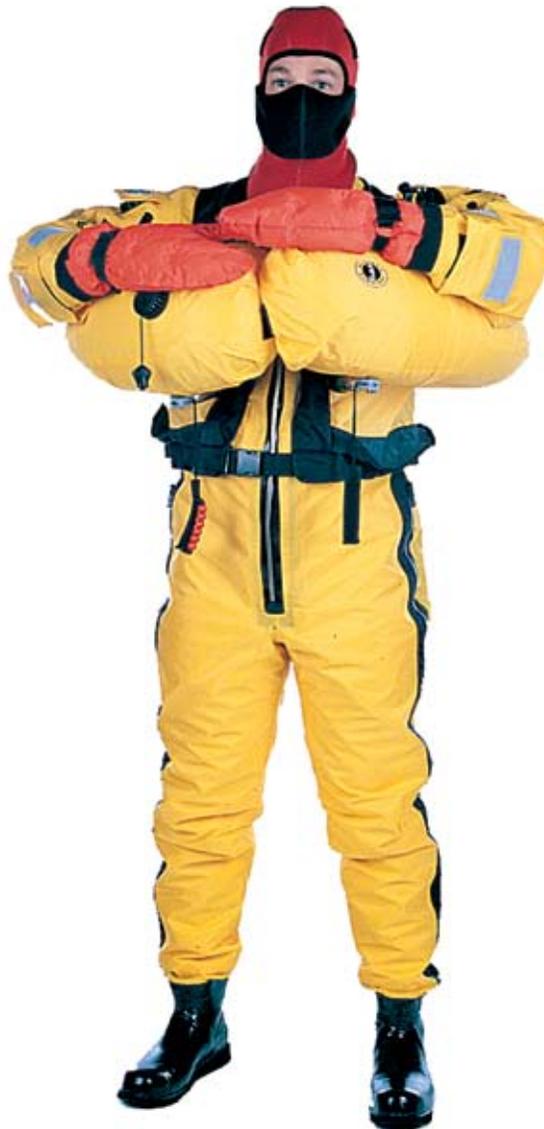
Maximum protection against drowning and hypothermia requires correct use of the life vest, splash guard over the nose and mouth, and thermal insulation of the head and hands, as provided by this immersion suit.

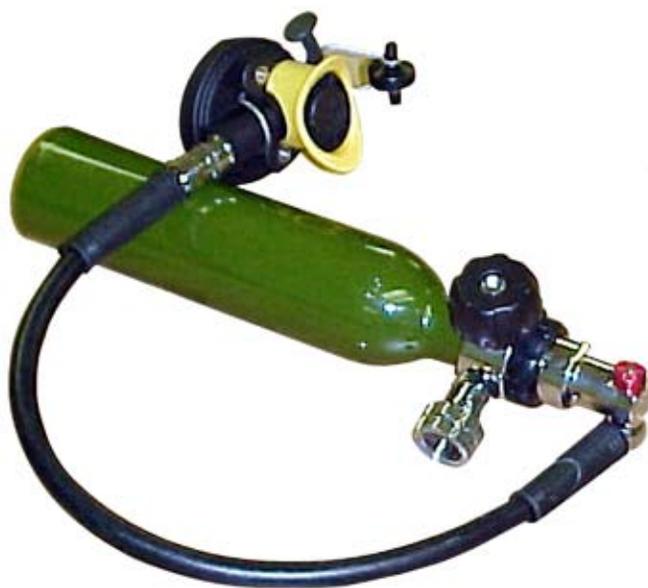
Shallow-water egress training provides practice using some emergency breathing devices at a depth of four feet (one meter).

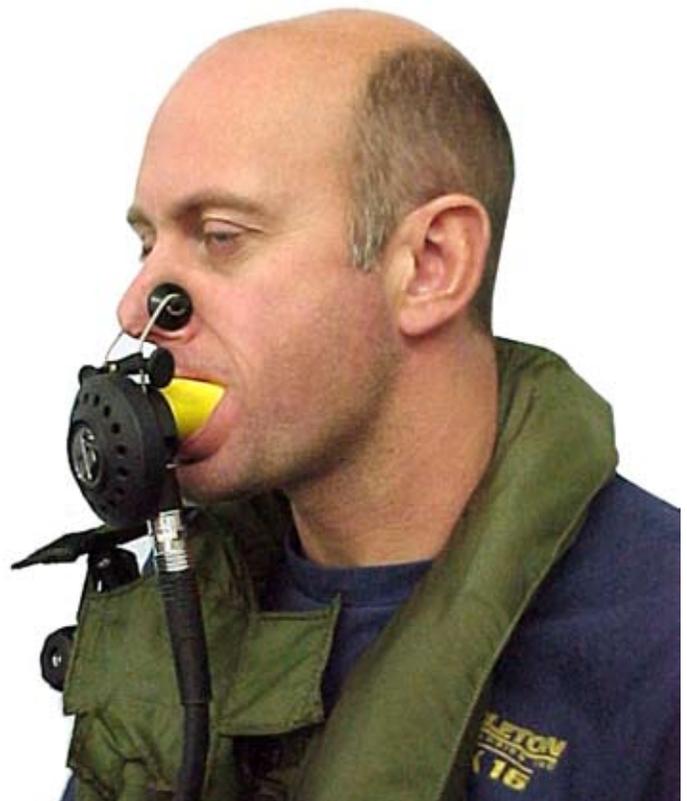
The passenger short-term air supply system includes passenger briefings and briefing cards to enable use without training.

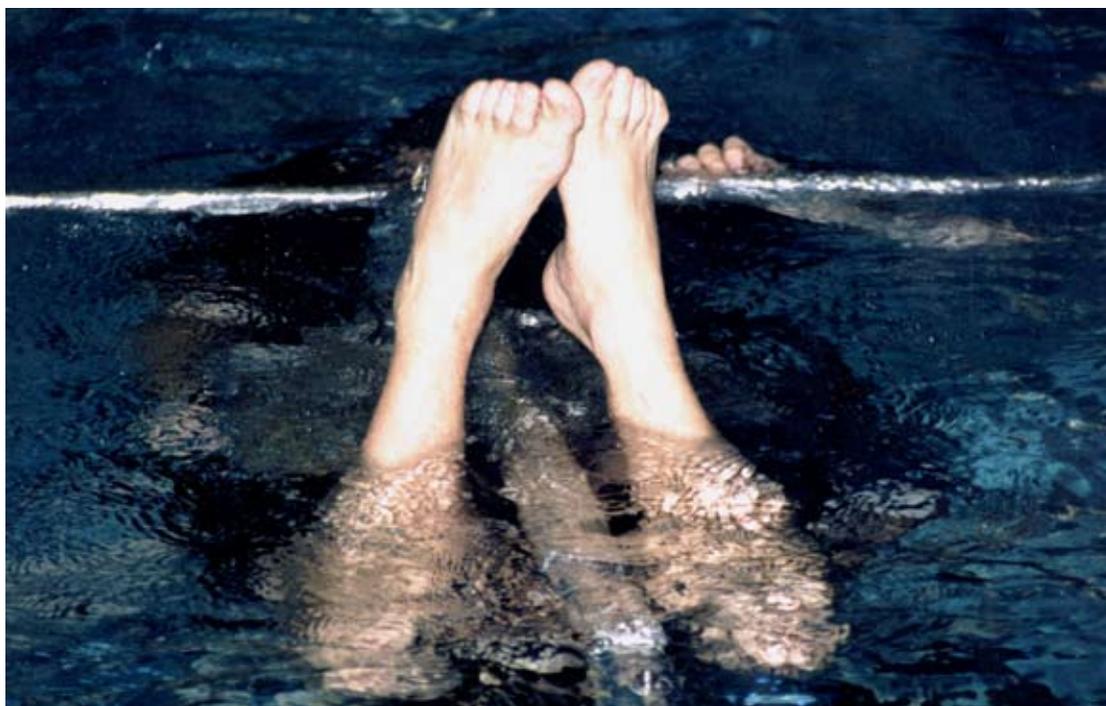
Upside down in a 'dunker' for underwater-escape training.
