Flight Safety

SEPTEMBER 2003–FEBRUARY 2004

Waterproof Flight Operations

■ A comprehensive guide for corporate, fractional, on-demand and commuter operators conducting overwater flights

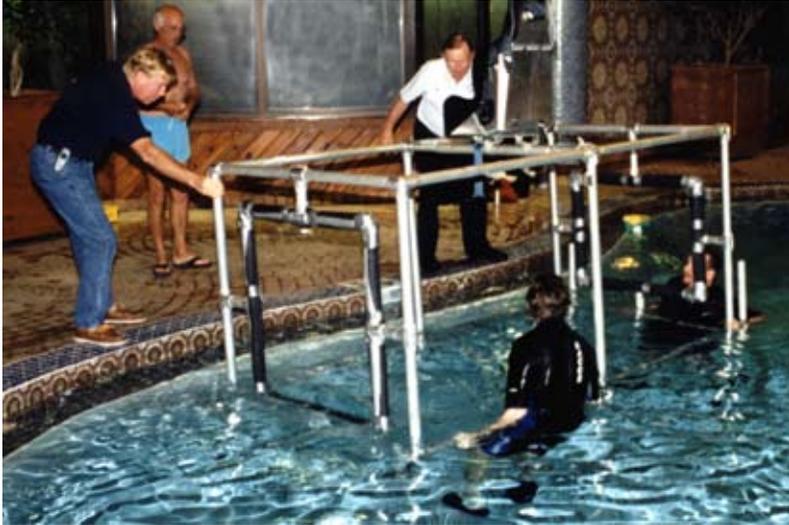
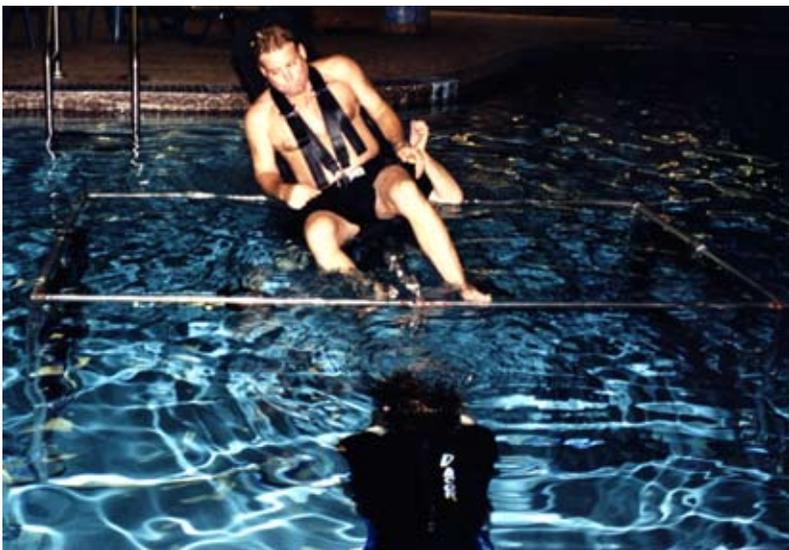
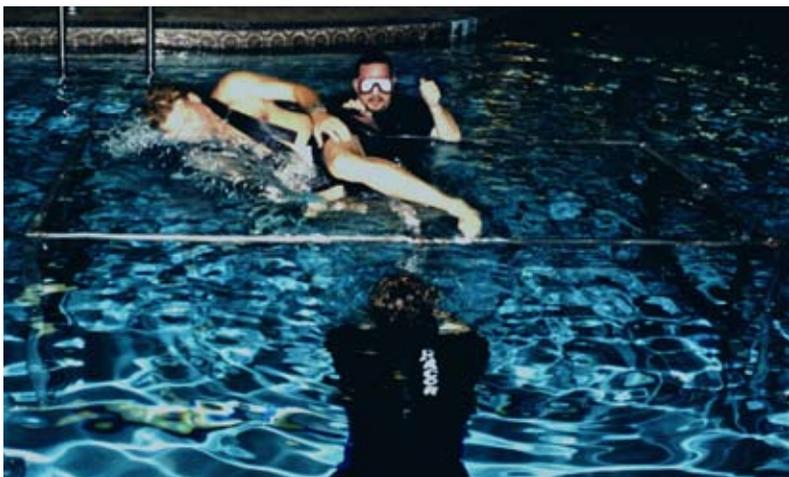
A portable egress trainer ('dunker') is easily assembled and lowered into a swimming pool (top). The dunker provides practice in escaping from a submerged, overturned aircraft.

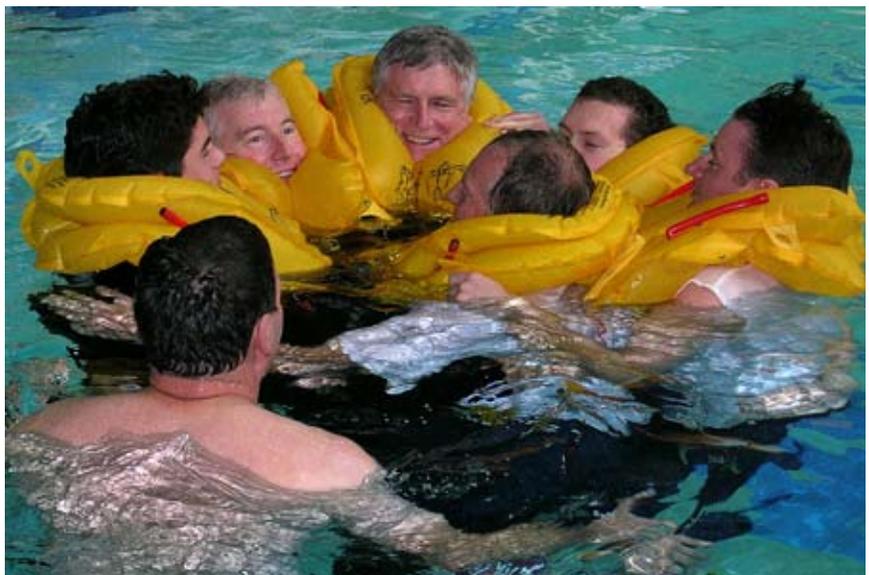
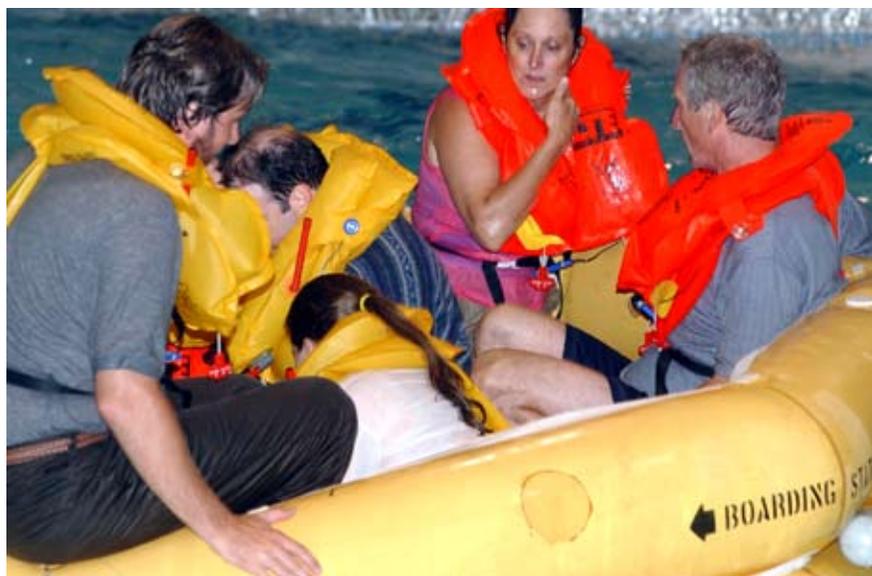
With no life raft available, survivors must huddle to conserve body heat and provide a bigger target for SAR.
