EMS Helicopter Strikes Terrain During Maintenance Ferry Flight

—
FSF Editorial Staff

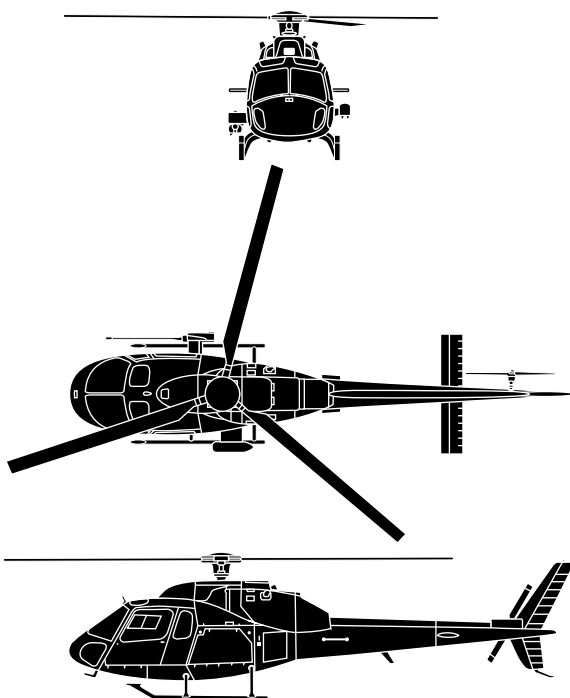
Eurocopter AS 355 Ecureuil 2/Twinstar

The Eurocopter (formerly Aerospatiale) AS 355 is a twin-engine version of the AS 350 Ecureuil/Astar. (The AS 355 is marketed in the United States as the Twinstar and elsewhere as the Ecureuil 2). Many of the components are identical to those of the AS 350, including the main-rotor mast, main-rotor head, tail-rotor hub, cabin and landing gear. The major differences involve the main-rotor blades, power plant, transmission, fuel system and fuselage structure.
