Unstable External Load Blamed in Helicopter Water-contact Accident

The U.K. Air Accidents Investigation Branch said that the BO 105 struck water off the coast of Scotland after the external load hit the tail rotor, severing the blades. The accident report included recommendations for improved guidance on the preparation, construction and carrying of external loads.

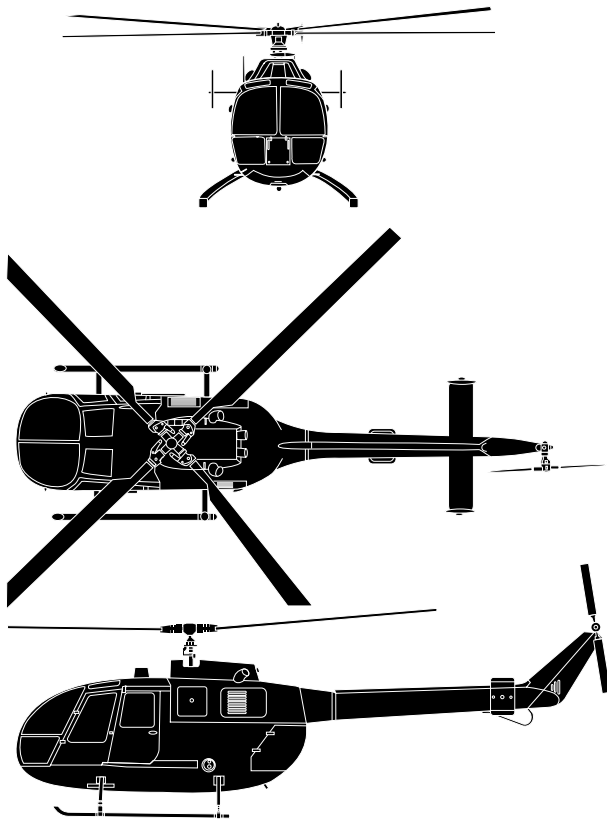
Messerschmitt-Bolkow-Blohm BO 105

The Messerschmitt-Bolkow-Blohm (MBB; now Eurocopter) BO 105 is a twin-turbine five/six-seat light helicopter with a four-blade main rotor and a two-blade tail rotor.
