## Maneuver Cited in AS 350's Uncontrolled Descent

*The U.S. National Transportation Safety Board said that the pilot on the Grand Canyon air tour apparently flew the helicopter over a cliff and then initiated a descent that he was unable to stop.*

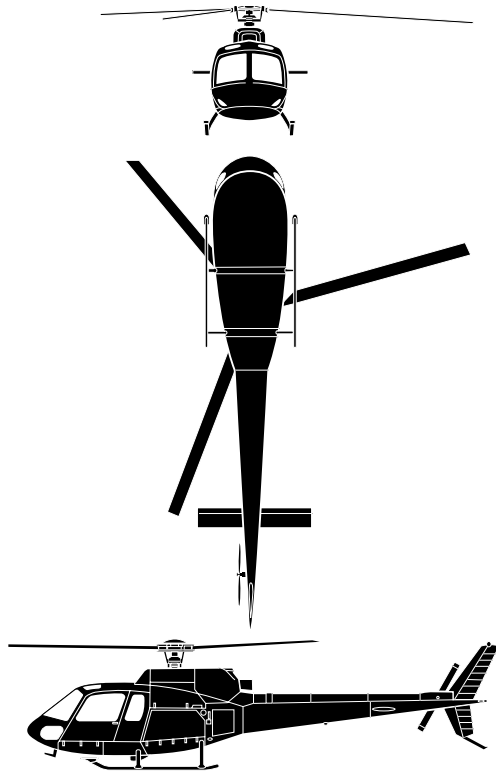
### **Eurocopter AS 350B2**

The Eurocopter (formerly Aerospatiale) AS 350B2 is a light utility helicopter with a Turbomeca Arriel 1D1 turboshaft engine and a main rotor of three fiberglass blades that rotate clockwise as viewed from above. A two-blade tail rotor is located on the right side of the tail boom.

The AS 350B2 has a more powerful 732-shaft-horsepower (546-kilowatt) engine, uprated transmission and wide-chord main-rotor blades and tail-rotor blades that originally were designed for the twin-engine AS 355.
