Bell 206L-3 Strikes Water While Maneuvering To Land on Offshore Platform in IMC

The U.S. National Transportation Safety Board said that the 18,913-hour commercial pilot was unable to control the helicopter after weather conditions deteriorated during a flight over the Gulf of Mexico.

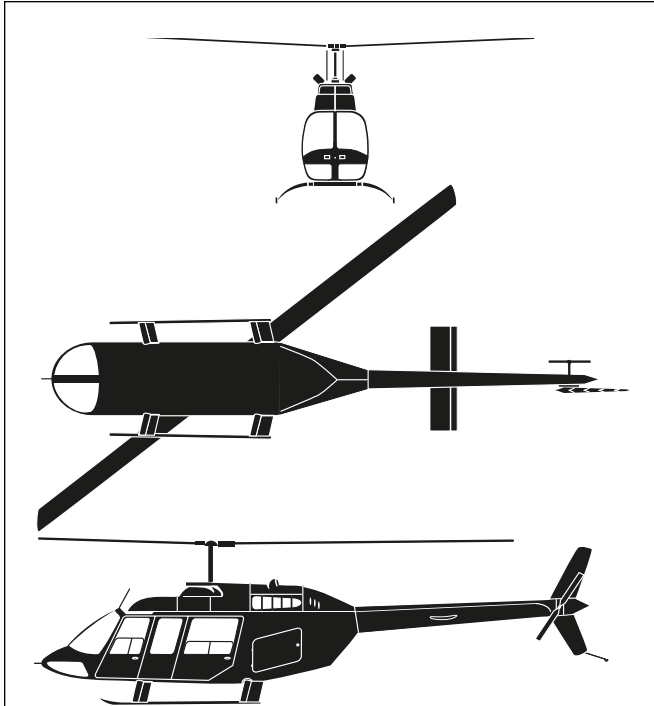
The Bell 206L LongRanger first was flown in 1974. Developed from the Bell 206B JetRanger II, the 206L has a fuselage that is about 2.0 feet (0.6 meter) longer than that of the 206B and a more powerful engine. The engine in the 206L-3 LongRanger III is a 650-shaft-horsepower (485-kilowatt) Rolls-Royce Allison 250-C30P turboshaft engine, with a maximum continuous rating of 557 shaft horsepower (415 kilowatts).
