Bell 206L Strikes Water During Low-altitude Flight in Whiteout Conditions

—
FSF Editorial Staff

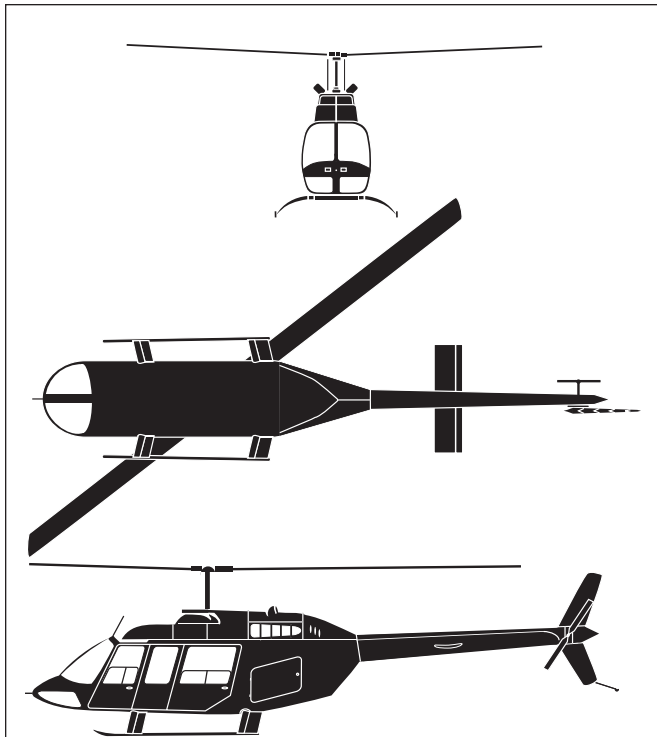
The Bell 206L LongRanger first was flown in 1974. Developed from the Bell 206B JetRanger II, the 206L has a fuselage that is about 2.0 feet (0.6 meter) longer than that of the 206B and an Allison 250-C20B engine with a takeoff rating of 420 shaft horsepower (313 kilowatts) and a continuous rating of 370 shaft horsepower (276 kilowatts).
