## Failed Hydraulic System Cited in Uncontrolled Descent of AS 350

*The Transportation Safety Board of Canada said that, while the pilot was maneuvering the helicopter to land at a remote logging site, he might have encountered control forces ‘too extreme to overcome,’ which made impossible a return to level flight.*

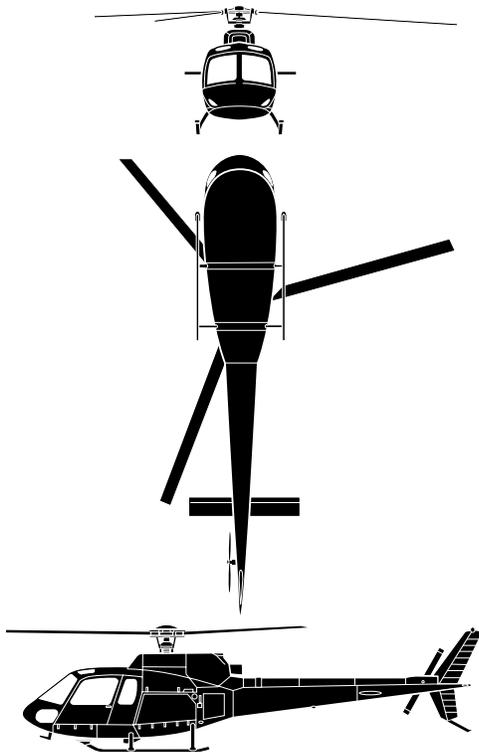
### **Eurocopter AS 350B2**

The Eurocopter (formerly Aerospatiale) AS 350B2 is a five-seat or six-seat light utility helicopter with a Turbomeca Arriel 1D1 turboshaft engine and a main rotor of three fiberglass blades that rotate clockwise as viewed from above. A two-blade tail rotor is located on the right side of the tail boom.
