## **AS 350BA Strikes Glacier During Alaskan Air Tour**

*Pilots flying two other helicopters in the area said that they had difficulty differentiating between the overcast sky and the snow-covered terrain and that the ceiling was only a few hundred feet higher than the mountain pass.*

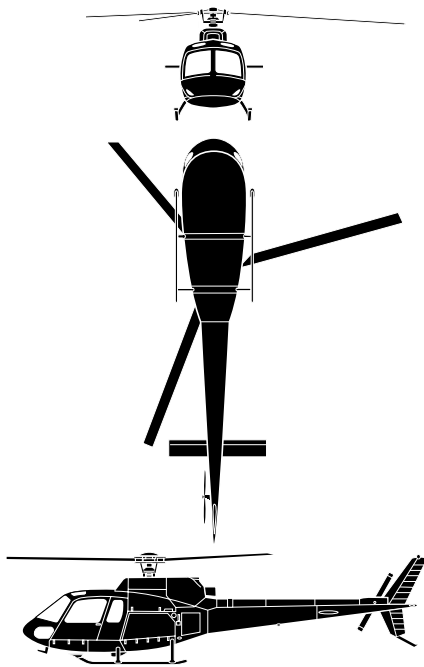
### Eurocopter AS 350

The Eurocopter AS 350 is a light five/six-seat utility helicopter, first produced in October 1977 by Aerospatiale as the AS 350B. The AS 350B is powered by a 478-kilowatt (641-shaft-horsepower) Turbomeca Arriel 1B turboshaft engine and a rotor of three fiberglass blades that rotate clockwise as viewed from above. Directional control is effected by a two-blade tail rotor on the right side of the tail boom.
