## **Aerial Ambulance Loses Engine Power During Approach in Dense Fog**

*After diverting a flight because of low fuel, the pilot was told that visibility was approximately five meters (16 feet) at the highway intersection where he attempted to land a Bell LongRanger III. The engine stopped producing power during the approach, and the helicopter struck terrain.*

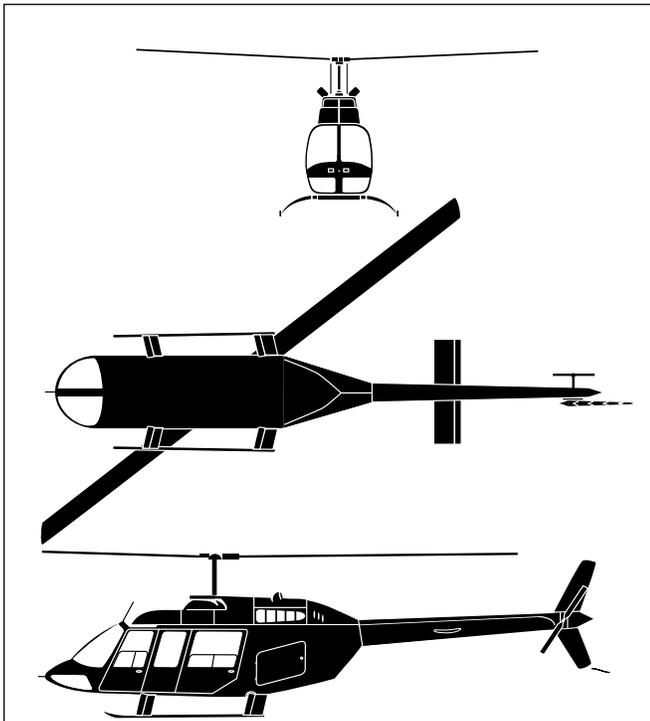
### Bell 206L-3 LongRanger III

The Bell 206L LongRanger was designed to fill a size-and-performance gap between the company's five-seat 206B-2 JetRanger II and 15-seat Model 205A-1. The helicopter, which first flew in 1974, has the Bell "Noda-Matic" cabin-suspension system, which reduces rotor-induced vibration.

Fuel capacity is 416 liters (110 gallons).
