FLIGHT SAFETY FOUNDATION
HELICOPTER SAFETY

Low Altitude Sight-seeing Flight Ends in Sudden Descent and Death

When the low time pilot elected to make a low-altitude turn near a steep glacier face, there was little time or room to maneuver when an emergency situation developed.

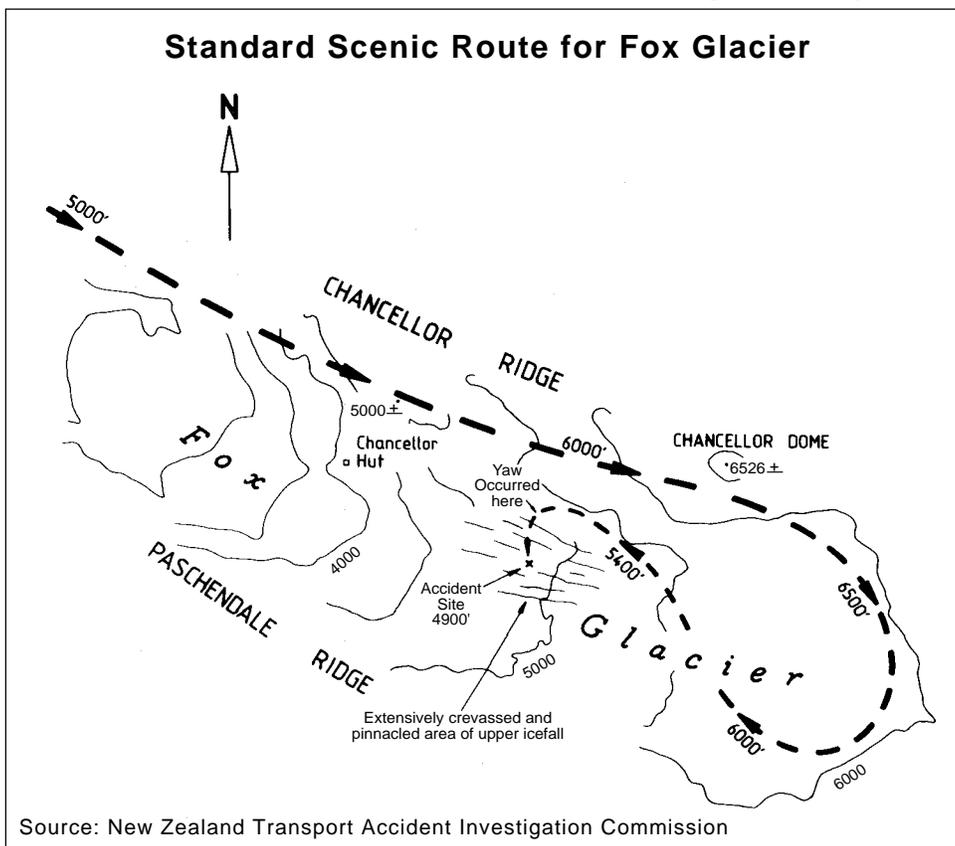
Figure 1

[The standard route scenic flight pattern (Figure 1), developed in conjunction with the Department of Conservation and the Ministry of Transport's Civil Aviation Division, was designed to reduce the danger of conflicting flight paths and to minimize environmental intrusion. "In addition, the rapid initial gain of height while flying up the northern side of the glacier and the subsequent zig-zag pattern down the glacier were intended to provide a suitable compromise enabling passengers to obtain an impressive view of the area, yet allowing for the opportunity for an autorotational descent to suitable terrain at the side of the glacier...at the base of the glacier or to lower ground beyond in case of an engine malfunction." But the report stressed: "The availability of an autorotational descent path to such areas varied considerably, depending on the aircraft's height at the time...the slope of the glacier in the immediate vicinity and the distance...(from) the nearest suitable landing surface."]
