# FLIGHT SAFETY FOUNDATION HELICOPTER SAFETY

## Enter At Own Risk

*The height-velocity diagram may be only advisory in nature,  
but the pilot who does not treat it with due respect is  
flirting with disaster.*

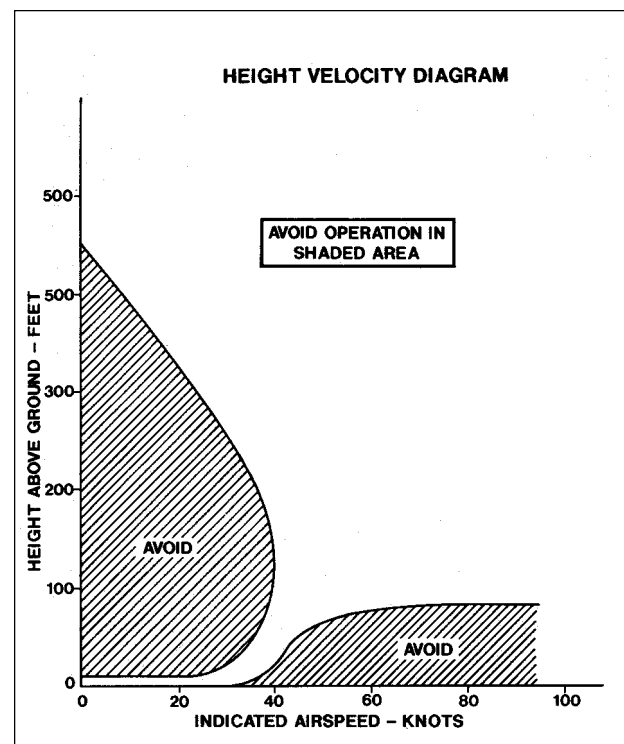
Figure 1

All helicopter flight manuals contain a similar warning. It is known by many names: Limiting height-speed envelope; avoid area; and dead man's curve are just a few. The generally accepted term is height-velocity (HV) diagram which, in itself, does not suggest anything hazardous. The fine print that accompanies the HV diagram is normally a mild admonition to "avoid operation in the shaded area." A typical HV diagram is shown in Figure 1.

“The high hover limit point (450 feet in the diagram) is the minimum height. I should fly downwind” — not so. The HV diagram only holds true for a landing in the direction of flight following power failure. Minimum recommended downwind height is dictated by the auto-
