Abrupt Maneuver and Mast Bumping Cited in Loss-of-control Accident

Witnesses said that the Fairchild Hiller FH-1100 helicopter was being flown at low altitude when the main rotor separated and a rotor blade struck the cabin.

The U.S. National Transportation Safety Board (NTSB) said, in its final report, that the probable cause of the accident was “the pilot’s abrupt, low-g maneuver, which resulted in mast bumping and separation of the main-rotor system.”

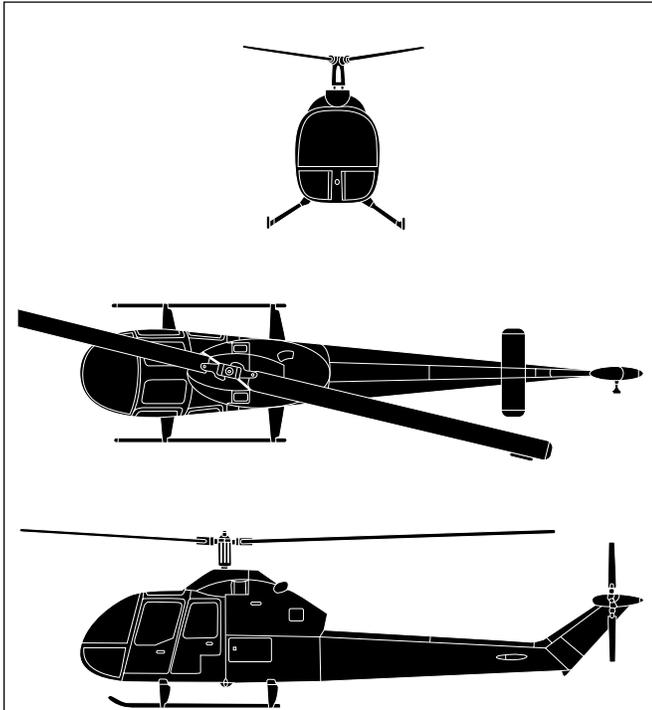
Fairchild Hiller FH-1100

Hiller Aircraft Co. began designing a light observation helicopter designated the OH-5A in 1961. The OH-5A competed for a U.S. military contract that was won by the Hughes OH-6A. In 1964, Hiller was acquired by Fairchild Stratos Corp. The company, renamed Fairchild Hiller, developed a civilian utility version of the OH-5A designated the FH-1100 and began production of the helicopter in 1966. Production ended in 1974, after 246 of the helicopters were built.
