Investigation of R44 Accident Focuses on Weight and Balance

There was no record that weight-and-balance calculations were performed after the passengers changed their seating assignments for the second leg of the charter flight in Australia. The helicopter was overweight and had a forward center of gravity when it struck terrain.

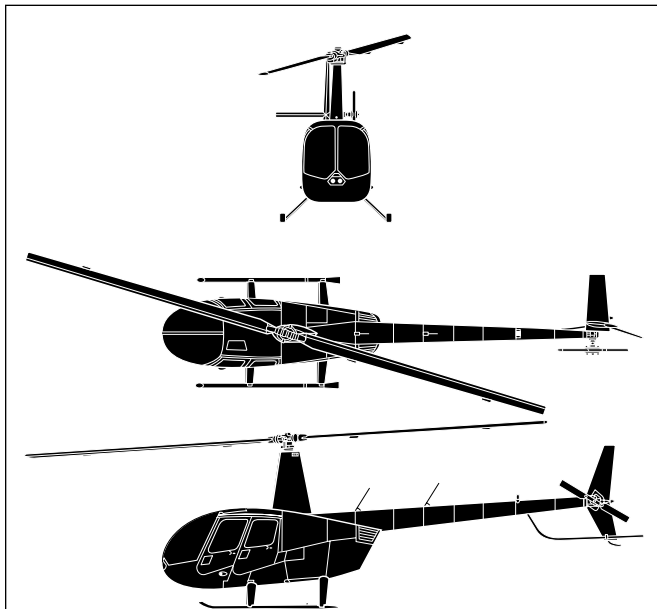
The Robinson R44 Astro is a four-seat light helicopter first flown in 1990. The design incorporates some elements of the two-seat R22, including the tri-hinge underslung rotor head designed to limit blade-flexing and rotor vibration.

The R44 Astro was replaced in 2000 by the R44 Raven, which has hydraulic flight controls, adjustable anti-torque pedals and elastomeric tail-rotor bearings. ♦
