## **‘Cardiac Event’ Suspected In Pilot’s Loss of Aircraft Control**

*The investigative report said that ‘some loss of control’ occurred during the final seconds of a charter flight in New Zealand. The cause of the loss of control was not established conclusively, but the report said that the pilot might have experienced ‘the sudden onset of a cardiac event.’*

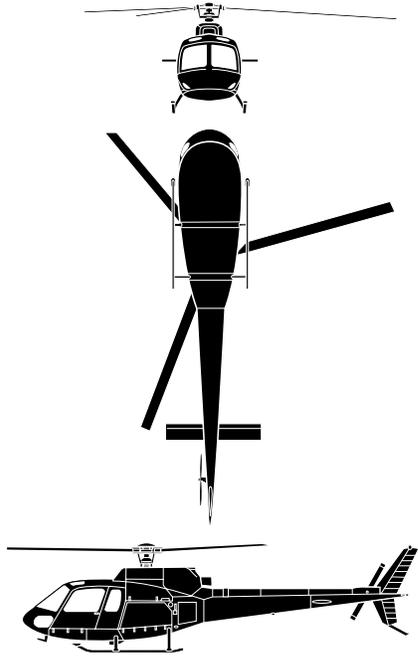
### Aerospatiale AS-350B Ecureuil (Squirrel)

The Aerospatiale (now Eurocopter) AS-350B is a light utility helicopter with a Turbomeca Arriel 1B turboshaft engine and a rotor of three fiberglass blades that rotate clockwise as viewed from above. Directional control is effected by a two-blade tail rotor on the right side of the tail boom.

The AS-350B has two standard bucket seats at the front of the cabin and two two-place bench seats aft.
