## Sikorsky S-76 Accident Rates Show Overall Decrease

*Accident statistics for 1994 through 1997 show continued improvement in the helicopter's overall safety record, but also show an increase in accidents related to pilot error and controlled flight into terrain.*

—  
*Joel S. Harris  
FlightSafety International  
West Palm Beach, Florida, U.S.*

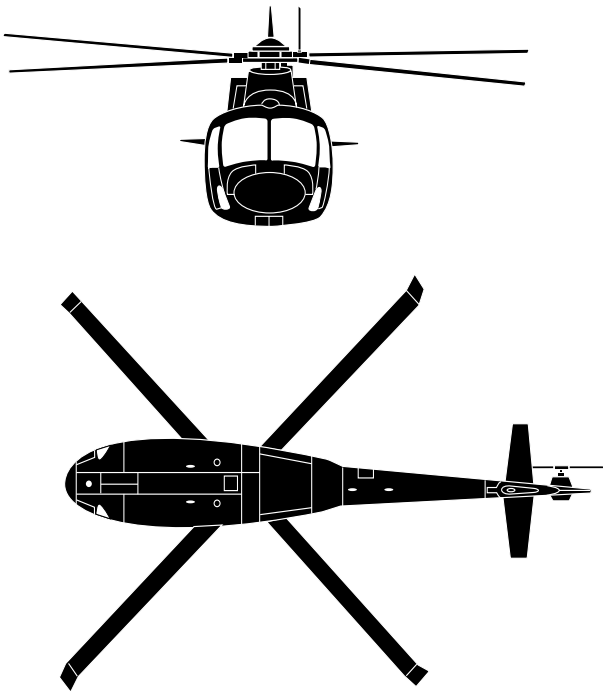
### Sikorsky S-76

The Sikorsky S-76 first flew in 1977. The S-76A is configured to accommodate 12 passengers and two pilots. It has a maximum takeoff weight of 10,300 pounds (4,672 kilograms), a maximum cruising speed of 145 knots (268 kilometers per hour) and a service ceiling of 15,000 feet (4,575 meters). The S-76A has a maximum range of 404 nautical miles (748 kilometers) with 12 passengers, standard fuel and 30-minute reserve. The S-76A is powered by two Allison 250-C30 turboshaft engines, each rated at 650 shaft horsepower.

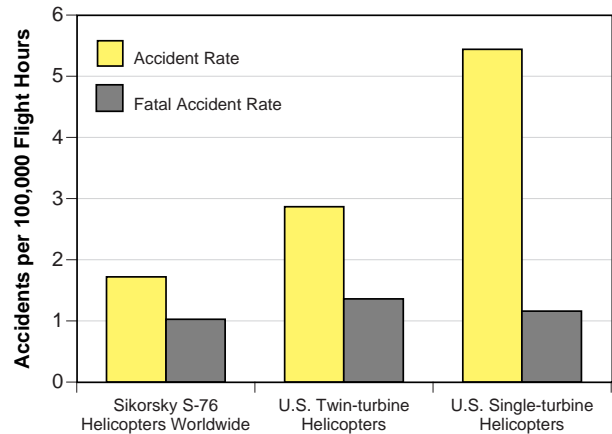
### Helicopter Accident Rates 1994–1997

Figure 1 (page 2) compares the S-76 helicopter's worldwide accident rates for 1994 through 1997 with the accident rates for all U.S.-registered single-turbine-engine helicopters and twin-turbine-engine helicopters.

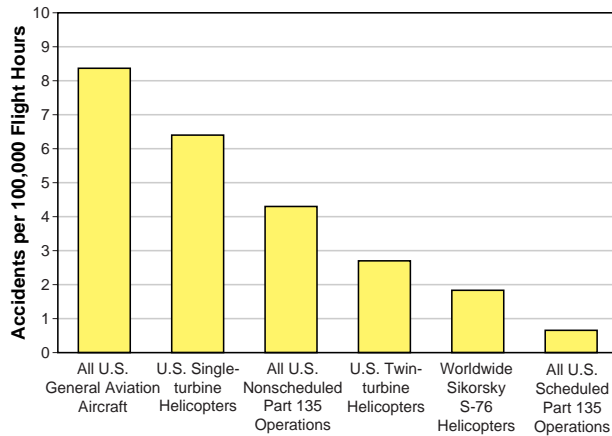
### Aircraft Accident Rate Comparison 1994–1997

Figure 2 (page 2) compares the S-76 helicopter's worldwide accident rate for 1994 through 1997 with the accident rates of U.S. general-aviation aircraft, U.S. single-turbine-engine helicopters, U.S. twin-turbine-engine helicopters, U.S. Federal Aviation Regulations (FARs) nonscheduled Part 135 operations and scheduled Part 135 operations.

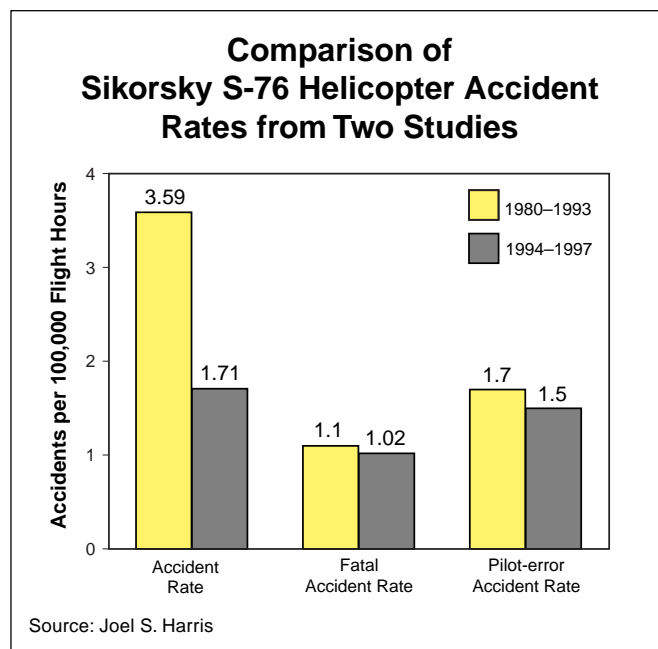
Figure 3 shows the accident rates, fatal-accident rates and pilot-error-accident rates for the two study periods.

The increased *percentage* of accidents attributed to pilot error does not mean that pilots are making more mistakes when operating S-76 helicopters. The *rate* of pilot-error accidents actually has decreased. There were 1.7 pilot-error accidents per 100,000 flight hours in 1980 through 1993, compared with 1.5 pilot-error accidents per 100,000 flight hours in 1994 through 1997.

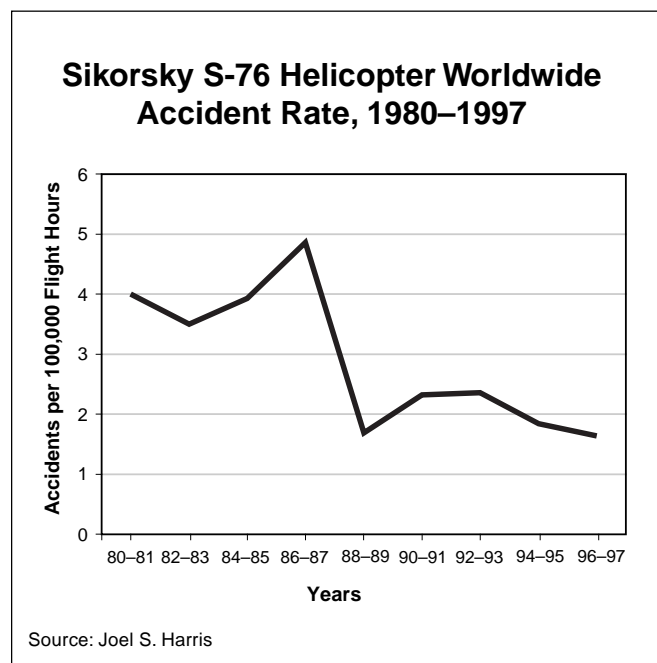
The S-76, which has been in service since 1980, is no exception. Figure 4 shows that the helicopter’s accident rate has diminished.

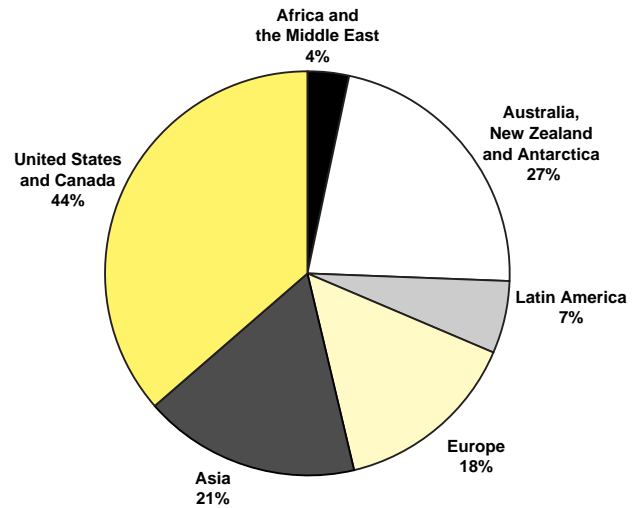
### Sikorsky S-76 Helicopter-fleet Distribution

Approximately 420 S-76 helicopters are in operation worldwide. About 38 percent (159) of the helicopters are registered in the United States. Figure 5 shows the distribution of the fleet.
