# AeroSafety WORLD

THE JOURNAL OF FLIGHT SAFETY FOUNDATION

SEPTEMBER 2014

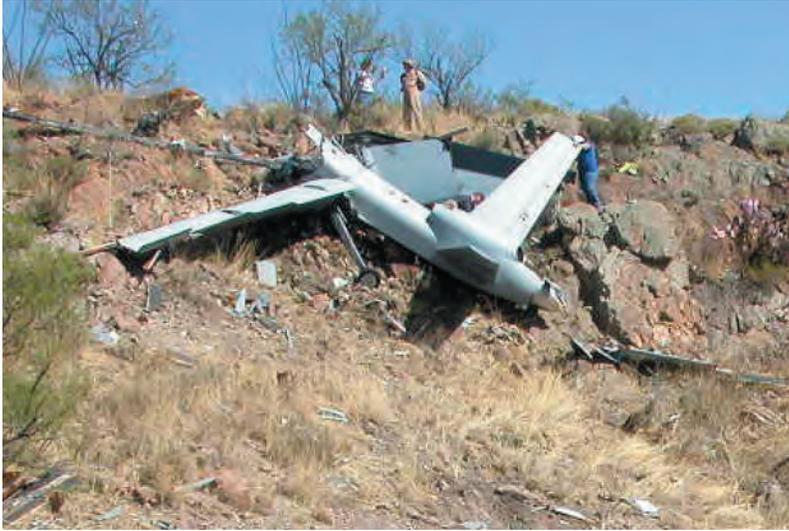
NTSB accident investigators examine the wreckage of a General Atomics MQ-9 Predator B that crashed near Nogales, Arizona, in 2006.

The NTSB’s 2007 final report on the first accident concluded that the probable cause was “the pilot’s failure to use checklist procedures” when switching from one ground control console to another ground control console that was inoperable because of a “lockup” to another console at the same ground control station. In the process, the fuel valve on the General Atomics Aeronautical Systems MQ-9 Predator B was inadvertently shut off, causing the engine to lose power; the aircraft crashed in a remote area near Nogales, Arizona, on April 25, 2006 (see Table 1).

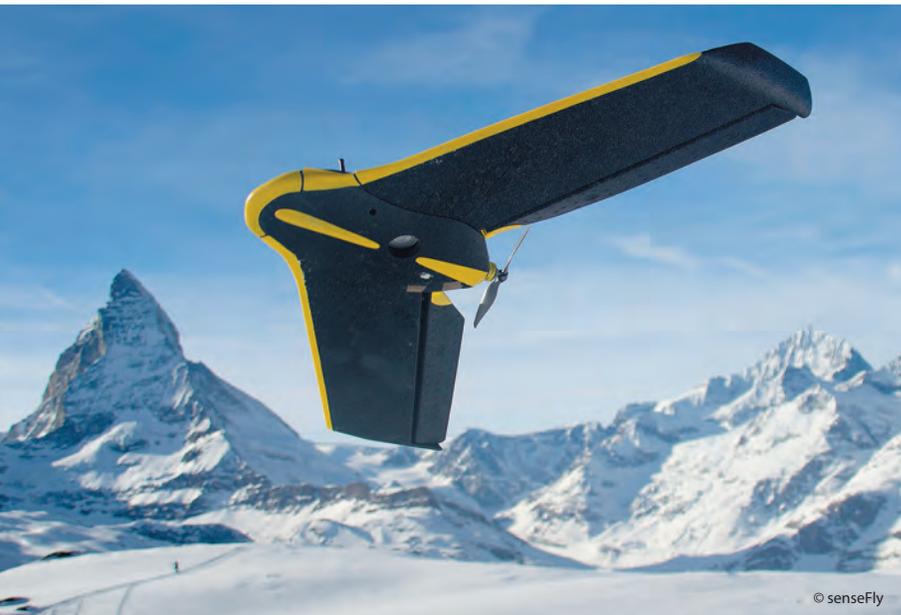
A senseFly eBee similar to this one was being used for aerial photography over a mining site in Australia when it had a close encounter with an agricultural spraying aircraft.

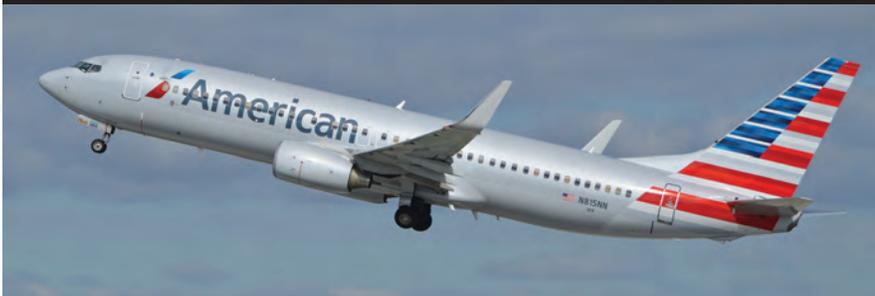
## Boeing 737-800

In 1964, Boeing began design work on a twin-turbine, short-range, narrow-body airliner that could compete with the Douglas DC-9, the British Aircraft Corp. One-Eleven and the Sud Aviation Caravelle. The result was the 737, which shared many components and assemblies with the 727 trijet, and differed from its competitors by having wing-mounted engines, a shorter fuselage and a wider cabin seating six abreast. It was the first Boeing airliner to have a two-pilot flight deck.

The first model, the 737-100, entered service in 1968, followed shortly by the -200, both with Pratt & Whitney JT8D engines. Continuous improvement over the years has increased the airplane's size, power, payload and performance.

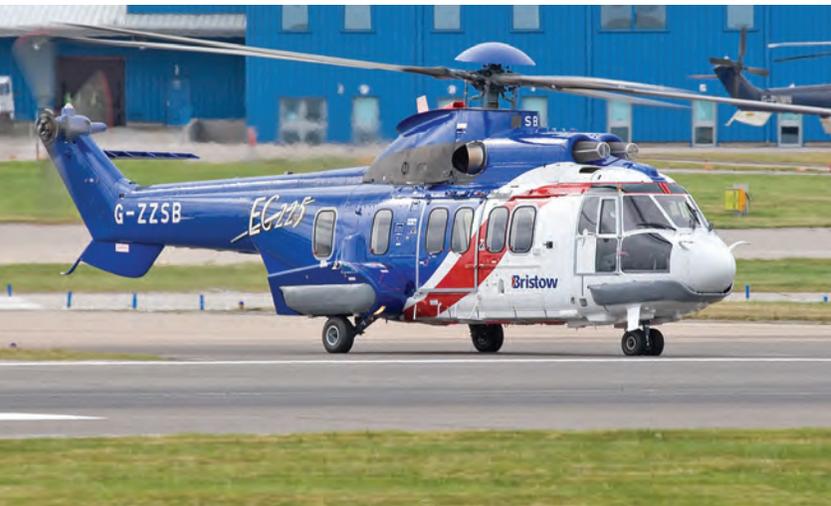
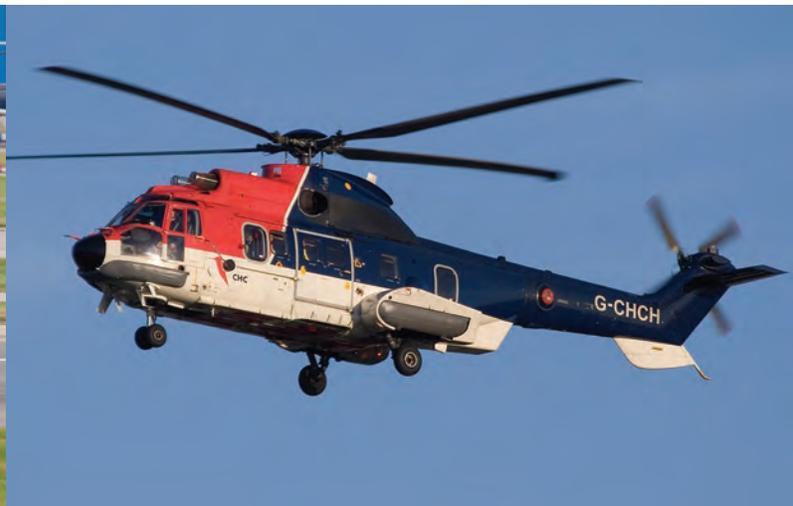
**Each accident occurred after a loss of main rotor gearbox oil pressure.**

Accident investigators found that the ditching of each of the helicopters involved in the 2012 accidents followed a loss of oil pressure that resulted from “a failure of the bevel gear vertical shaft in the main rotor gearbox, which drives the oil pumps,” the report said. “The shafts had failed as a result of a circumferential fatigue crack in the area where the two parts of the shaft are welded together.”

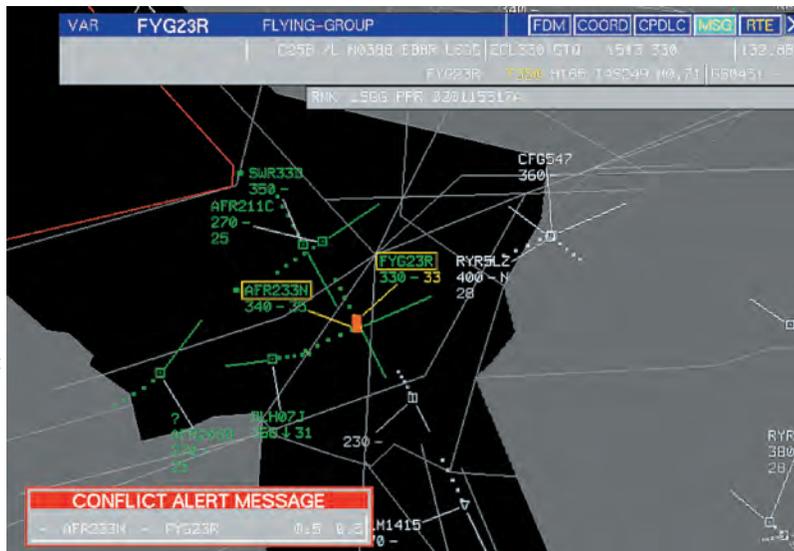
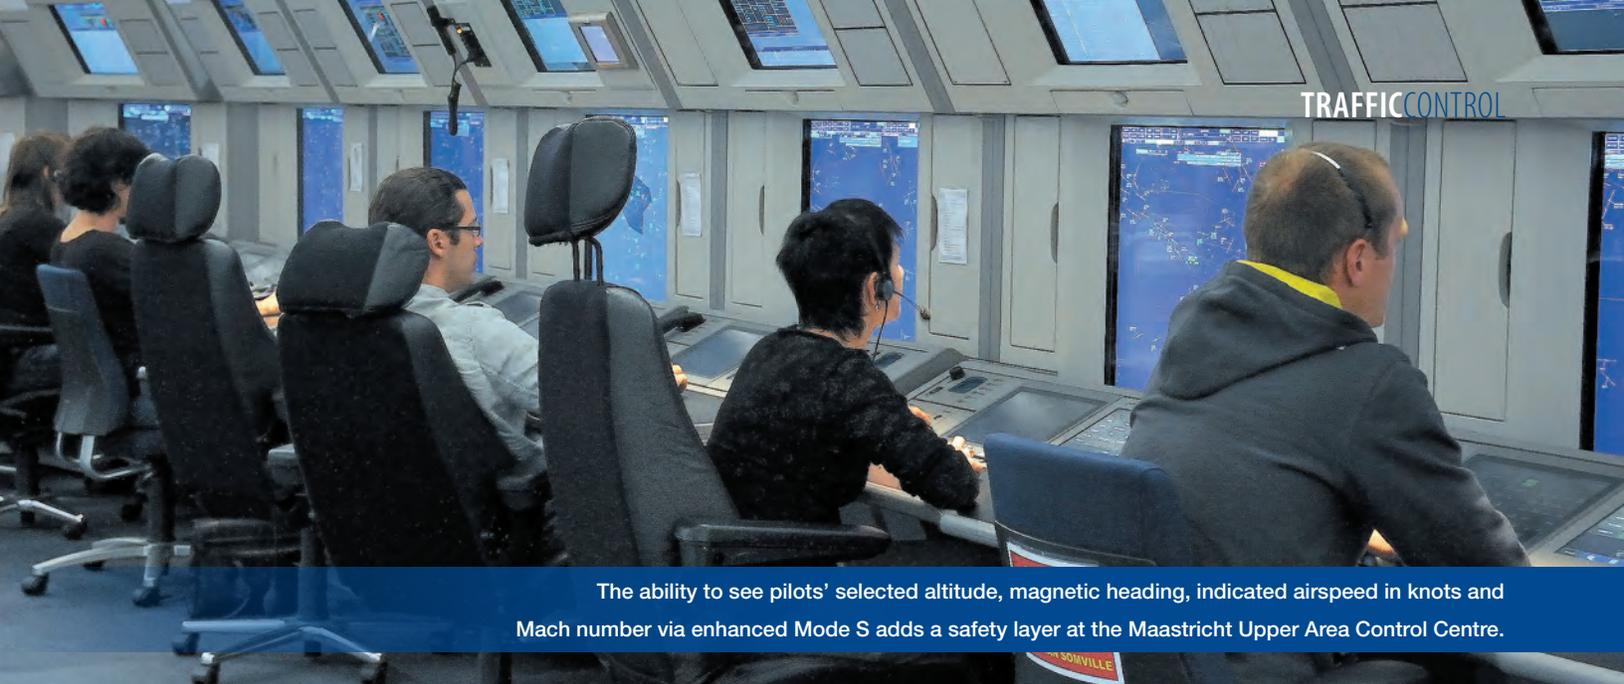
The short-term conflict alert system “listens” to pilots’ altitude selections through enhanced Mode S and, if mismatched to clearance, stops the typical 10-second “grace period” for pilot response to a clearance, enabling faster controller intervention.

The ability to see pilots' selected altitude, magnetic heading, indicated airspeed in knots and Mach number via enhanced Mode S adds a safety layer at the Maastricht Upper Area Control Centre.

On the technology side, 60 percent of the events involved ATC flight data displays that either were not updating correctly or were not capable of being updated by the controller. Most involved an aircraft flight crew cleared for direct
