AeroSafety WORLD

THE JOURNAL OF FLIGHT SAFETY FOUNDATION

NOVEMBER 2014

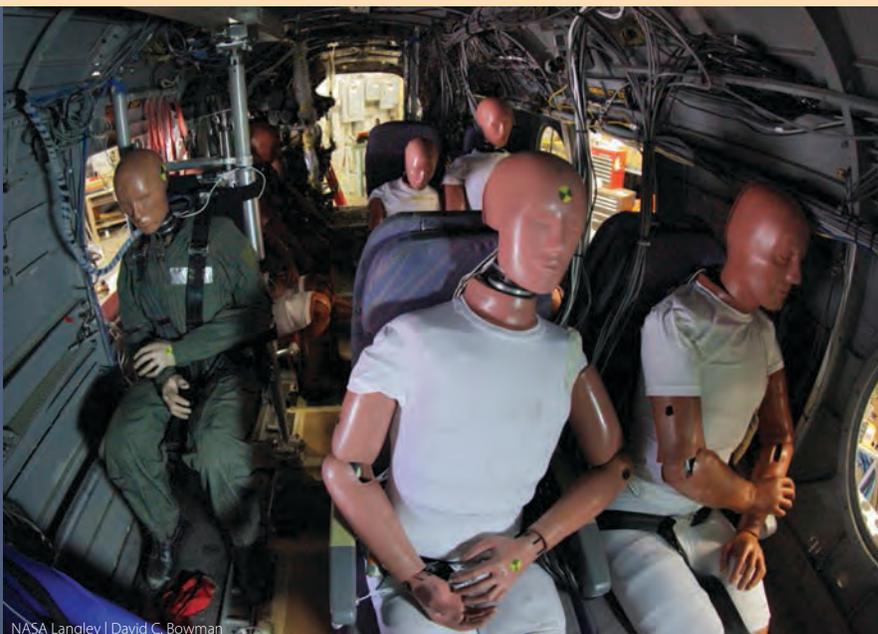
The helicopter had been outfitted with three energy-absorbing composite materials — concepts developed by NASA and the Australian Cooperative Research Center for Advanced Composite Structures — which were installed beneath the passenger floor, NASA said. When the helicopter was dropped, Annett said, the cameras recorded unexpected motion that he described as “an excessive shearing action that almost slipped the entire floor instead of crushing the subfloor like we anticipated.”

The crash was designed to enable a number of experiments, all aimed at designing safer helicopters, NASA said. Forty cameras and on-board computers with 350 data channels recorded all movements of the helicopter and its dummy passengers.

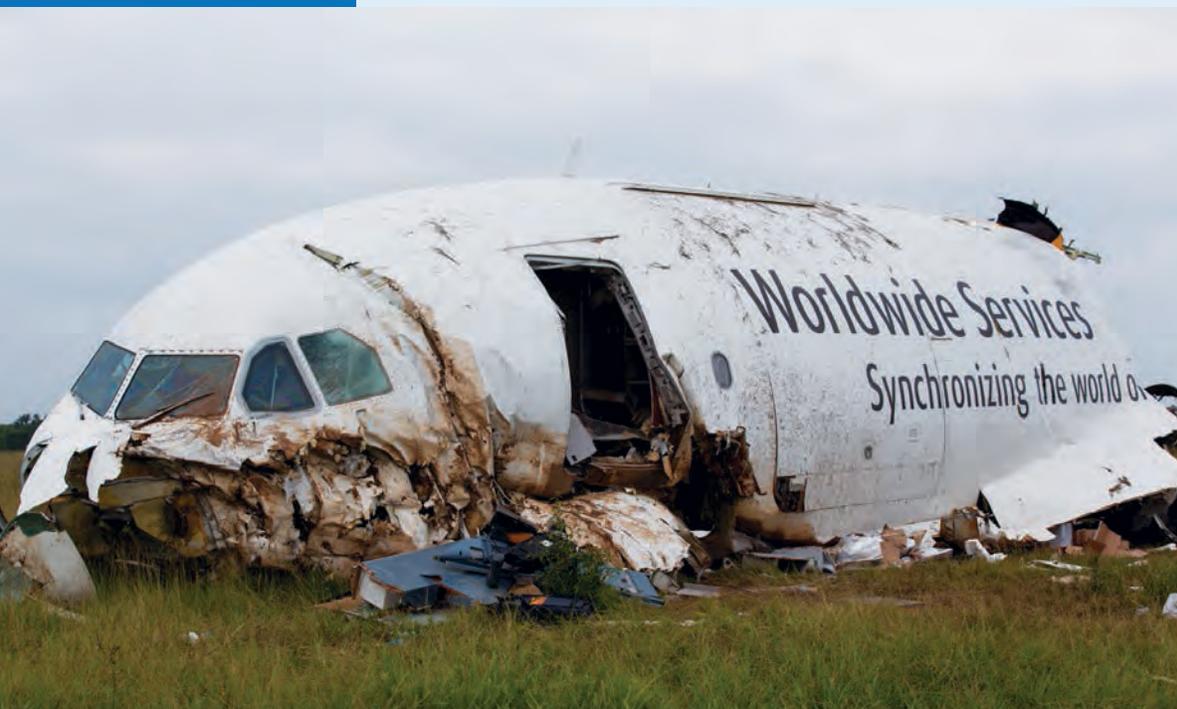
The NTSB cited pilot fatigue as a contributing factor in the early morning crash of this UPS Airbus A300 in Birmingham, Alabama, on Aug. 14, 2013.

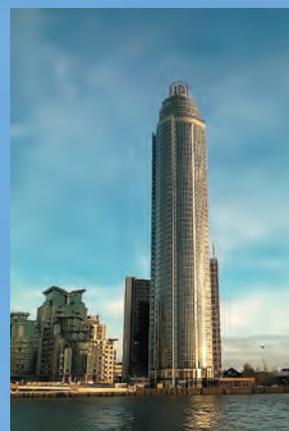
A witness said the top of the building at St. George Wharf was ‘in and out of the mist’ in the minutes before the fatal January 2013 crash.

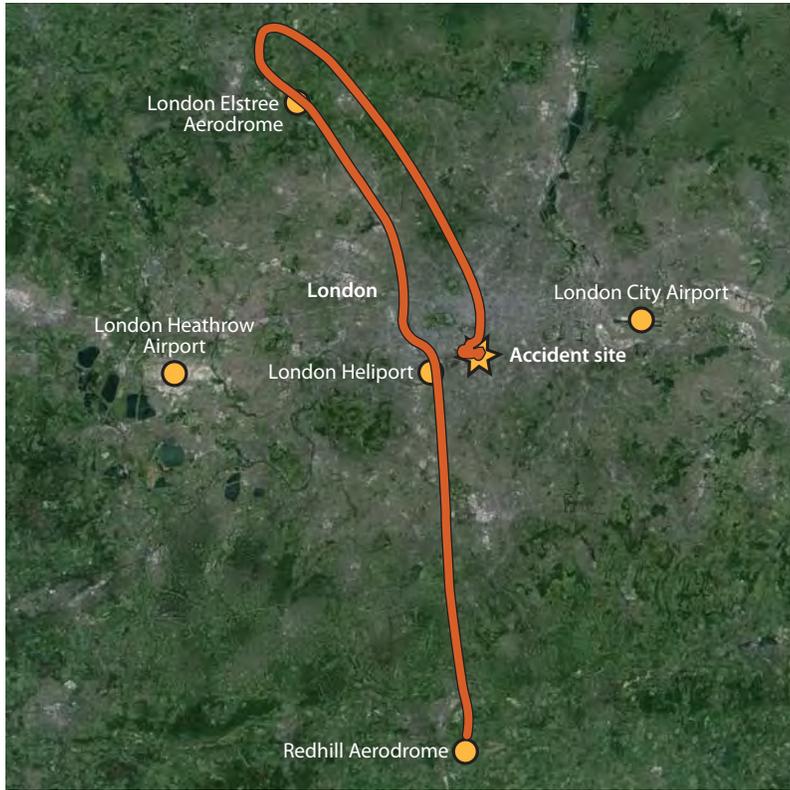
The pilot left Redhill Aerodrome for Elstree, but low clouds prompted his en route decision to divert to the London Heliport.

“This exchange ended at 0759:22 ... [when the helicopter] was approximately 250 m [902 ft] southwest of Vauxhall Bridge,” the report said. “The final two recorded radar positions show a turn to the right at 770 ft [MSL], initiated abeam a building development at St. George Wharf, approximately 275 m [886 ft] from the southeast end of Vauxhall Bridge. The helicopter struck a crane attached to the building. The final recorded radar position was at 0759:24 ... at an altitude of 770 ft.”
