NTSB cites pilot determination to return to home base in connection with two fatal EMS helicopter crashes in 2010.

Heading for Home

BY LINDA WERFELMAN

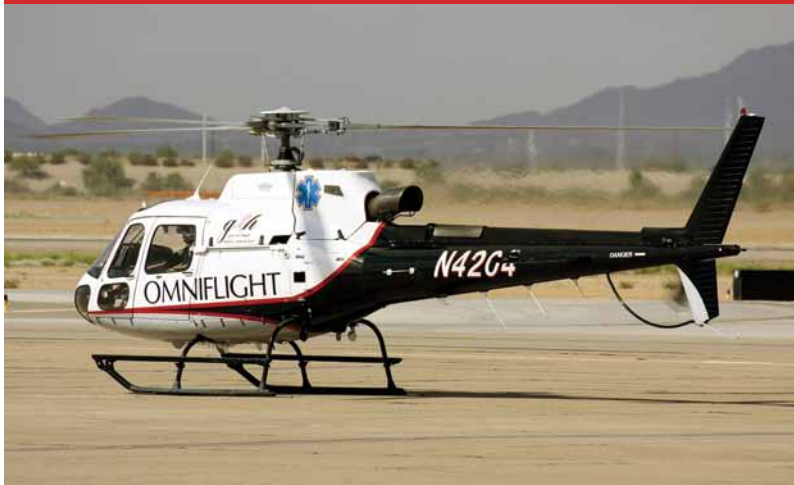
The Eurocopter AS350 is a light five/six-seat utility helicopter first flown in 1974.

The first versions to be marketed were AS350 Bs, with either Avco Lycoming or Turbomeca Arriel turboshaft engines. The AS350 B2s, with uprated engines and transmissions, were certified in 1989; the B3s, with digital engine controls, were first flown in 1997.

Both models have a maximum takeoff weight of 4,960 lb (2,250 kg). Maximum cruising speed at sea level is 134 kt for the AS350 B2 and 140 kt for the B3, and maximum rate of climb at sea level is 1,752 fpm for the B2 and 2,028 fpm for the B3. Range at recommended cruising speed with maximum fuel is 362 nm (670 km) for the B2, and 352 nm (652 km) for the B3.
