Low Visibility and Citation Crew's Deviation From Taxi Instructions Lead to Collision With MD-87

Runway visual range was about 200 meters/700 feet when the crew of a Cessna Citation CJ2 taxied on the wrong taxiway and into the path of a Boeing MD-87 that was taking off on the active runway at Milan, Italy.

—
FSF Editorial Staff

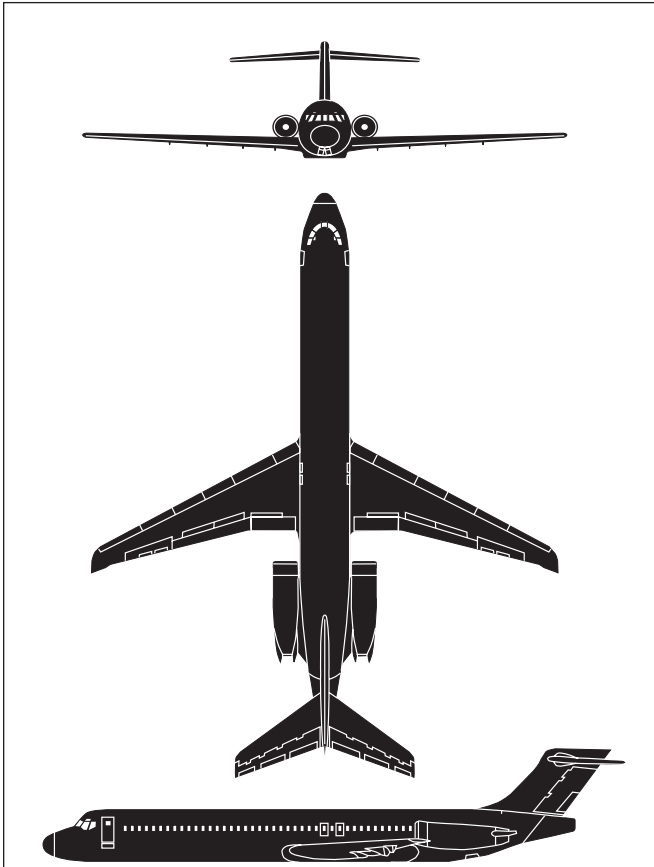
Boeing MD-87

The MD-80 series short/medium-range jet transports are derivatives of the Douglas DC-9, which first flew in 1965. Originally called the Super 80, the MD-80 has longer wings, a longer fuselage and more fuel capacity than the DC-9, and is equipped with a digital flight control system. The MD-80 prototype flew in 1979, and the airplane entered production in 1980 as the MD-81.

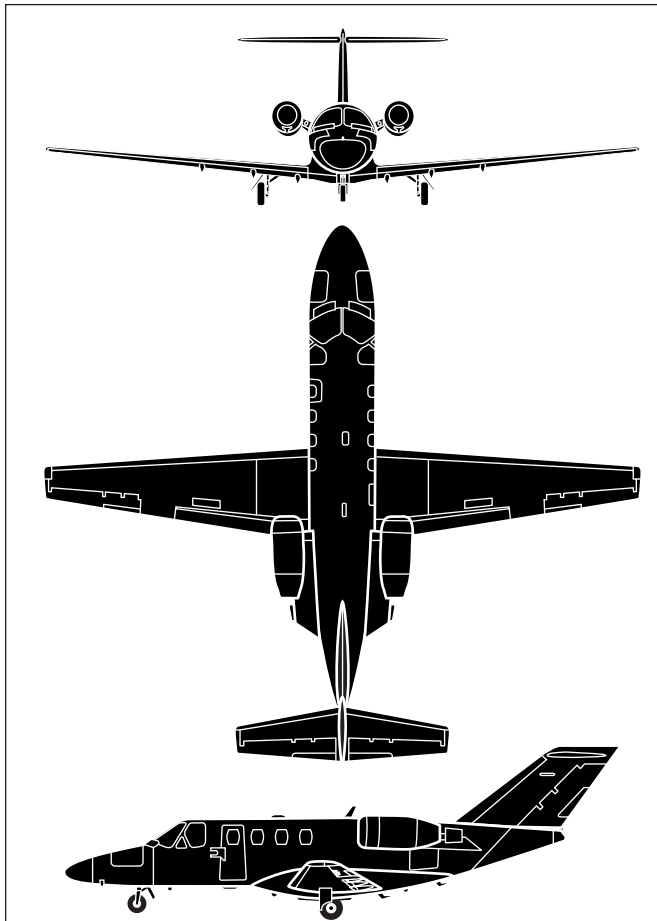
Cessna Citation CJ2

Cessna Aircraft Co. announced in 1968 the development of an eight-seat executive jet called the Fanjet 500. When the prototype flew in 1969, the name was changed to Citation. Produced from 1971 to 1976, the Citation was succeeded by the Citation I, which has a longer wing and more powerful engines. Production of the Citation I was terminated in 1985.
