# Deadly Drift

The pilots did not realize that an engine on their Brasilia had failed during final approach.

BY MARK LACAGNINA

Deficiencies in procedures for verifying fuel quantity and the absence in Australia of a flight simulator for emergency procedures training were among the safety issues identified by the investigation of a serious incident in which the flight crew nearly lost control of their Embraer EMB-120ER Brasilia following an engine failure on final approach.

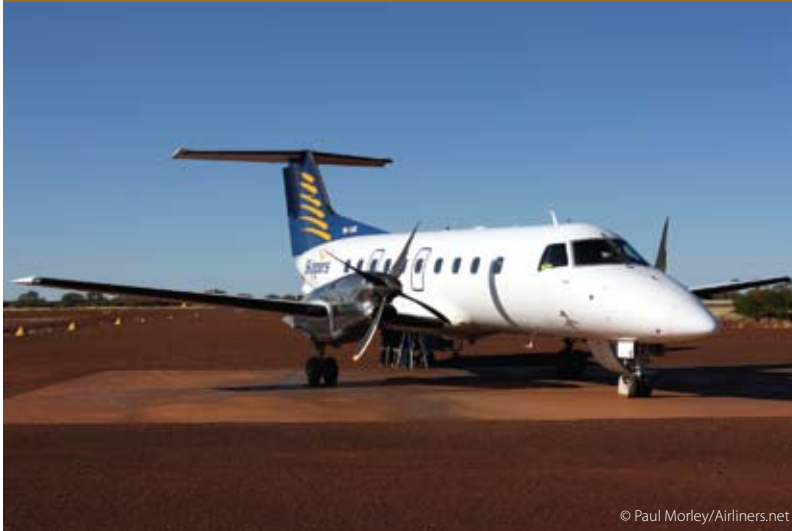
## Embraer EMB-120ER Brasilia

The EMB-120ER is the extended-range version of the Brasilia, the twin-turboprop passenger and cargo aircraft that Empresa Brasileira de Aeronáutica (Embraer) began delivering in 1985. The ER was introduced in 1991 and was the standard version until production ceased in 2000.

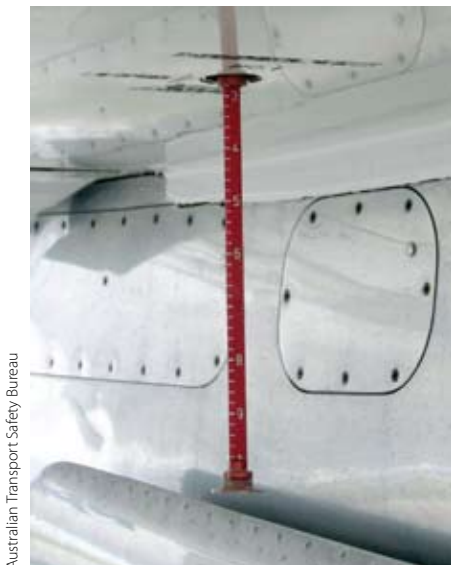
The incident likely would have been avoided if the aircraft's dripsticks had been used to verify fuel gauge readings.

The inaccurate fuel indication was traced to the failure of a capacitance probe in the left outboard tank. The probe had been disabled by an electrical short in wiring that had been abraded from contact with the airframe.

The report noted that the flight logs for the operator’s six Brasilias showed that the dripsticks had been used to validate fuel quantities only twice — and by the same pilot — in the three months preceding the incident.

Commercial aircraft rarely are operated with full tanks, as recommended by the first option, and the use of devices such as dripsticks is “not generally favored” by operators because it is time consuming and requires the aircraft to be on a level surface for accurate measurements, the report said.
