Turnaround Story

Risk also lurks *between* flights.

Ground operations accidents and incidents were dominated by one causal factor — failure to comply with clearances — according to a study conducted by the Australian Transport Safety Bureau (ATSB) of occurrences at Australian airports, 1998–2008.^{1,2} The occurrences occurred most frequently on taxiways, at the gate and during pushback.

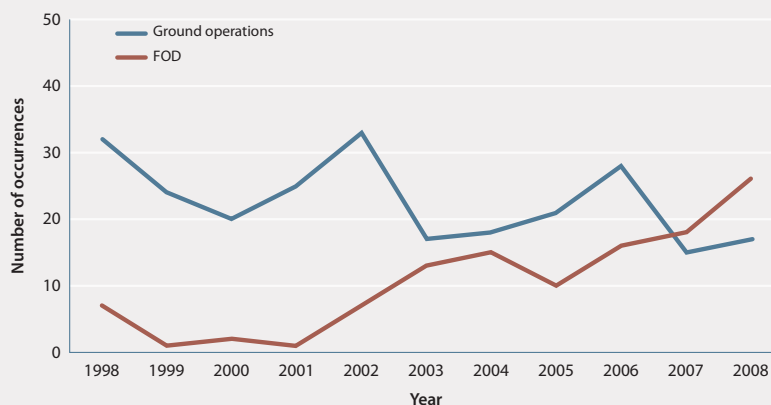
Figure 1

Occurrences, Australian Airports, 1998–2008

FOD = foreign object debris

Note: Airports are those serving high-capacity aircraft.

During the study period, there were 282 ground operations occurrences. Those on a taxiway, at the gate or during pushback accounted for 34 percent, 28 percent and 26 percent of the total, respectively, for a combined 88 percent of occurrences.

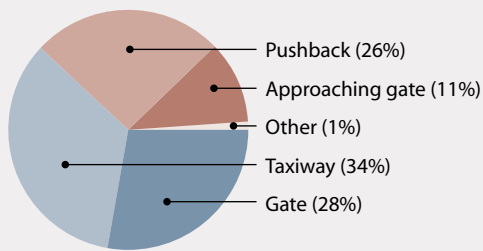
Figure 2

Ground Operations Occurrence Types, Australian Airports, 1998–2008

Note: Airports are those serving high-capacity aircraft.

Six types of ground operations occurrences represented about 75 percent of the total. “Failure to comply with a clearance,” at 28 percent of the total, was most common type, representing more than double the next highest type, “collision or contact with an aircraft by a vehicle,” 13 percent of the total.

The report analyzes the categories of occurrences according to whether they took place on taxiways, at or approaching the gate, or during pushback (Figure 2).

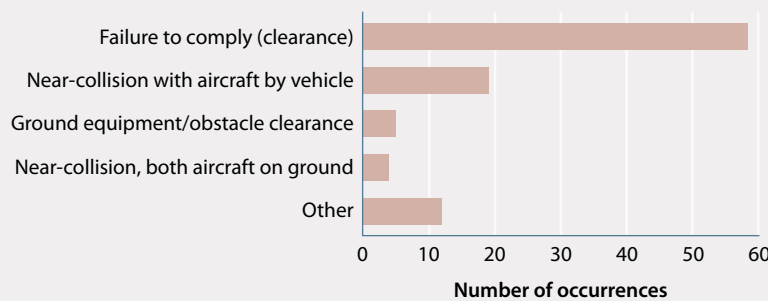
Figure 3

Taxiway Occurrences, Australian Airports, 1998–2008

Note: Airports are those serving high-capacity aircraft. Occurrences in the “Other” category involved a vehicle that was parked in the instrument landing system critical area when weather was below minimums; vehicles on perimeter roads operating contrary to traffic lights used to stop vehicles when aircraft land (two occurrences); and a large aircraft making a 180-degree turn, damaging lighting and pavement.

“About 77 percent of taxiway occurrences involved a deviation by vehicles from a surface movement

controller clearance (not a runway incursion),” the report says (Figure 3). Such failures, the report says, included using an incorrect taxiway; failing to stop at a taxiway holding point; failing to stay on the surface-movement control frequency; and failing to seek a clearance.

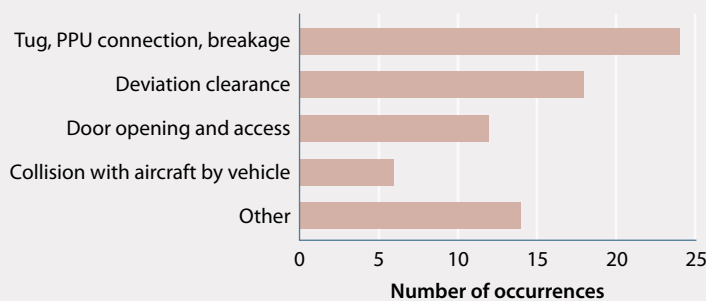
Pushback Occurrences, Australian Airports, 1998–2008

PPU = power push unit

Note: Airports are those serving high-capacity aircraft. “Other” occurrences included near aircraft-aircraft collisions; near vehicle-aircraft collisions, where pushback was stopped to avoid a collision; flight crew monitoring lapses, including making sure the aircraft dispatcher was disconnected before starting to taxi; and ground crewmembers being close to an operating aircraft engine.

Pushback occurrences, the third-most frequently reported category in ground operations, were identified as those occurring during the time between connection of a tug or PPU and the time an aircraft taxis under its own power. “Commonly, pushback might involve up to four ground personnel, including a tug or PPU driver, a dispatcher and possible observers,” the report says.

Four subcategories dominated, in total accounting for about 80 percent of pushback occurrences: tug or PPU connection and breakage; failure to comply
