Flight Safety

NOVEMBER 2004

RVSM Heightens
Need for Precision in
Altitude Measurement

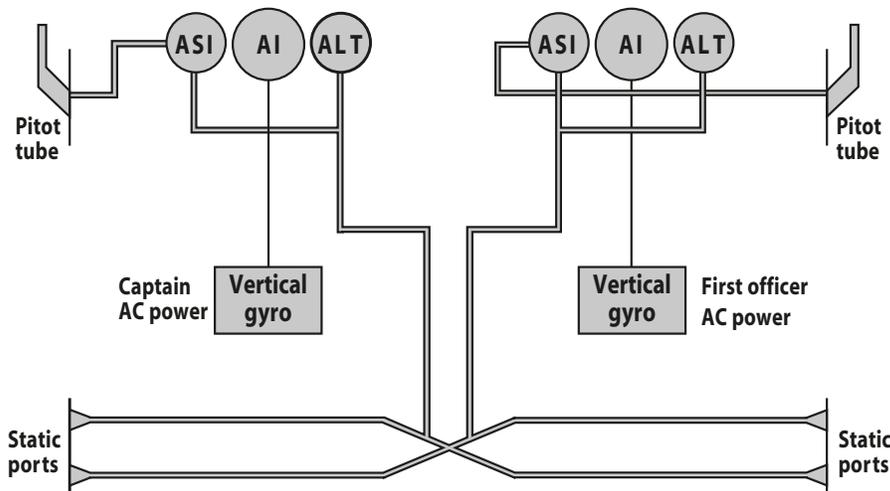
Figure 1
Typical Flight Instrumentation on Early Jet Transports

AC = Alternating current AI = Attitude indicator ALT = Altimeter ASI = Airspeed indicator

Figure 1 shows how the system typically works in early jet transports. A static line connects the static ports to the altimeter, mounted in an airtight case in which a sealed aneroid barometer reacts to changes in static air pressure. When static air pressure increases, the barometer contracts; when static air pressure decreases, the barometer expands. The movement of the barometer causes movement of height-indicating pointers, which present an altitude indication on the face of the altimeter.¹

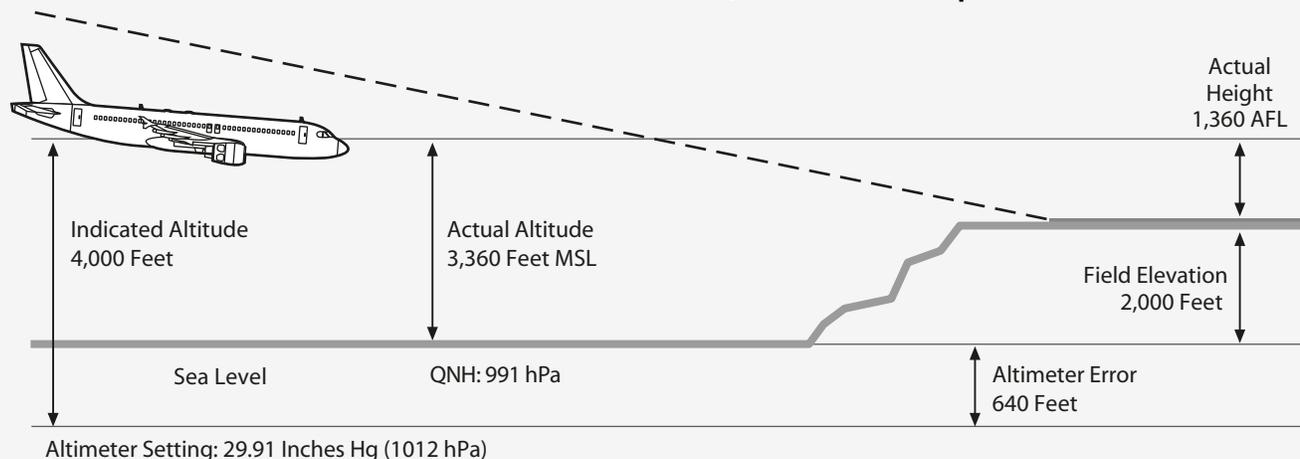
Figure 3
Effect of an Altimeter Mis-set to Inches, Rather Than Hectopascals

AFL = Above field level MSL = Mean sea level Hg = Mercury hPa = Hectopascals
 QNH = Altimeter setting that causes altimeter to indicate height above mean sea level (thus, field elevation at touchdown)

Many civil aviation authorities use hectopascals (millibars), to measure barometric pressure; others use inches of mercury (Figure 1); if a pilot confuses the two and mis-sets the altimeter, the result can mean that the aircraft is hundreds of feet lower (or higher) than the indicated altitude (Figure 2; Figure 3, page 8).¹⁹

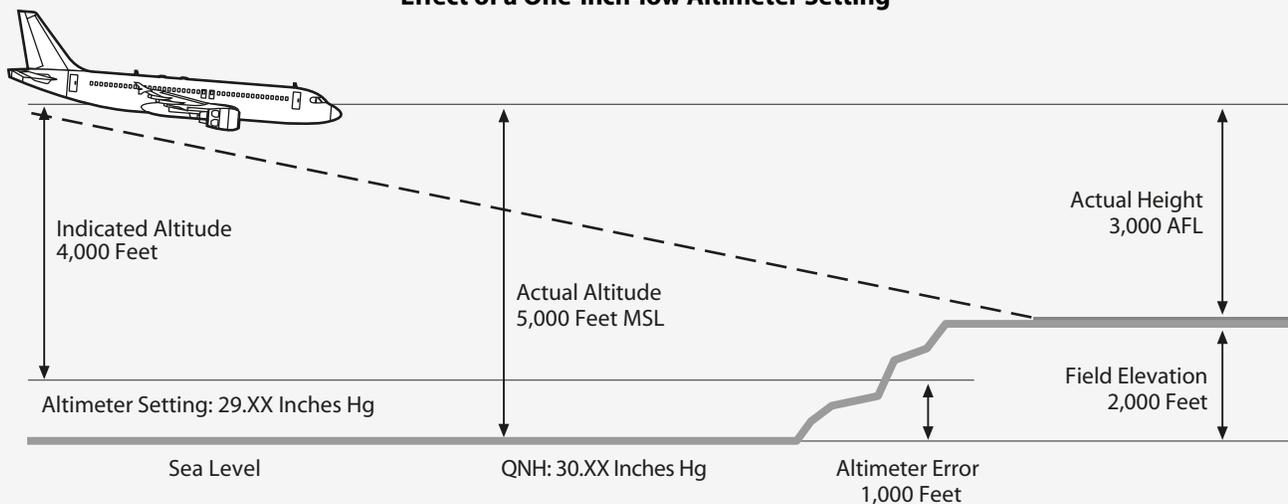
Figure 5
Effect of a One-inch-low Altimeter Setting

AFL = Above field level MSL = Mean sea level Hg = Mercury
 QNH = Altimeter setting that causes altimeter to indicate height above mean sea level (thus, field elevation at touchdown)
