The fatal crashes of two helicopters during Hawaiian sightseeing flights have led to safety recommendations calling for improved pilot training on hazardous weather phenomena, rest breaks for air tour pilots and accelerated development of automatic dependent surveillance-broadcast (ADS-B) technology.

Misreading the Weather

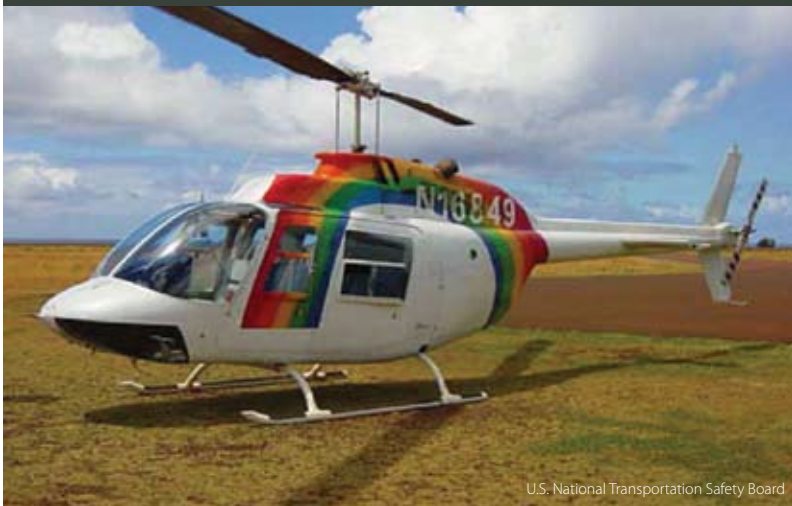
Bell 206B JetRanger

The Bell Helicopter (now Bell Helicopter Textron) 206B JetRanger is a general-purpose light helicopter powered by a 400-shaft-horsepower (298-kilowatt) Allison 250-C20 engine. The 206B was developed as a more powerful version of the 206A, which had a 317-shaft-horsepower (236-kilowatt) engine. The first deliveries of the 206B were in early 1971.

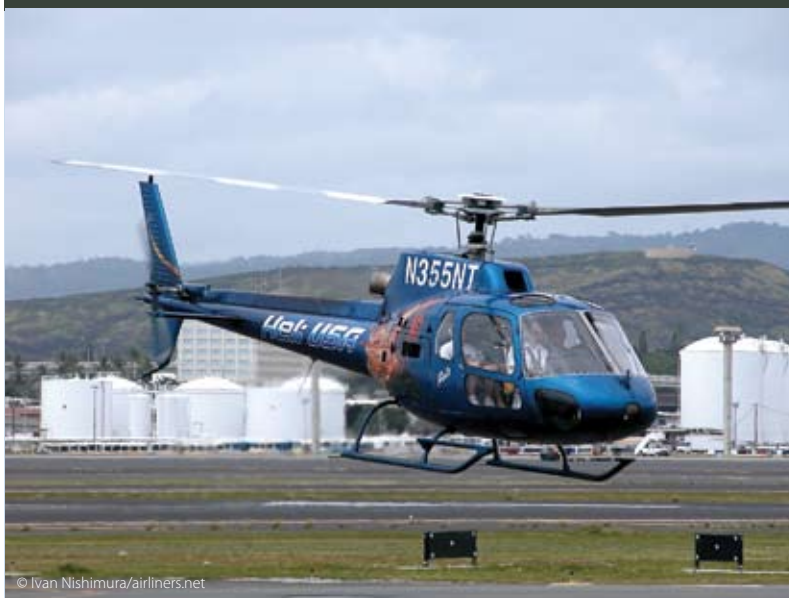
Eurocopter AS 350 Ecureuil

The Eurocopter AS 350 is a light utility helicopter first produced in October 1977 by Aerospatiale as the AS 350B. The AS 350BA is an upgraded version of the 350B, with larger main-rotor blades and a maximum takeoff weight of 4,630 lb (2,100 kg), or 331 lb (150 kg) more than the AS 350B.
