### **DISTRACTED VIGILANCE**News Helicopters Collide

April2009 Vol 4 Issue 4

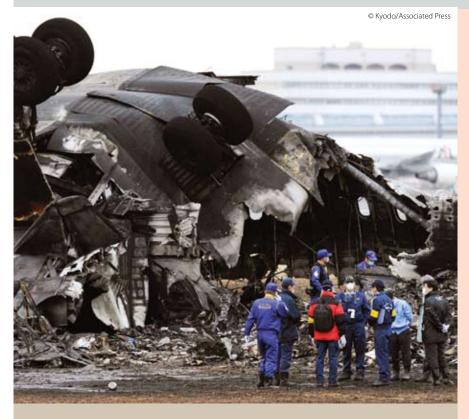
Japanese accident investigators inspect the wreckage of a FedEx McDonnell Douglas MD-11 cargo plane that crashed on landing at Narita International Airport east of Tokyo on March 23. The two pilots — the only people in the airplane — were killed.

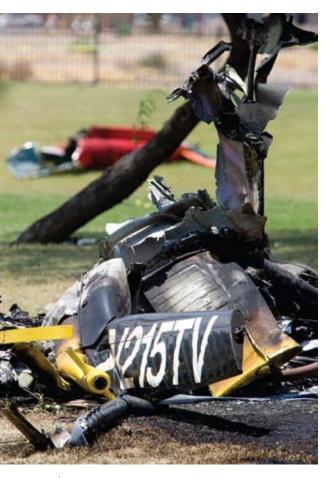
Pilots of the two TV
news helicopters had
traded information
about the positions
of their aircraft
several times, but
investigators say
the last exchange
came about four
minutes before their
midair collision.

In accordance with informal procedures, the six helicopter pilots shared an air-to-air radio frequency to report their positions and their intentions. The accident helicopters — from Channel 3 and Channel 15 — had audio-video recording systems, and the information recorded by those systems was analyzed in the accident investigation. At 1238, the Channel 15 pilot was recorded telling the other pilots that he was flying at 2,200 ft, and the Channel 3 pilot said that his helicopter was at 2,000 ft (Figure 1).

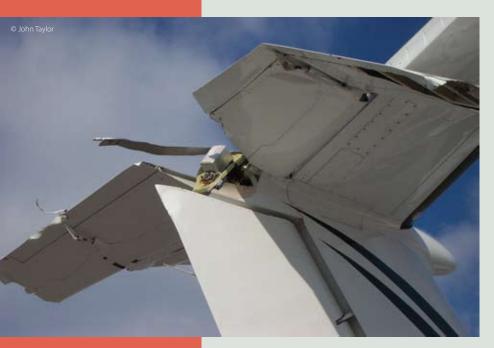
The King Air's tail
was extensively
damaged during the
uncontrolled descent
and the pilots'
recovery from
the upset.

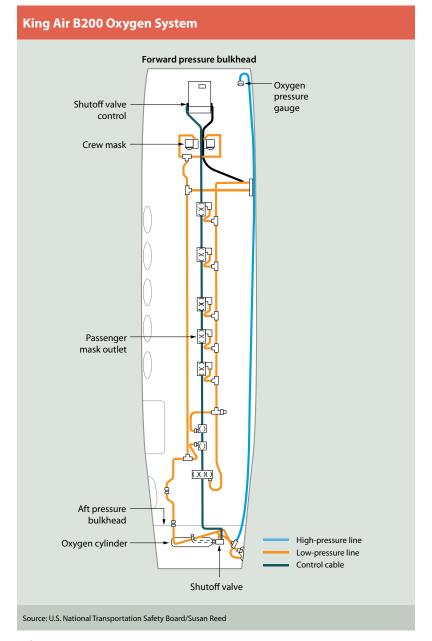
Figure 1

The oxygen cylinder is located behind the aft cabin firewall. The oxygen system shutoff valve on the cylinder is connected to the cockpit control knob by a cable (Figure 1). Opening the shutoff valve is among the actions specified by the "Before Start" checklist — as well as by several emergency checklists — in the AFM, but it was not included in the truncated "Before Start" checklist that the pilots were using.

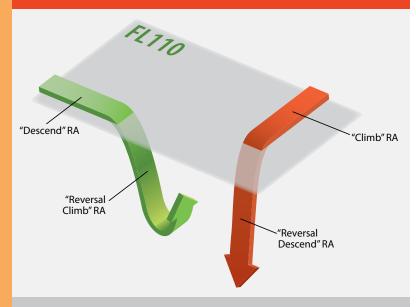
Figure 1

## **TCAS II Version 7.1 Solution to Pilot Error**

TCAS = traffic alert and collision avoidance system; RA = resolution advisory; FL = flight level **Note**: Current TCAS II logic allows only one climb/descend sense reversal, and reversing an ongoing RA is not permitted while the aircraft are maneuvering within a vertical distance of 100 ft of each other. The illustrated enhancement in the new Version 7.1 logic is that if the aircraft with the red flight path descends contrary to a "Climb" RA, immediate reversal RAs will be generated for pilots of both aircraft.

Version 7.1 solves the first problem with a significant software code change that monitors compliance with RAs and enhances the reversal logic, allowing reversals when the aircraft are vertically within 100 ft. Version 7.1 solves the second problem by replacing AVSA RAs with a "Level Off, Level Off" RA. Independent validations by computer simulations with actual air traffic data

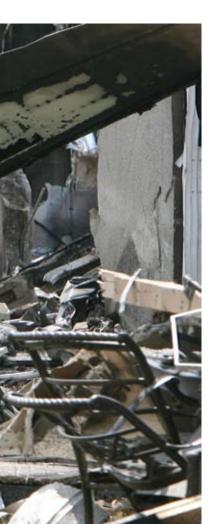
NTSB investigators found signs of an in-flight fire.

Examination of the wreckage revealed signs of an in-flight fire. Thermal damage and soot deposits were found on components that came to rest outside the area of the postcrash fire. The cabin door, for example, was found relatively intact about 60 ft (18 m) from the main wreckage. "The undamaged latching pins and the location and existence of the observed trailing soot deposit are consistent with the pilots having opened the cabin door to vent smoke during an in-flight fire," the report said.

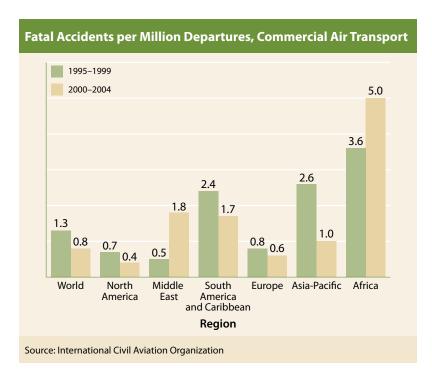
Figure 1

frica has the highest rate of fatal accidents in commercial air transport among all International Civil Aviation Organization (ICAO) regions, and the trend has not been improving (Figure 1). The International Air Transport Association (IATA) calculated that in 2005, total hull losses per million departures were 12.9 times the world average. The report from the ICAO conference at which the IATA data were presented said, "Causal factors for the accidents occurring in Africa are generally difficult to identify due to the lack of proper reporting and/or investigation of the occurrences. Often, data on accidents and serious incidents are known from various sources, including the media, but some

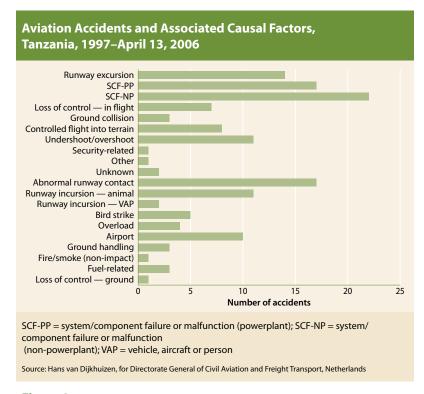
Figure 2

Although Tanzania is not a proxy for all of Africa, data published recently about causal factors of that country's aviation accidents and incidents offer some insight into safety issues in sub-Saharan states.<sup>2</sup> They show that when the ICAO/Commercial Aviation Safety Team (ICAO/CAST) aviation occurrence categories were applied to Tanzanian aviation accident and incident data for the 1997–April 13, 2006, period, the most frequent causal factor was "system/component failure or malfunction, non-powerplant" (Figure 2).

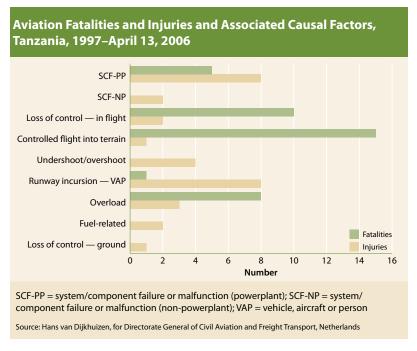
Figure 3

In accidents involving fatalities between 1997 and April 13, 2006, the ICAO/CAST category that ranked highest in the number of fatalities was "controlled flight into terrain," or CFIT (Figure 3).<sup>3</sup> Following in descending order were "loss of control in flight" and "overload."
