Aero Safety WORLD

EXCURSION DEFENSES KEEP IT ON THE RUNWAY

OVERRUN PROTECTION

Improving runway safety areas

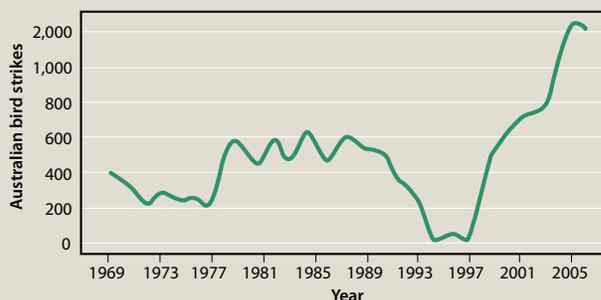
Reported Australian Birdstrikes, 1969 to 2006

Source: Australian Transport Safety Bureau

The report attributed the increased number of reported bird strikes to several factors, including an increase in aircraft movements; the establishment in 2003 of the Australian Animal Wildlife Hazard Group, which disseminates information about bird strikes and encourages the reporting

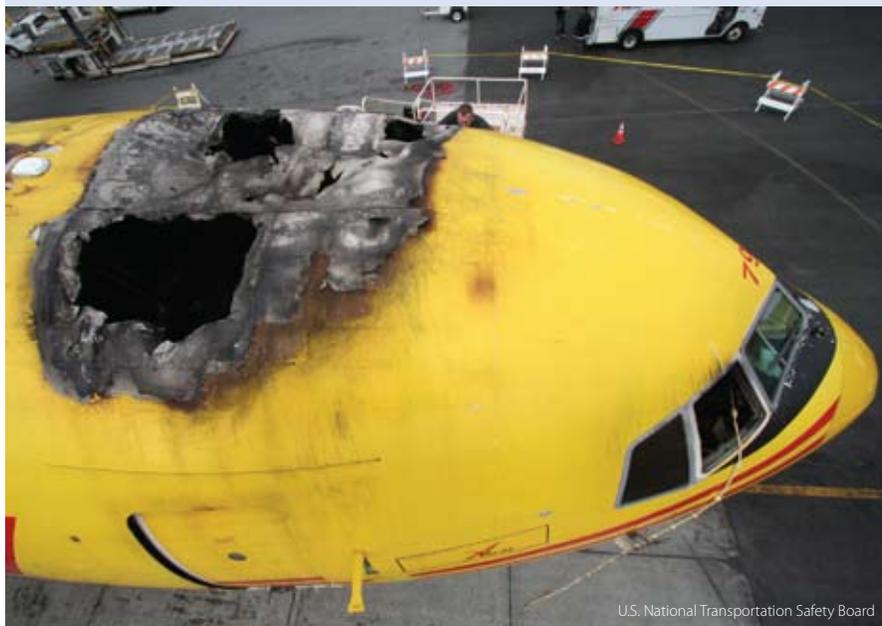
Investigators are trying to determine the cause of the fire that burned through the top of this ABX Air Boeing 767 cargo airplane while it was parked at San Francisco International Airport. The fire broke out just behind the cockpit as the two-member crew was about to start the engines. Both crewmembers escaped without injury, and the airplane received substantial damage from the blaze, the U.S. National Transportation Safety Board said.

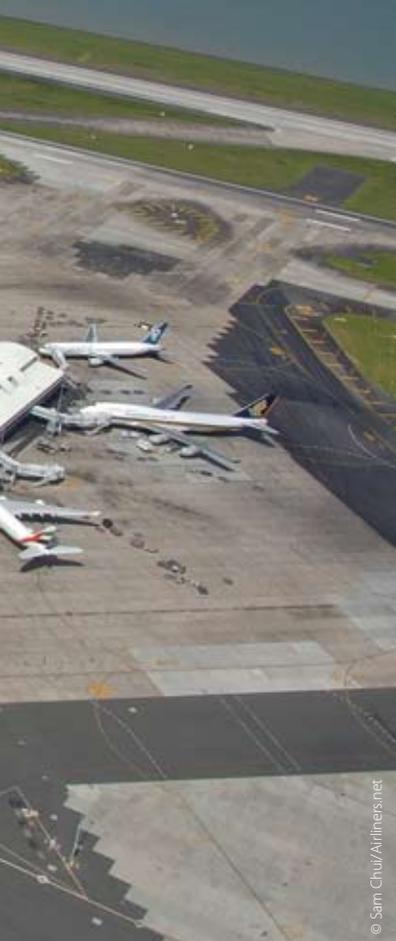
The pilots' limited view of the runway while holding on angled taxiways at Auckland International was a factor in two critical incursion incidents.

Auckland has a single runway — Runway 05R/23L, which is 3,635 m (11,926 ft) long and 45 m (148 ft) wide. "Six of the 10 taxiways [join] the runway at an angle of 30 degrees to the runway centerline to form rapid-exit taxiways for landing aircraft," the report said. "For example, Taxiways A4 and A6 [are] rapid-exit taxiways for Runway 23L." The parallel taxiway was used temporarily as a runway during the 1990s when extensive repairs were being performed on Runway 05R/23L; although closed as a runway, the taxiway retains markings as Runway 05L/23R.
