2006 ACCIDENT NUMBERS DROP Fatalities still elevated

### LANDINGS RECONSIDERED CALCULATIONS FOR CONTAMINATED RUNWAYS

THE JOURNAL OF FLIGHT SAFETY FOUNDATION

**FEBRUARY 2007**

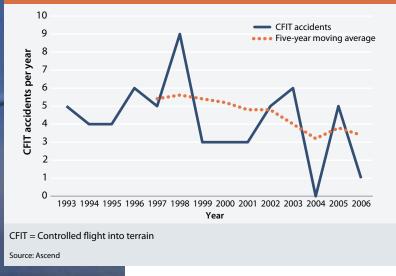
Figure 2

#### Western-Built Commercial Jet CFIT Accidents. 1993–2006

The five-year moving average of commercial jet CFIT accidents continues to improve, but slowly (Figure 2, page 20). Despite a 30 percent decrease in CFIT accidents since 1998, a look at the average trend line highlights the difficulty of sustaining low CFIT accident numbers. The average number of commercial jet CFIT accidents for the past decade has been stuck at around four, while the average number of CFIT accidents

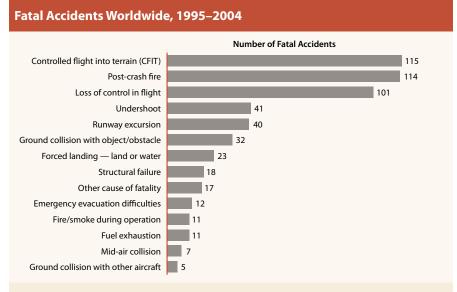
**Notes**: More than one contributing factor can be allocated for each accident. Includes fixed-wing turbine-powered aeroplanes for a which a variant has MTWA > 12,500 lbs or 5,700 kg (includes business jets).

The CAA's latest development of its strategic risk management framework is more data driven than ever before, starting with the analysis of fatal accidents involving large public transport airplanes worldwide. Figure 1 provides an overview of the contributing factors in accidents that occurred between 1995 and 2004, as determined by the CAA's Accident Analysis Group. Note that the categories are not mutually exclusive.
