AeroSafety WORLD

THE JOURNAL OF FLIGHT SAFETY FOUNDATION

FEBRUARY 2009

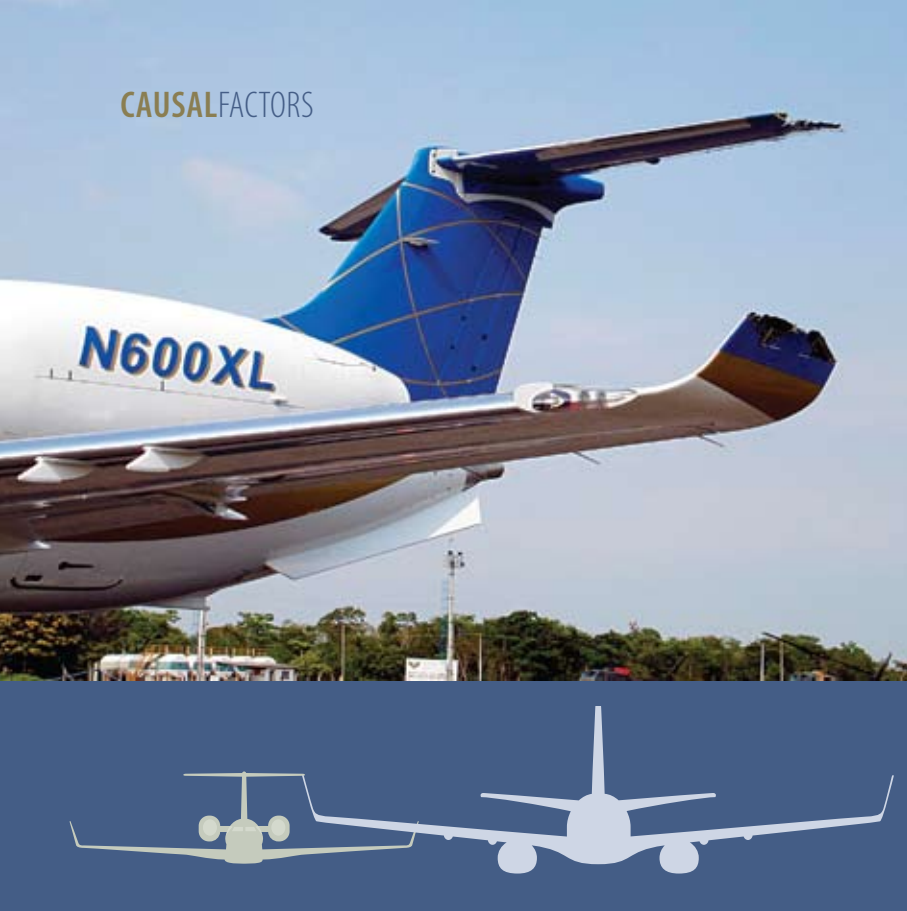
The Legacy pilots experienced control difficulties after the collision but were able to land the airplane. The 737 descended out of control after losing the outer portion of its left wing.

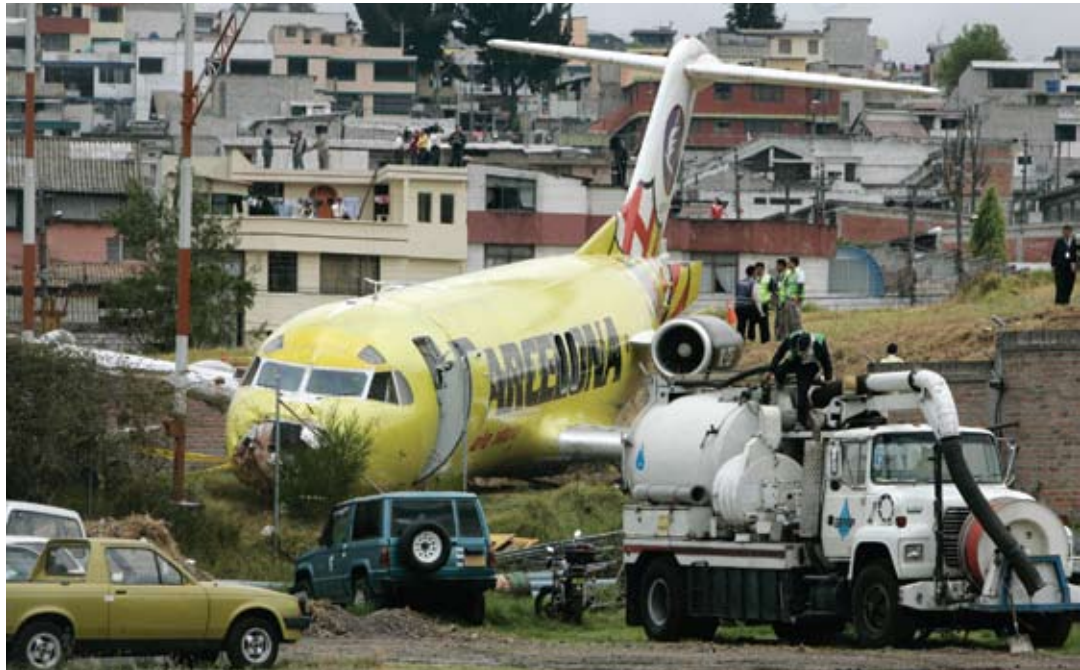
A Fokker F-28
ran off the runway
during takeoff at
Quito, Ecuador.

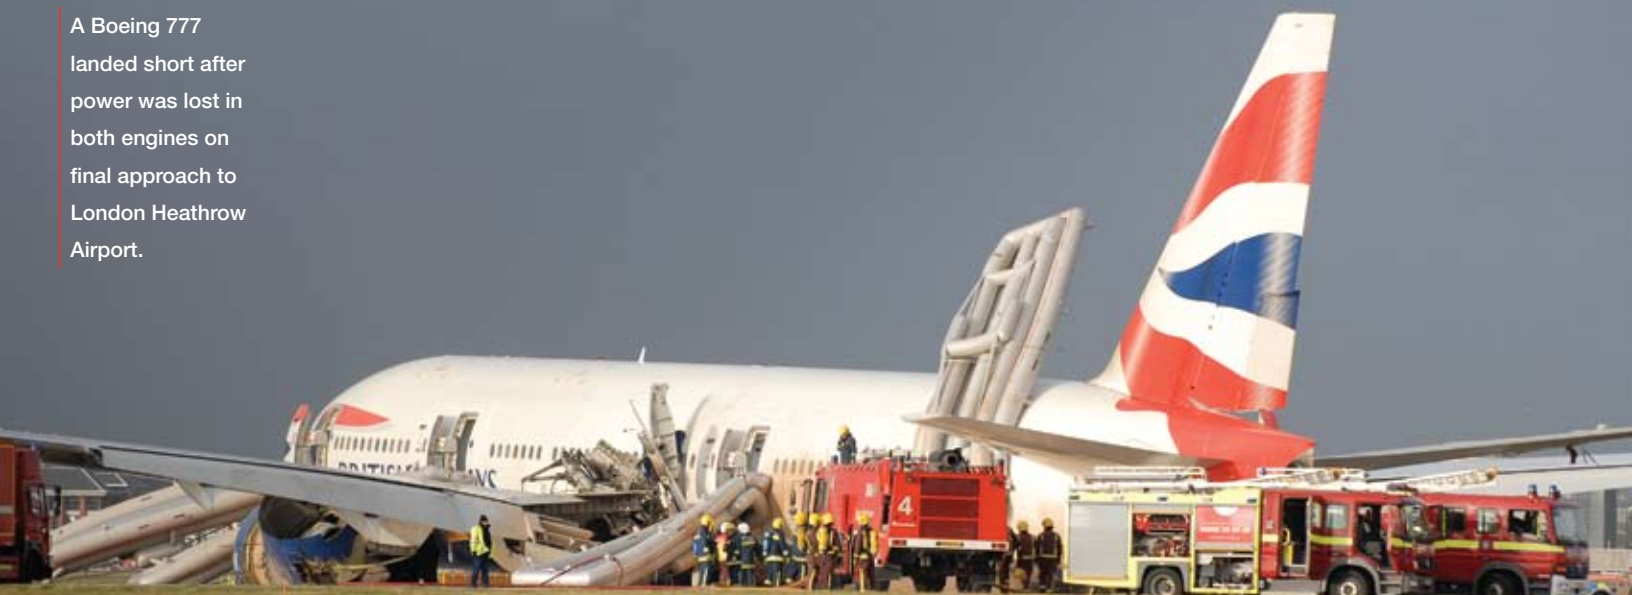
A Boeing 777 landed short after power was lost in both engines on final approach to London Heathrow Airport.

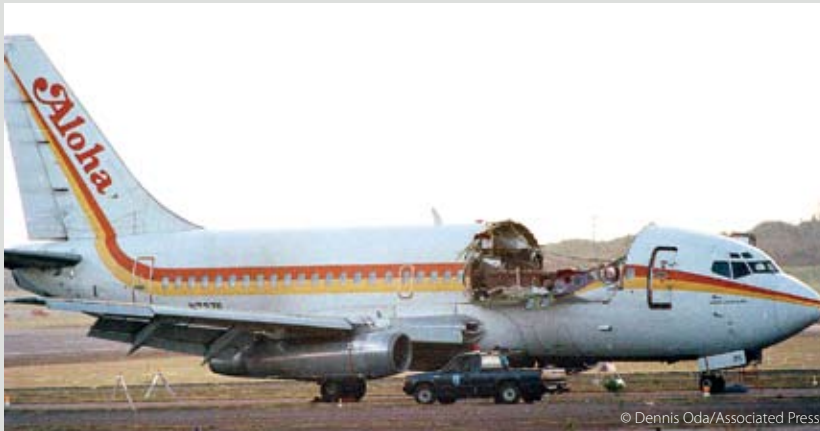
Aloha Airlines 737, April 1988

The Australian Transport Safety Board (ATSB) cited several accidents and incidents associated with human aspects of aviation maintenance, including the April 1988 explosive decompression of an Aloha Airlines Boeing 737-200 — an accident that revealed the human factors of inspection and maintenance as a major safety issue.¹

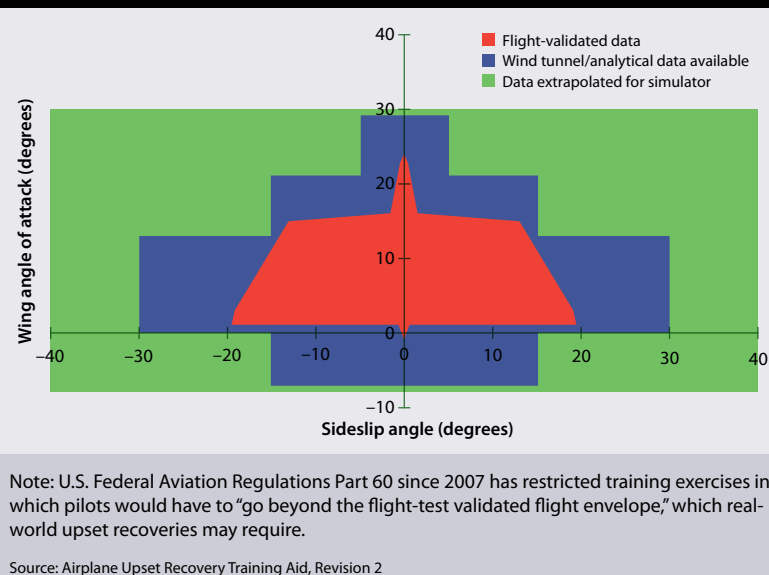
Figure 2

Data Sources for Boeing 737 Full Flight Simulator

A longstanding issue is that the aerodynamic envelopes of simulators — specifically the angle of attack range and sideslip range — simply are not extensive enough.⁵ One NTSB scientist has noted that fidelity of simulators for upset recovery training becomes a significant practical issue only in the post-stall flight regime, whereas many loss of control accidents have occurred after upsets within the nominal aerodynamic data envelope (Figure 2).⁶

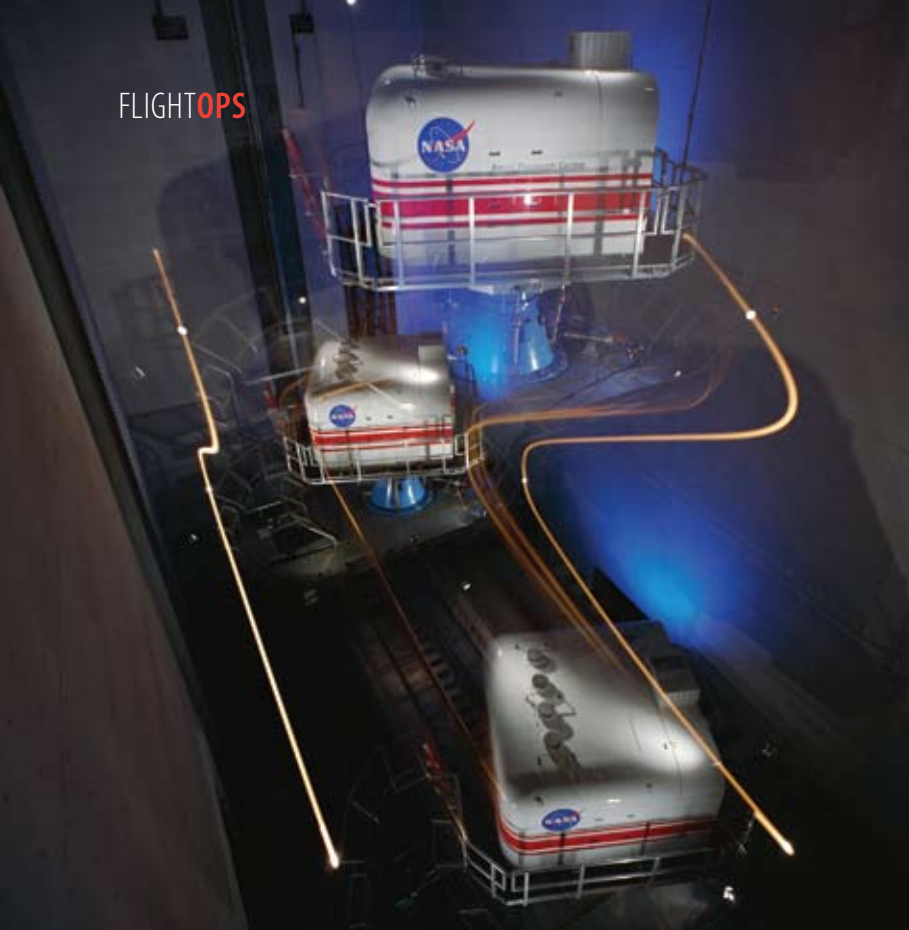
The NASA Vertical Motion Simulator, shown here in a multiple-exposure photo, exceeds capabilities of conventional full flight simulators.

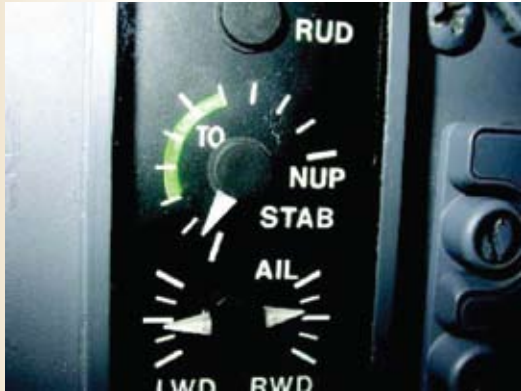
This Bombardier Challenger 600 pitch-trim position indicator is similar to one examined in the Teterboro crash.

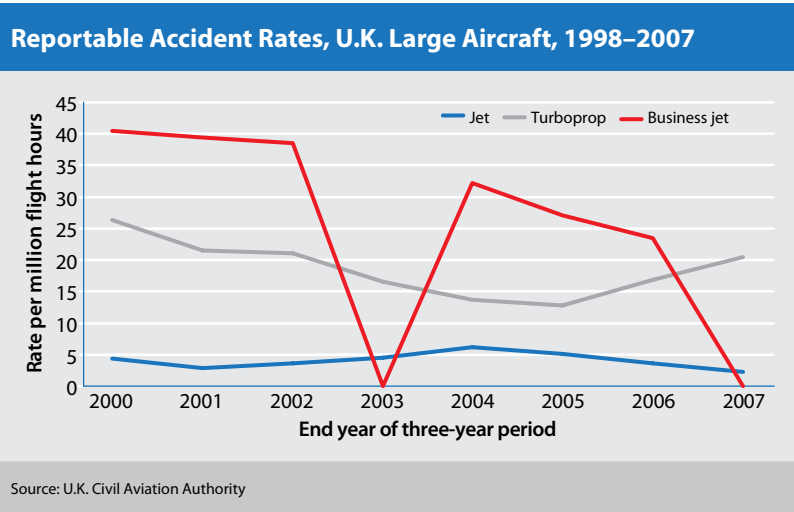
Figure 1

Reportable and Fatal Accident Rates, U.K. Large Public Transport Airplanes, 1998–2007

This reportable accident rate was also more volatile than the rates for jets and turboprops when shown as a three-year moving average (Figure 1).⁴ At 16.8 per million flight hours, this rate for business jets remained lower than that for turboprops (Table 1). The fatal accident rate, 8.4 per million flight hours, compared with 1.4 per million flight hours for turboprops and 0.04 per million flight hours for jets.
