Debonding Problems

Some hot, humid operating environments may be contributing to the degradation of adhesive bond joints in Robinson Helicopter rotor blades, and new testing methods are required to ensure the detection of separation at bond joints, the U.S. National Transportation Safety Board (NTSB) says.

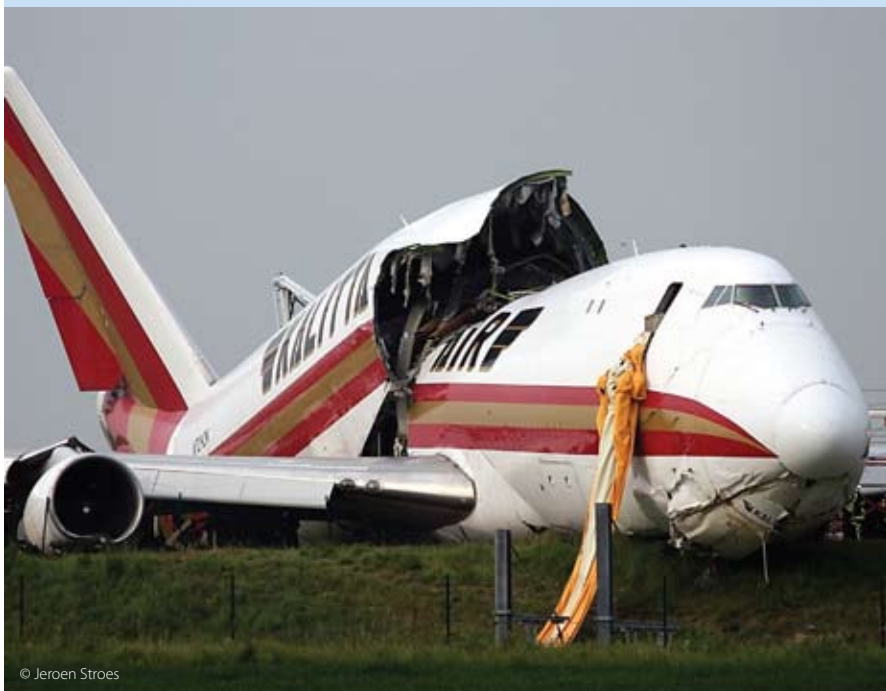
Belgian accident investigators are searching for the cause of the May 25 crash of this Kalitta 747-200 during takeoff from Brussels for a flight to Bahrain. Witnesses reported hearing a loud bang just before the airplane ran off the runway and broke apart. None of the four people in the cargo airplane was injured.
