# AeroSafety WORLD

# SUN DANGER

THE JOURNAL OF FLIGHT SAFETY FOUNDATION

JUNE 2007

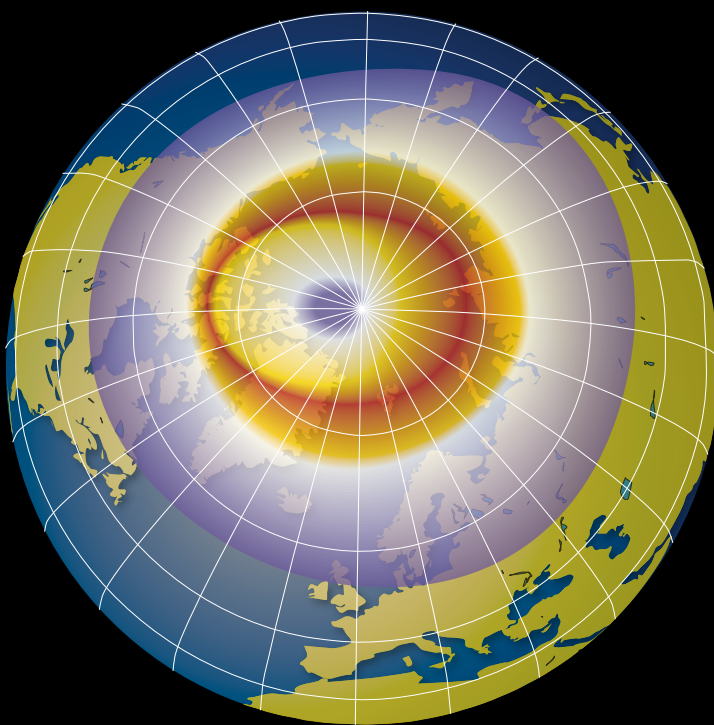
Monitoring the power flux carried by solar protons and electrons just above Earth's atmosphere at the North Pole, a U.S. polar-orbiting satellite's instruments transmit data to generate color-coded statistical maps of the aurora that help airline dispatchers visualize areas where these high-speed particles produce the aurora as they collide with the atmosphere.

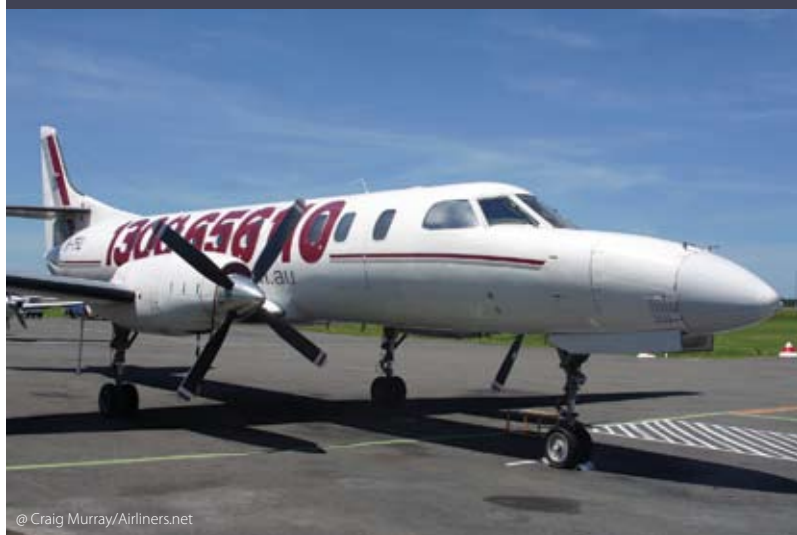
## Fairchild SA-227DC Metro 23

Designer Edward J. Swearingen's Merlin corporate/business aircraft first flew in 1965 with Pratt & Whitney Canada PT6A-20 engines. All subsequent versions of the Merlin and its longer-fuselage, 19-passenger regional airline derivative, the Metro, have had Garrett, now Honeywell, TPE331 engines.

The original SA-226TC Metro was introduced in 1969 and was replaced in 1974 by the Metro II, which has larger windows and improved systems. The SA-227AC Metro III, introduced in 1981, has longer wings, a higher useful load and more powerful engines. Maximum takeoff weight was increased from 14,500 lb (6,577 kg) to 16,500 lb (7,484 kg) with the introduction of the more powerful SA-227DC Metro 23 in 1990.

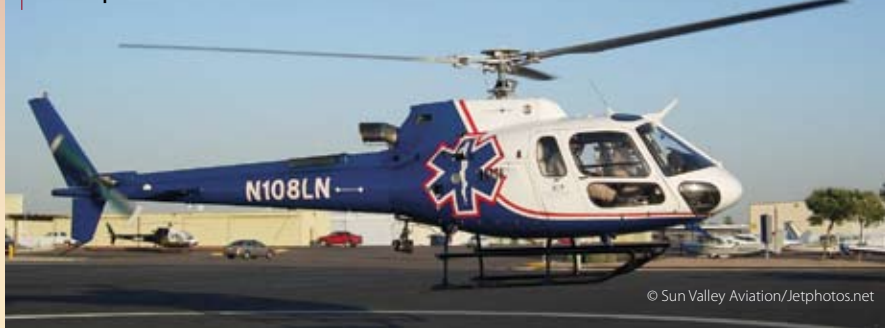
Eurocopter AS 350B3

G-loading for the phenomenon onset, the hydraulic system does not have enough pressure available to move the main left lateral, right lateral and fore/aft servos against the dynamic forces being fed back from the rotor system into the controls,” the report said. “At the onset of servo transparency, the flight controls essentially go from boosted to manual reversion, where they remain until the G-loads decrease below the onset threshold values.”

Eurocopter’s chief test pilot for the AS 350 program told the NTSB that when the phenomenon begins, the pilot typically feels the collective control moving down and the cyclic control moving right.

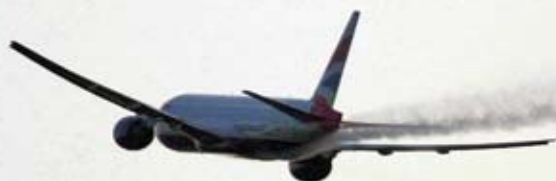
Leaking fuel trails the British Airways Boeing 777 after takeoff from London Heathrow Airport.

The failure by maintenance personnel to reattach a fuel tank purge door inside the left main landing gear bay of a British Airways Boeing 777-200 was a causal factor in an incident in which a vapor trail of fuel streamed from the center wing tank after takeoff, the U.K. Air Accidents Investigation Branch (AAIB) said.
