THERMAL

New guidance for extinguishing lithium-battery fires is on the way.

RUNAWAY

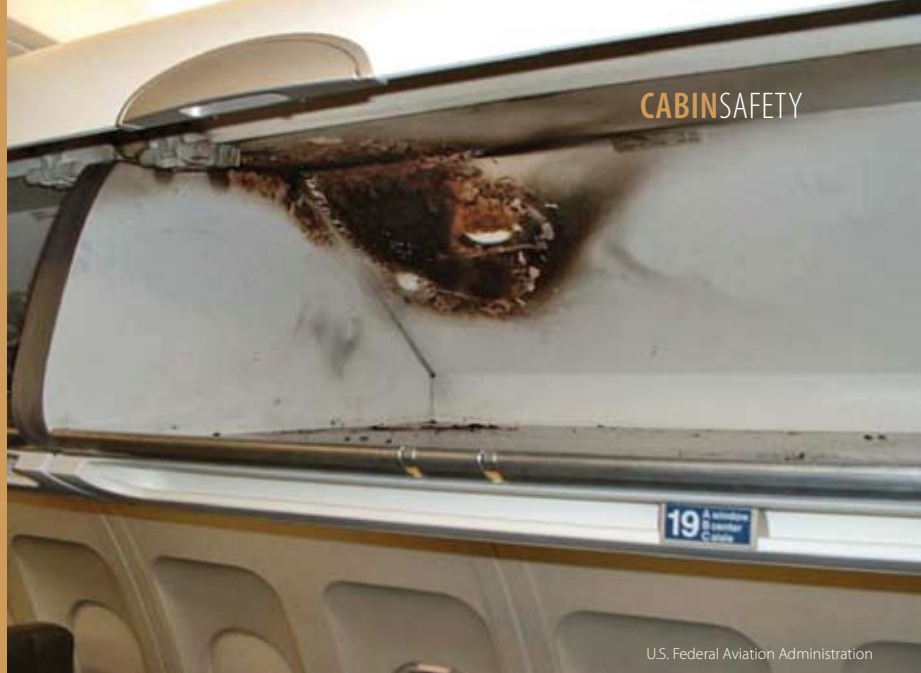
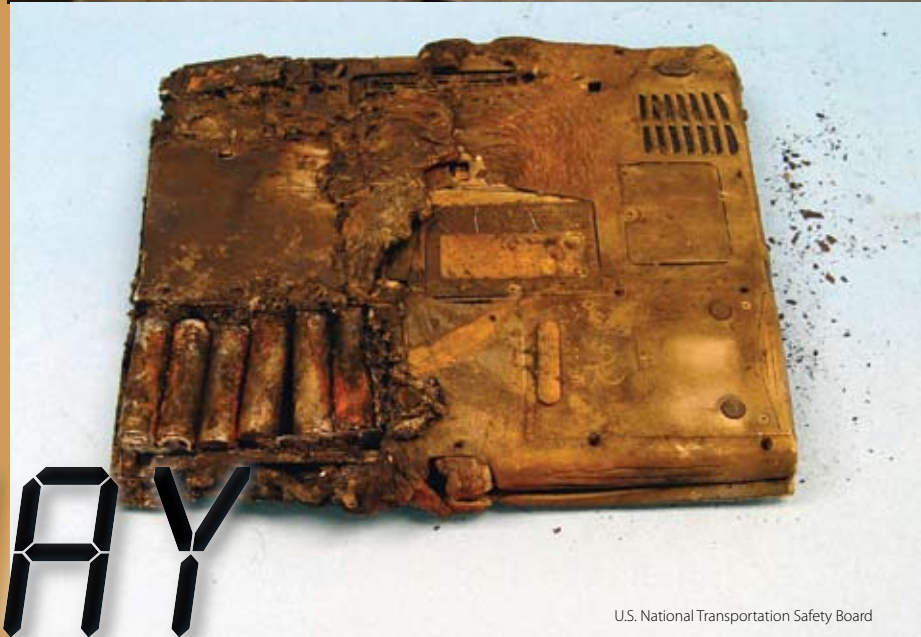
Left, overheated lithium-ion cell releases flaming electrolyte; six cells burned in a carry-on spare laptop battery. Above, a thermal runaway charred a JetBlue Airways overhead compartment; one of the laptops shipped on UPS Flight 1307.
