FROZEN FLIGHT INSTRUMENTS

Protection of pitot-static systems often is neglected.

BY BART J. CROTTY

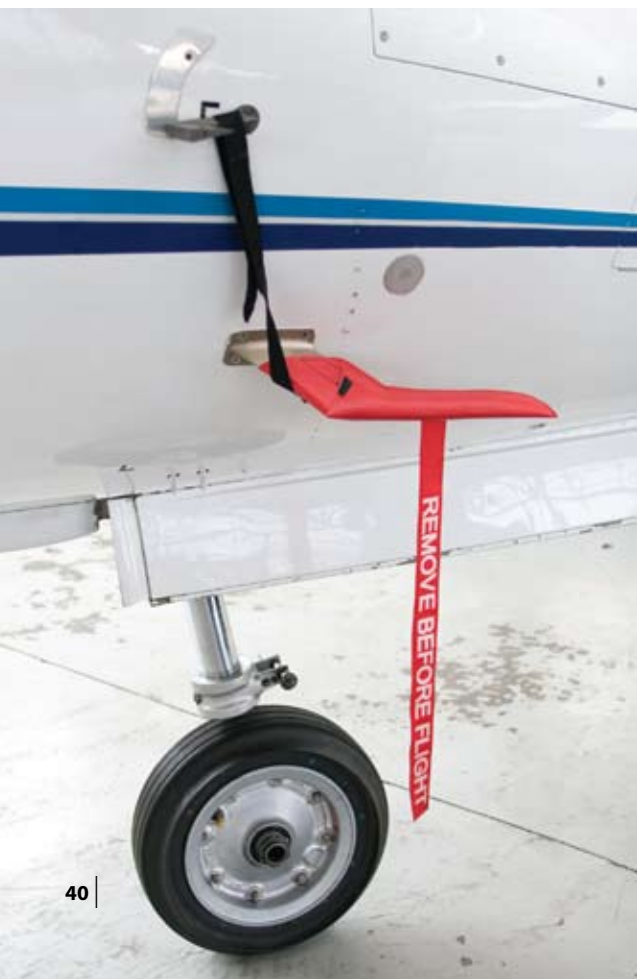
The pitot cover on this Learjet has a strap to secure the angle-of-attack vane; the circular static port, however, is not protected.
