# AeroSafety WORLD

THE JOURNAL OF FLIGHT SAFETY FOUNDATION

NOVEMBER 2008

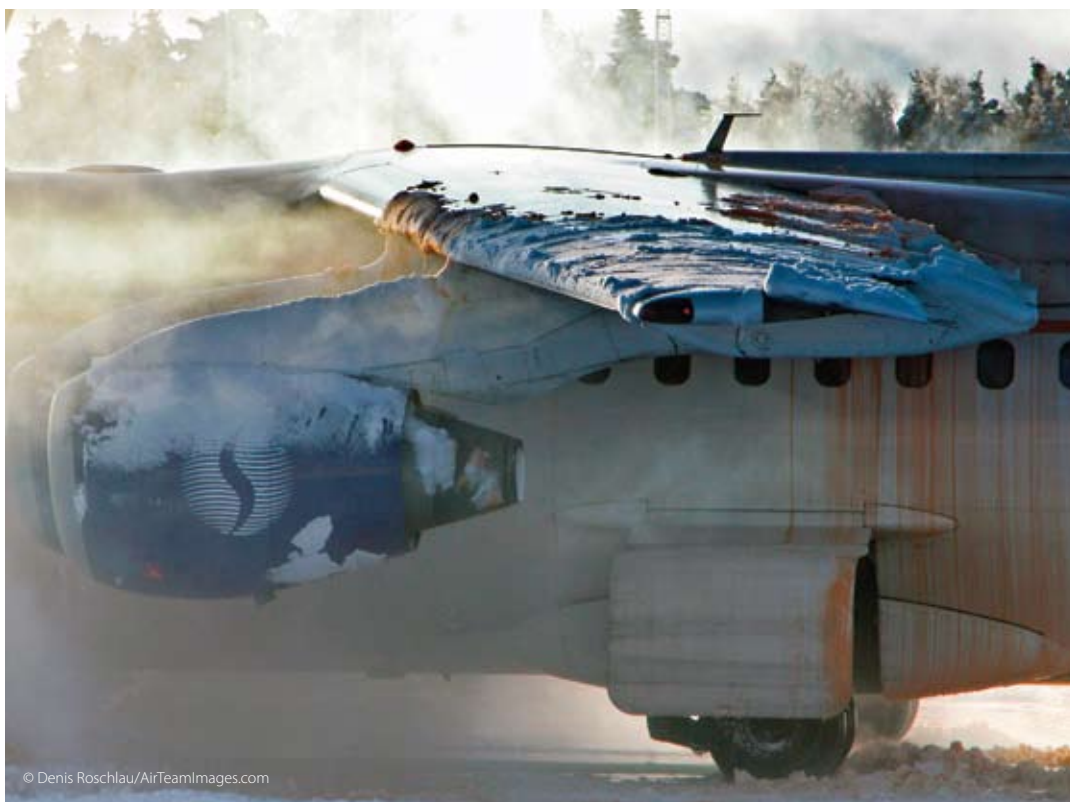
Aircraft type certificate holders urge service providers to spray anti-icing fluid from the front toward the rear to reduce fluid penetration into aerodynamically quiet areas.

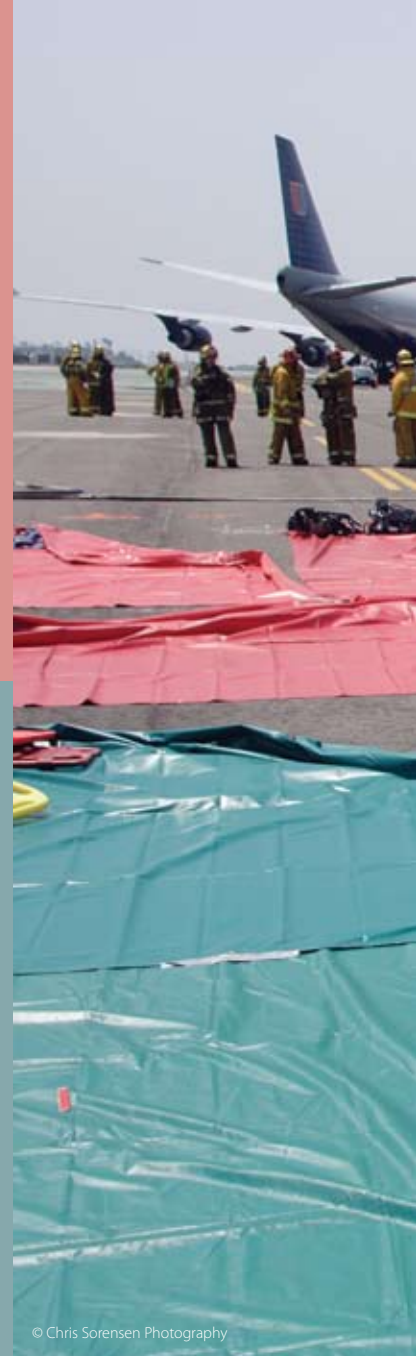
**Los Angeles  
Fire Department  
firefighters practice  
moving a survivor  
during LAX Air  
Exercise 2007, a full-  
scale simulated fatal  
crash of a Boeing 747  
designed to test Los  
Angeles International  
Airport's emergency  
response plan.**

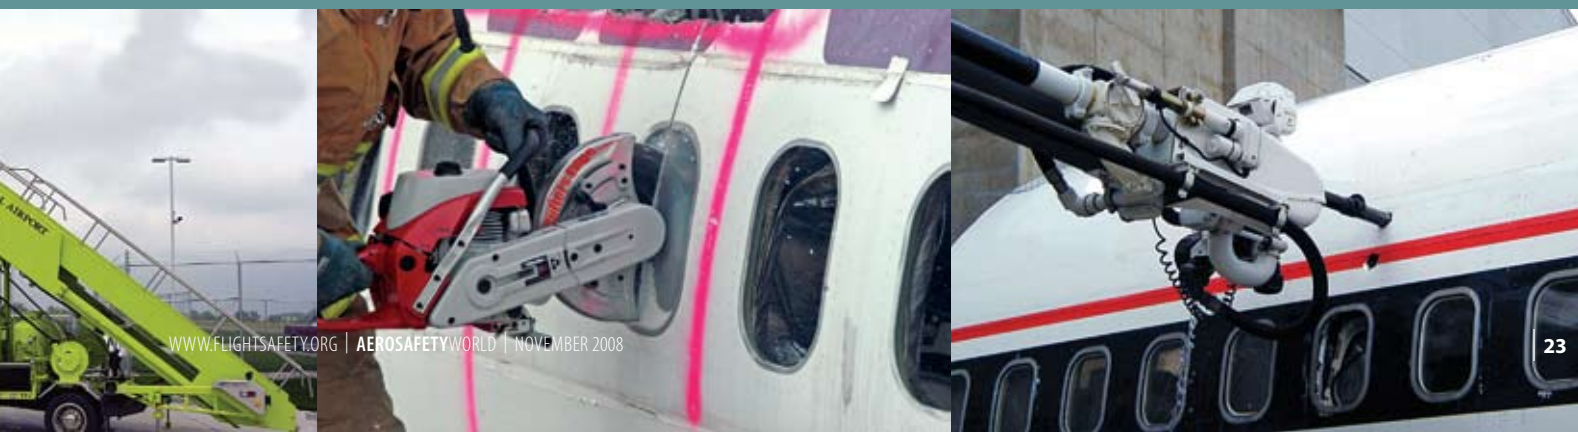
Technologies available include, from left, the hydraulically powered spreader, ax, airstair-based interior access vehicle, rescue saw and high-reach extendable turret with aluminum skin-piercing nozzle.
