# Aero Safety WORLD

THE JOURNAL OF FLIGHT SAFETY FOUNDATION

OCTOBER 2008

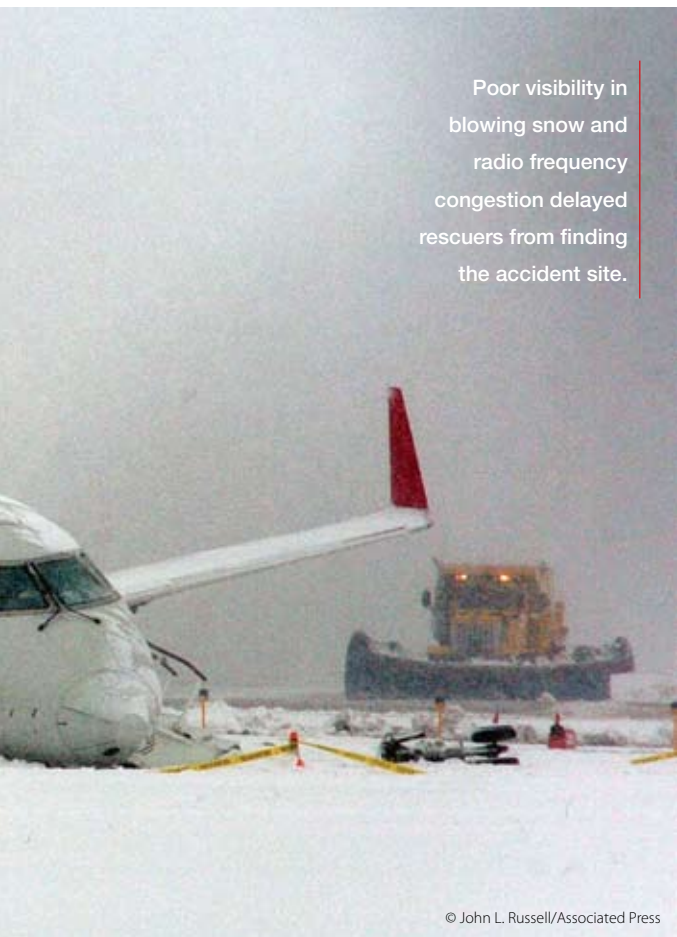
Snow was piling up rapidly on Runway 28, the threshold of which is at the top of the photo, and braking action was reported as nil.

Poor visibility in blowing snow and radio frequency congestion delayed rescuers from finding the accident site.

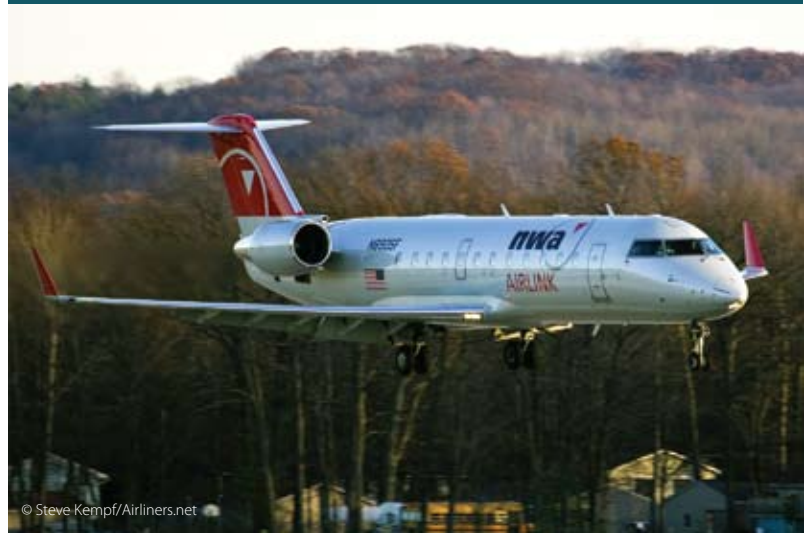
### Bombardier CRJ200LR

The first in Bombardier’s line of Canadair Regional Jets, the CRJ100 began service in 1992 and shares the engineering designation CL600-2B19 with the Challenger business jet, on which its design was based. Increases in maximum takeoff weights and fuel capacities resulted in the extended-range (ER) and long-range (LR) versions.

The CRJ200 versions were introduced in 2002 with the same airframe, accommodating 50 passenger seats, and with upgraded General Electric CF34-3B1 engines, flat-rated at 9,220 lb (41 kN) thrust.

The accident airplane, shown above, is a CRJ200LR. Maximum weights are 53,000 lb (24,041 kg) for takeoff and 47,000 lb (21,319 kg) for landing. Normal cruise speed is 0.74 Mach, and maximum range is 1,700 nm (3,148 km).

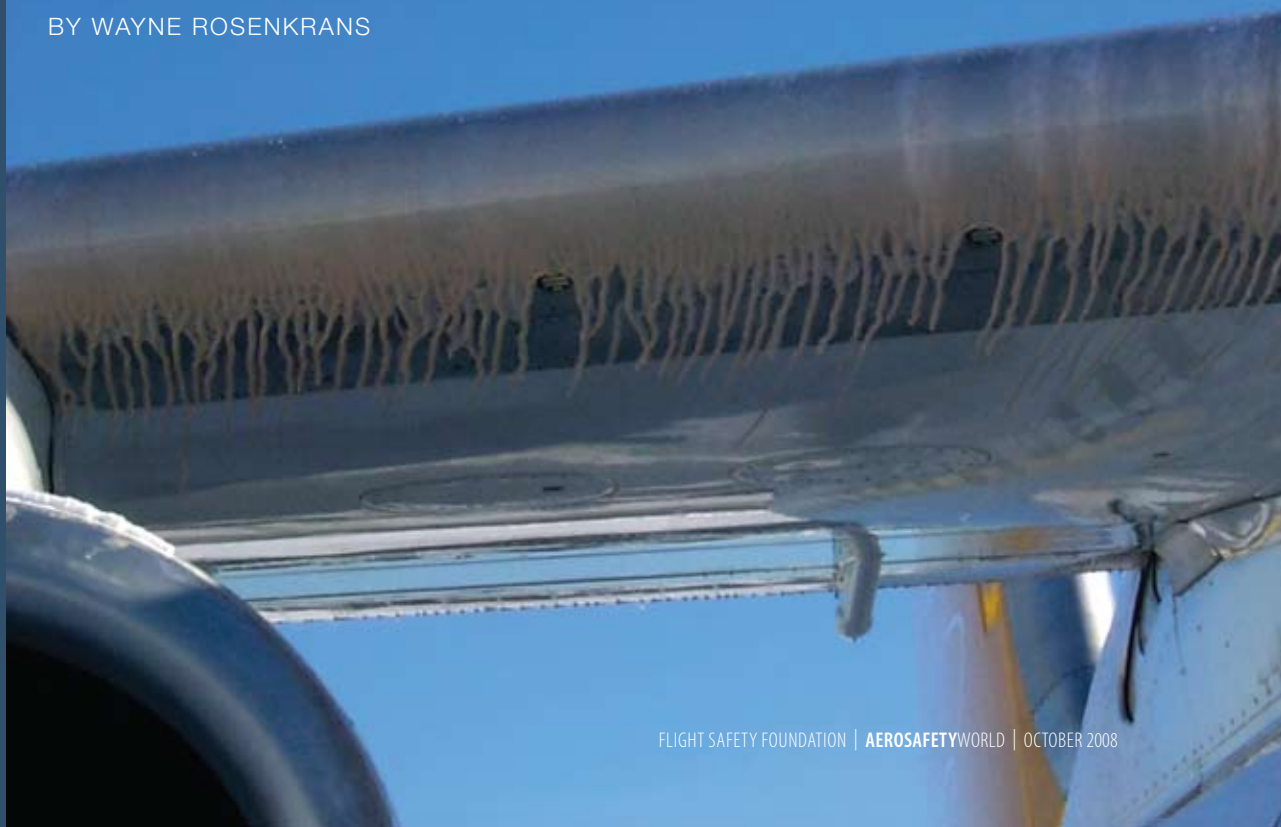
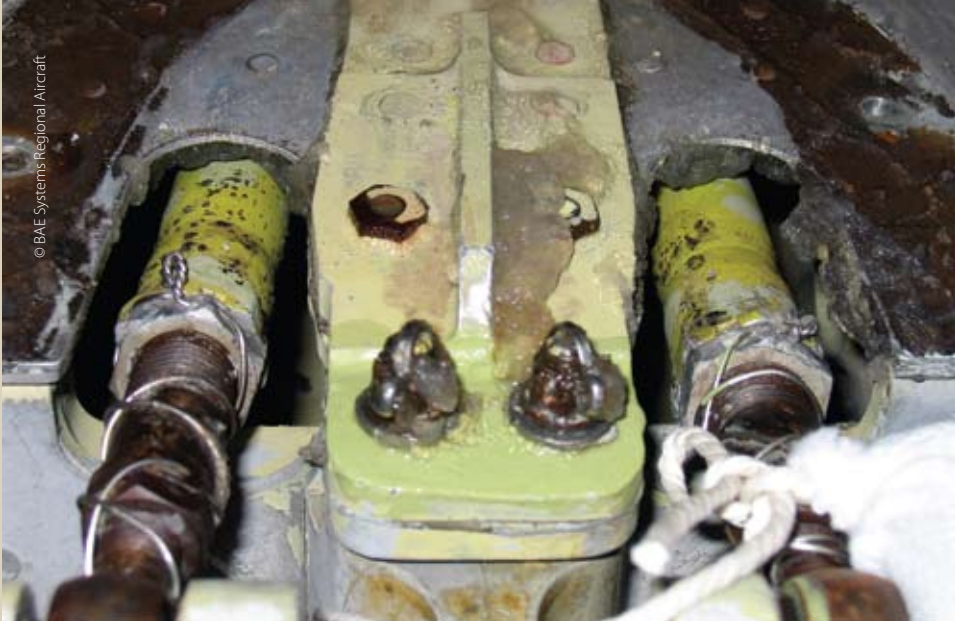
Paste-like gels form when anti-icing fluid residue absorbs water in aerodynamically quiet areas.

“Dried fluid residue could occur when surfaces have been treated but the aircraft has not subsequently been flown and not been subject to precipitation,” says EASA’s latest advisory information. “Repetitive application of thickened deicing/anti-icing fluids may lead to the subsequent formation/buildup of a dried residue in aerodynamically quiet areas, such as cavities and gaps. This residue may rehydrate [absorb water] if exposed to high humidity conditions, precipitation, washing, etc., and increase to many times its original size/volume [often described as a wallpaper paste-like gel].

“This residue will freeze if exposed to conditions at or below 0 degrees C [32 degrees F]. This may cause moving parts such as elevators, ailerons and flap actuating mechanisms to stiffen or jam in flight. Rehydrated residues may also form on exterior surfaces, which can reduce lift, and increase drag and stall speed. Rehydrated residues may also collect inside control surface structures and cause clogging of drain holes or imbalances to flight controls. Residues may also collect in hidden areas around flight control hinges, pulleys, and grommets, on cables and in gaps.”<sup>5</sup>

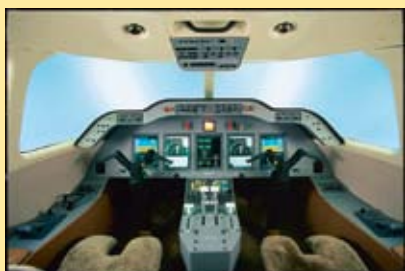
**Normal cockpit visibility**

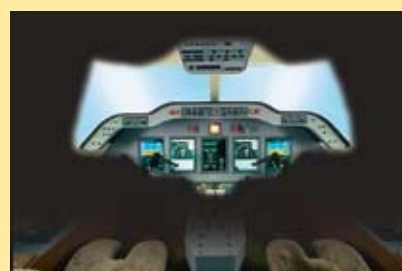
**Uncontrolled smoke in the cockpit  
-Visibility with EVAS**

The Emergency Vision Assurance System (EVAS) provides a clear space of air through which a pilot can see flight instruments and out the front windshield for landing. The pilot still relies on the oxygen mask for breathing, smoke goggles for eye protection and employs approved procedures for clearing smoke from the aircraft. When smoke evacuation procedures are not sufficient, EVAS provides emergency backup allowing the pilot to see and fly the aircraft to a safe landing.
