The Airbus safety magazine

#25

Safety first

Safety first, #25 January, 2018. Safety first is published by Airbus S.A.S. - 1, rond point Maurice Bellonte - 31707 Blagnac Cedex/France. Publisher and Editor: Yannick Malinge, Chief Product Safety Officer. Concept Design by Airbus Multi Media Support 20172357. Reference: X00D16031905 Issue 25. Photos by Airbus, A. Tchaikovski, S. Ramadier, P. Masclet, Lindner Fotografie, P. Pigeyre, JB. Accariez, A. Doumenjou. Computer renderings by Fixion.

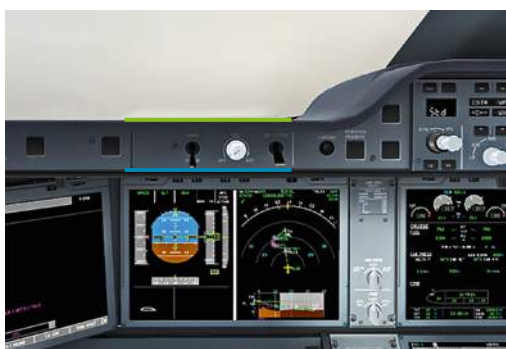
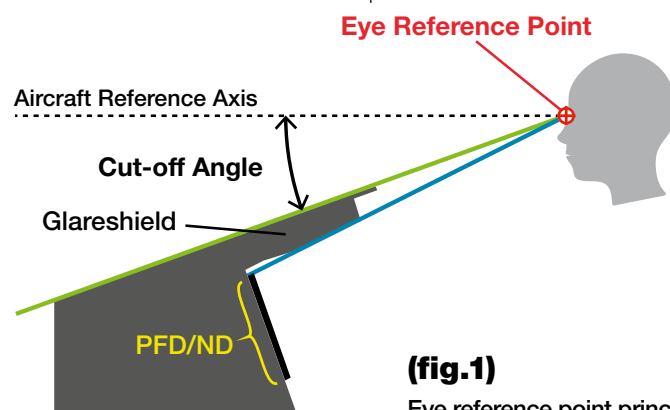
(fig.1)

The cockpit is designed so that when the pilot has aligned themselves to the eye reference point; all of the instruments and displays on the front panel are in their field of view **(fig.1)**.

Eye reference point principle

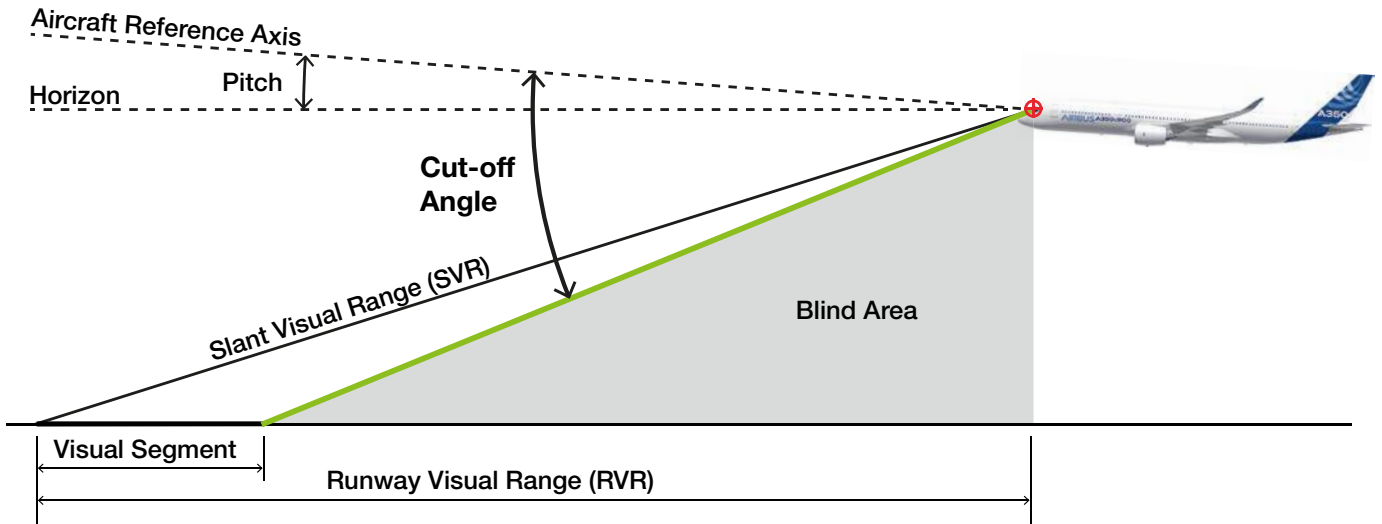
(fig.2)
Cut-off angle

A pilot needs to have good situational awareness during a flight. Alignment using the eye reference point enables the pilots to have an optimal field of view through the cockpit's windows to see what is around them outside the aircraft. The eye reference point position ensures the pilot can maintain the best cut-off angle that will provide the longest visual segment **(fig.2)**. This is especially important to get visual references during Low Visibility Operations (LVO).

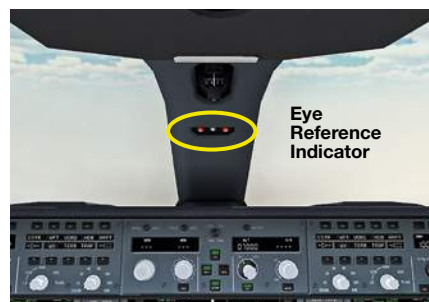
Since the A300 Airbus has provided an eye reference indicator on the centre structure of the windshield in all Airbus aircraft **(fig.3)**. It enables flight crew to adjust their seat position so that their eyes position matches the eye reference point. The indicator is a device that is fitted with 3 balls painted red or white. To achieve a correct seating position, pilots must align the red and white ball meaning that the white ball is hidden when in the correct position.

(fig.3)
Example of the eye reference indicator in the A350

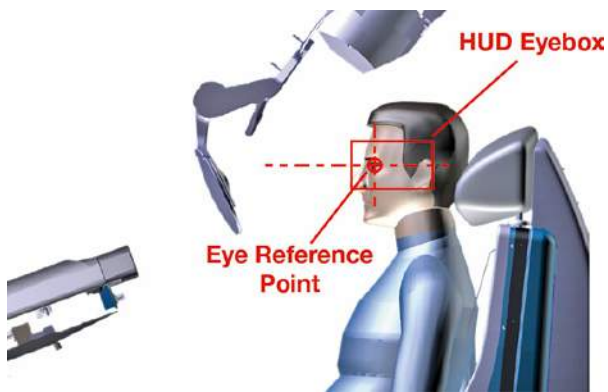
**(fig.4)**

HUD symbols are fully visible when the pilot's eyes are closest to the eye reference point. An "eye box" is defined as an area around the eye reference point that gives a position tolerance range **(fig.4)**. Hence the pilot correctly sees indications on the HUD when their eyes are positioned inside this virtual box. The HUD eye box area extends further aft than forward to allow HUD readability when seated in a more reclined position for comfort.

HUD eyebox principle

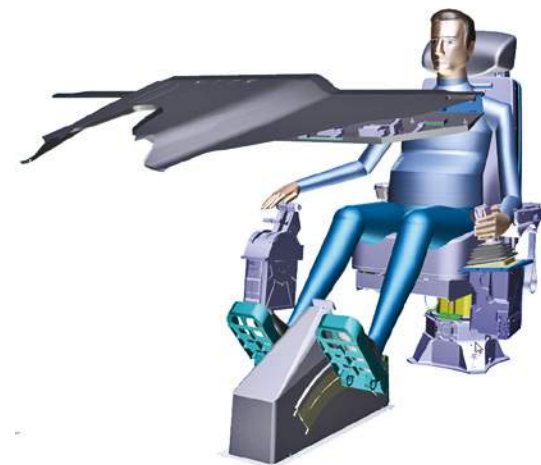
**(fig.5)**

A pilot properly seated with their seat harness fastened is able to reach and operate all of the aircraft's controls through their full range of motion or deflection as it is defined by the design certification requirements **(fig.5)**.

3D model to visualize the access to flight controls

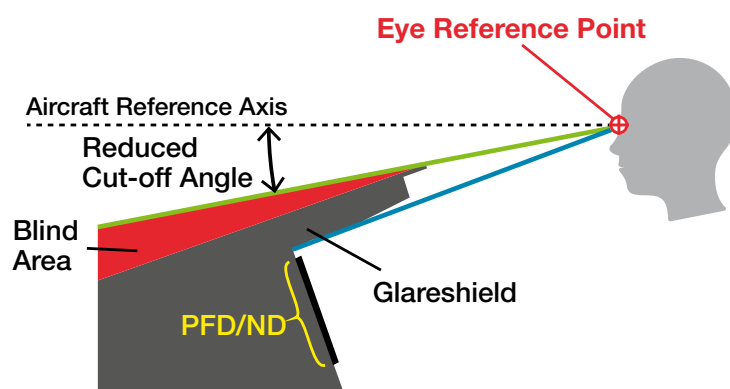
**(fig.6)**

In flight, if pilots position themselves too low, during final approach their perception of the flight path angle may be inaccurate.

Impact of a too low seating position

Being seated too low can also create a blind area due to the glareshield, reducing the cut-off angle and thus limiting the visual segment **(fig.6 and 7)**. Such reduced visual segment during approaches with poor visibility conditions, including Low Visibility Operations (LVO), impairs the ability of the flight crew to obtain the proper visual references for landing, increasing the likelihood of a go-around.

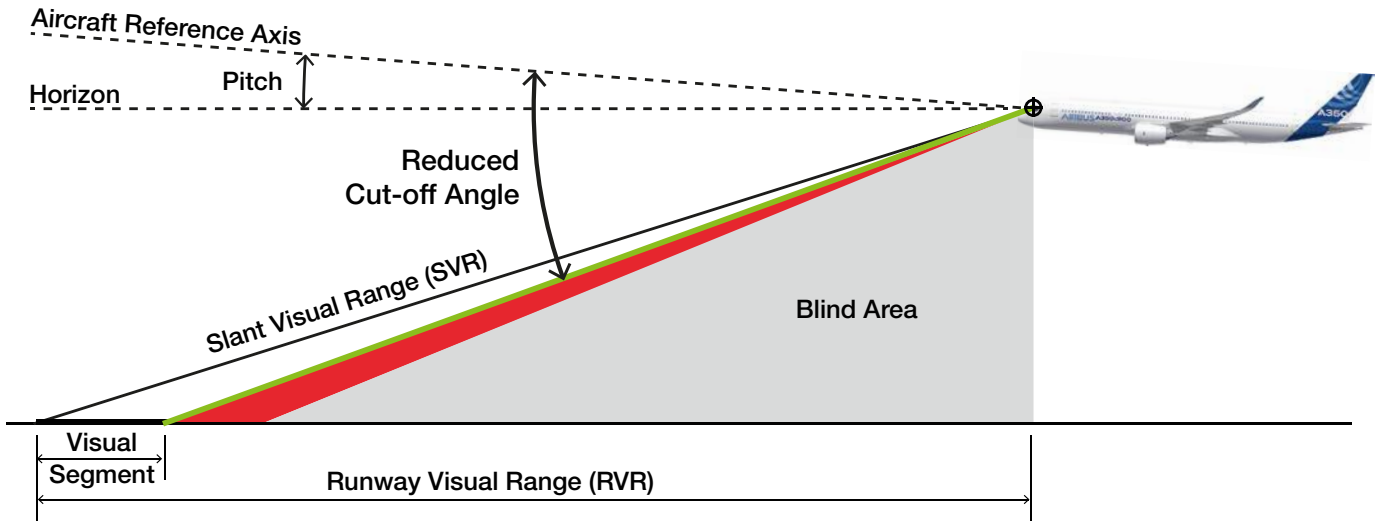
(fig.7)

Cut-off angle when seated too low

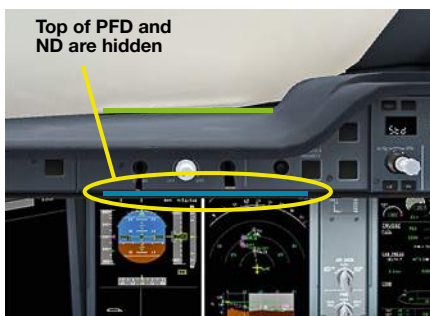
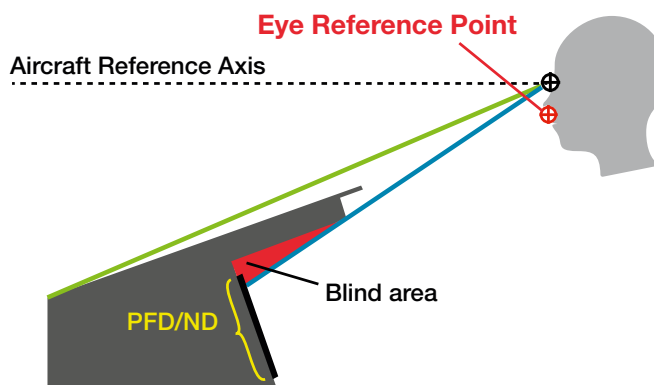
(fig.8)

If the pilots' eye level is above the eye reference point, then the glareshield impairs their view of the instrument panel and in some cases, hides the upper PFD and ND from view **(fig.8)**.

Impaired view on the instrument panel when seated too high

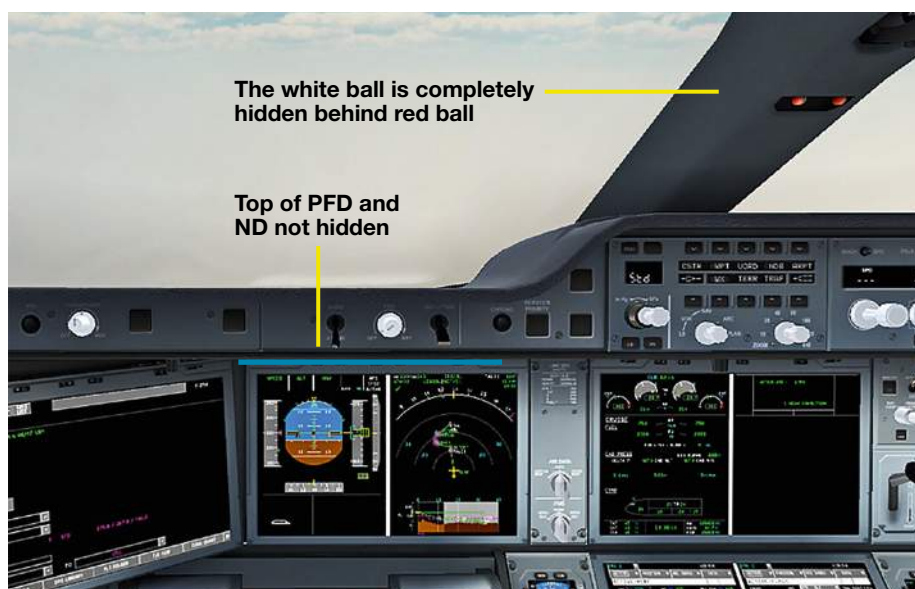
(fig.9)

Step 1: Adjust the seat longitudinal and vertical position to align your eye-level with the eye reference indicator and also check that the glareshield does not obstruct the view the upper PFD and ND (**fig.9**).

Correct seat adjustment

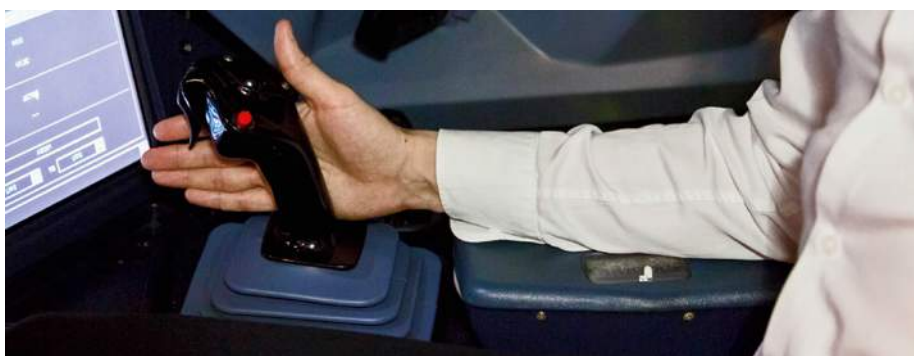
(fig.10)

Step 2: Adjust the armrest to a position where your hand can grip the sidestick naturally without stretching the forearm and with a straight wrist. If the armrest is correctly adjusted, your forearm should rest comfortably on the armrest and you will only need to move your hand and fingers to give the appropriate inputs to the sidestick (**fig.10**).

Correct armrest adjustment

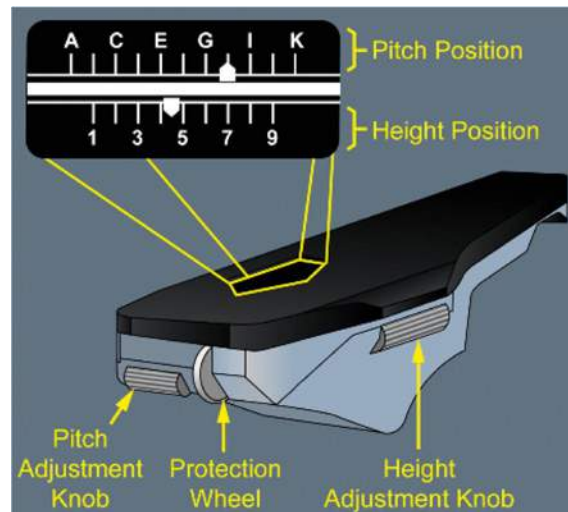
(fig.11)

Tip: Take a note of the positions of both the armrest and pedals on their associated position indicators when your adjustment settings are correct and comfortable to save time when making seat adjustments for your next flights **(fig. 11)**.

Armrest position indicator

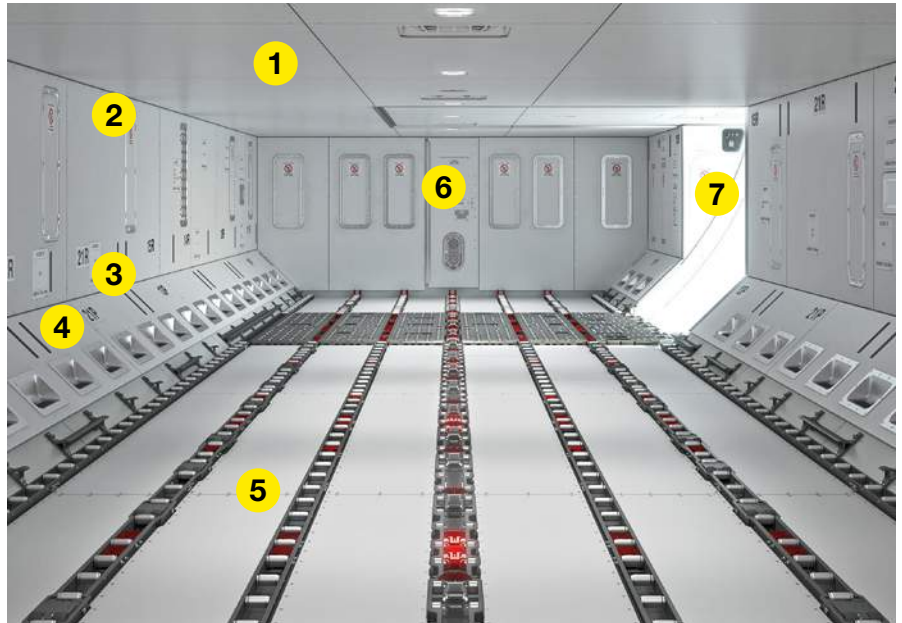
- 1 Ceiling panels
- 2 Decompression panels
- 3 Vertical sidewall panels
- 4 Sloping sidewall panels
- 5 Floor panels
- 6 Partition
- 7 Door

Lower deck cargo holds are constructed out of their doors, and many composite panels attached to the aircraft's primary and secondary structure. Various categories of panels are used, including ceiling, sidewall, sloped and floor panels, as illustrated in Figure 1. Even if we just consider the sidewalls and ceilings, a shipset of these different panels for a specific hold can include anything from 42 on an A320 up to 188 on the A380.

The Maintenance Planning Document (MPD) of all Airbus aircraft specifies a regular visual inspection of each cargo hold. The maintenance procedures associated with the MPD tasks specify a general visual inspection of the entire compartment, including all types of panels identified in figure 1, to identify any damage or deformation, or any panels which are in the wrong position.

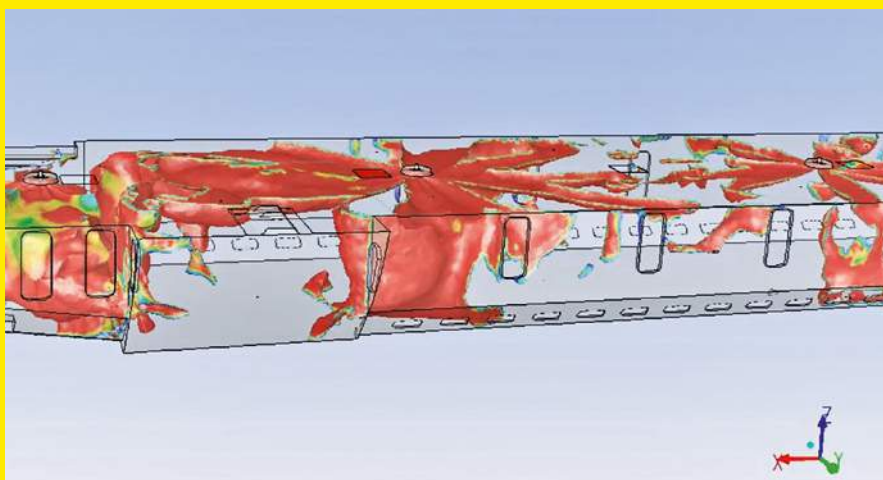
For the certification of the A350-1000, Airbus has taken advantage of the successful flight test campaign performed for the A350-900 and developed a Computational Fluid Dynamic (CFD) model of the cargo hold together with its Halon release system. Both EASA and the FAA have accepted this model as an acceptable means of compliance. This significant advancement will enable Airbus to perform more complex analyses in the support of Safety objectives.

CFD simulation of halon discharge into the aft cargo hold of the A350-1000

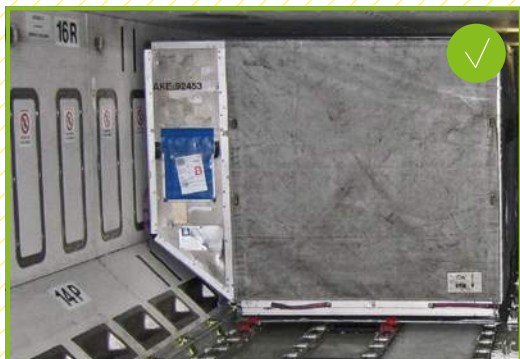
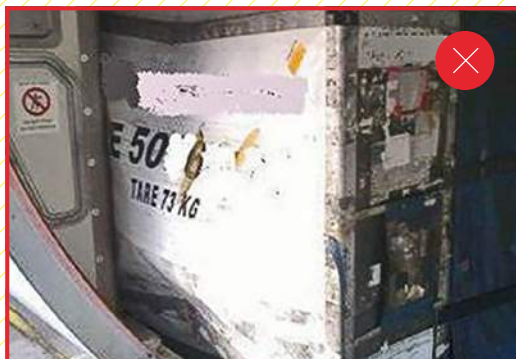
Don't load out of contour ULDs (containers or pallets)

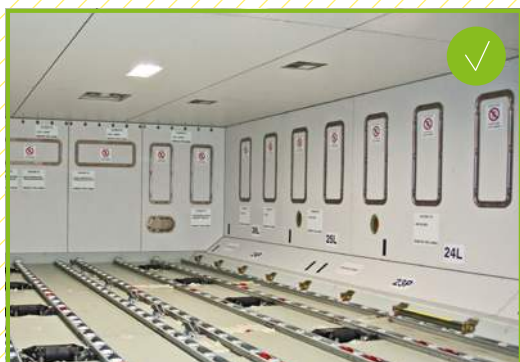
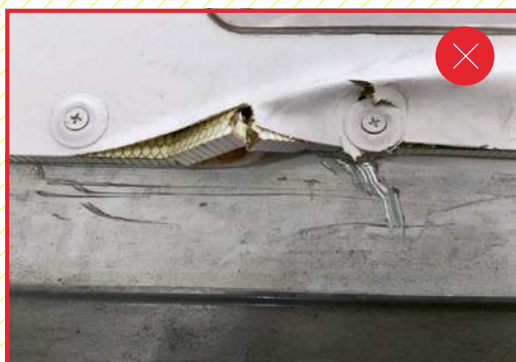
Report any damage to the lining

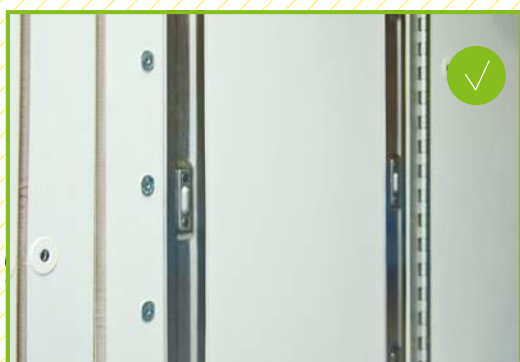
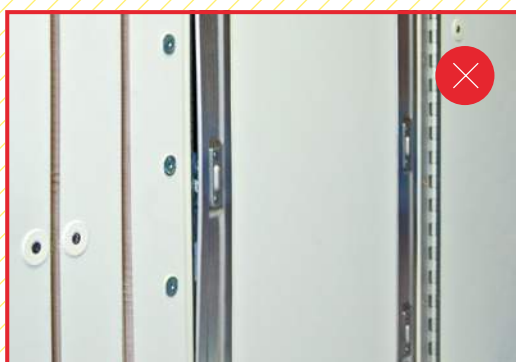
Check decompression panels and catches are in the correct position

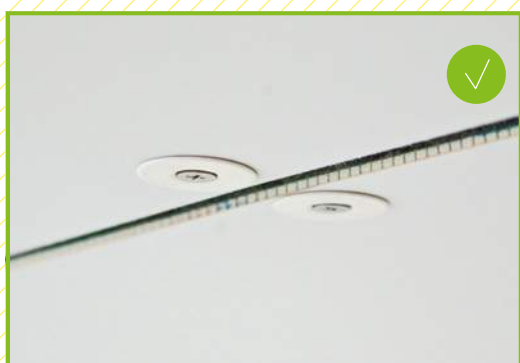
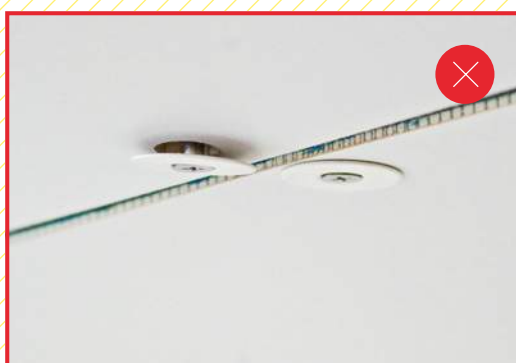
Ensure fasteners are present, tightened, and flat on the panel

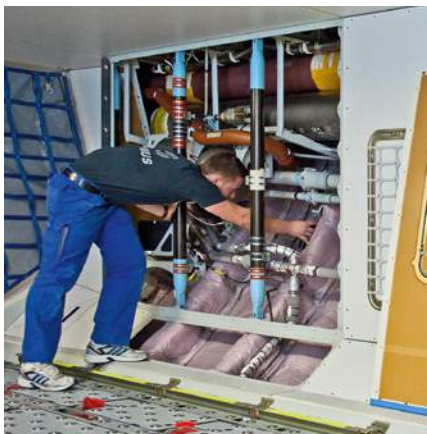
Correct

Access by removal of sidewall panel assembly to perform maintenance

Decompression panels are clearly identified with placards mentioning 'DO NOT PUSH' and 'DO NOT REMOVE'. In case any panel is found partially or totally dislodged, it must be reinstalled as per AMM procedures in order to avoid additional damage. These require removal of the sidewall panel upper assembly for proper completion.

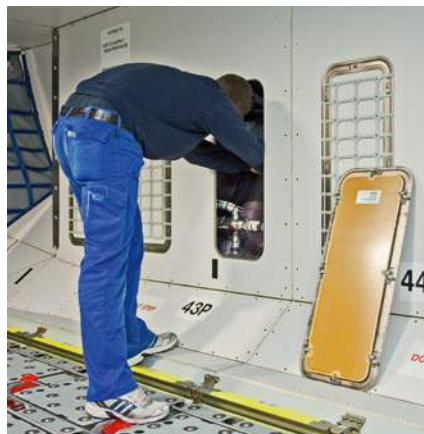
Incorrect

Access by removal decompression panel to perform maintenance
