NTSB National Transportation Safety Board

John DeLisi, Director Office of Aviation Safety

63rd Annual Business Aviation Safety Summit
May 10 -11, 2018

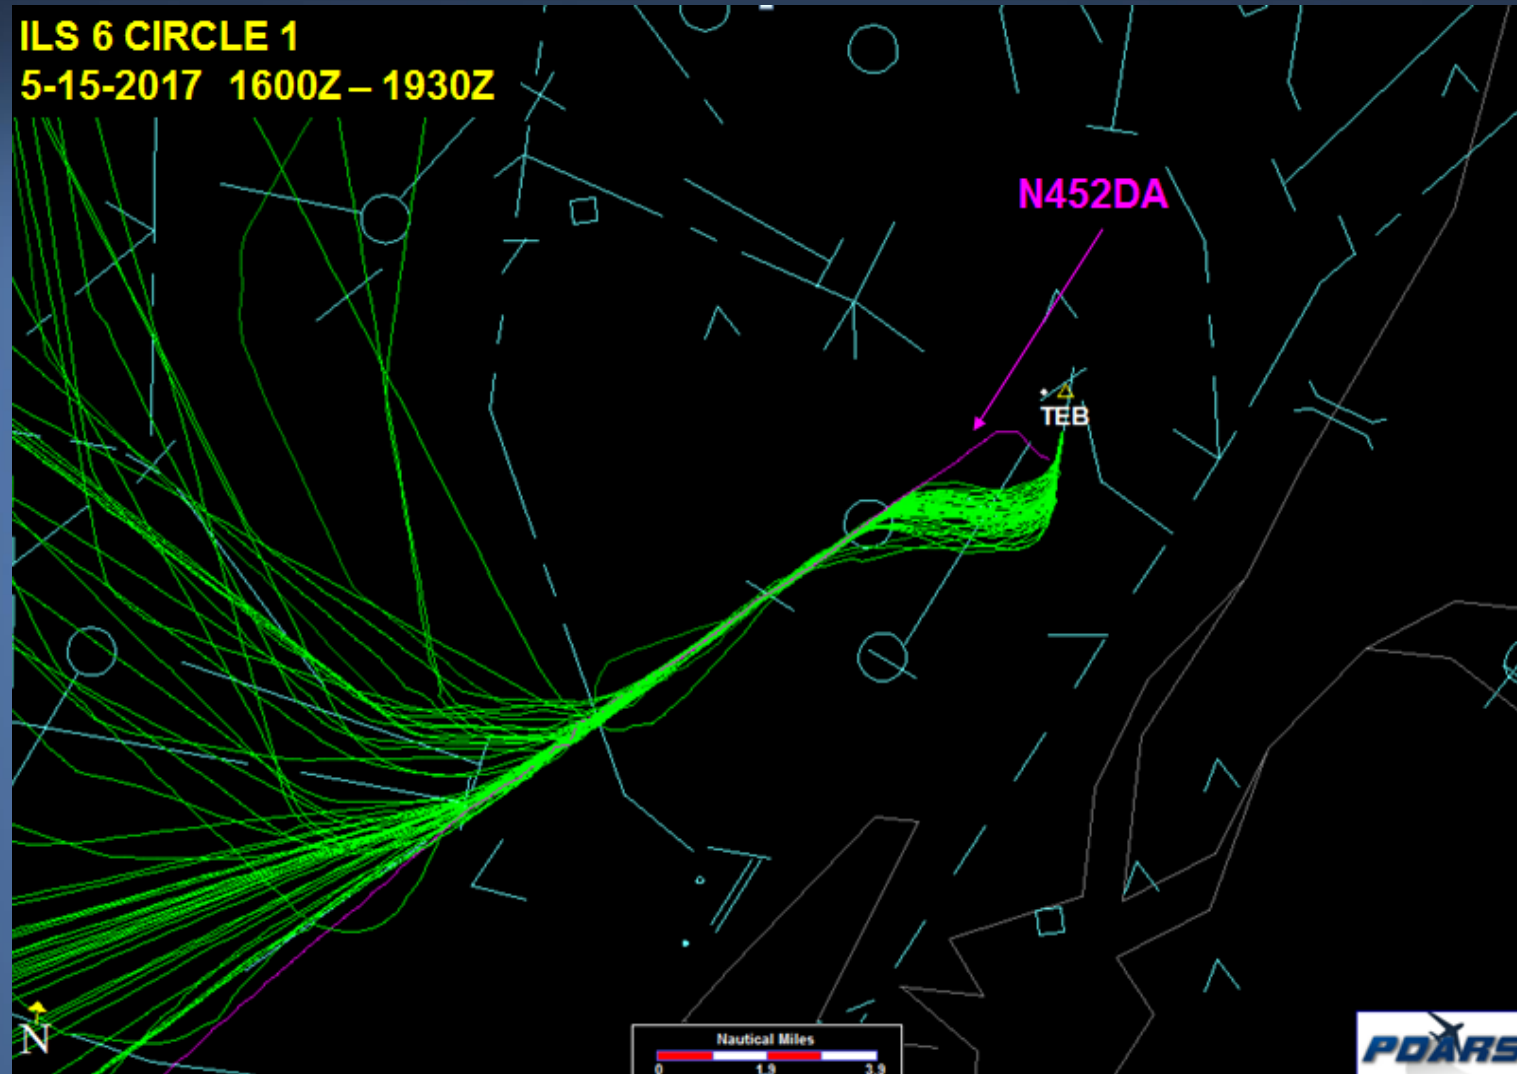
Airplane Track

- Third flight of the day
- Departed PHL for short repositioning flight
- SIC – 0 was the Pilot Flying
- Captain filed for 27,000 ft (?)
- Flight was cleared to 4,000 ft
- Flew the ILS Rwy 6 Circle to Runway 1

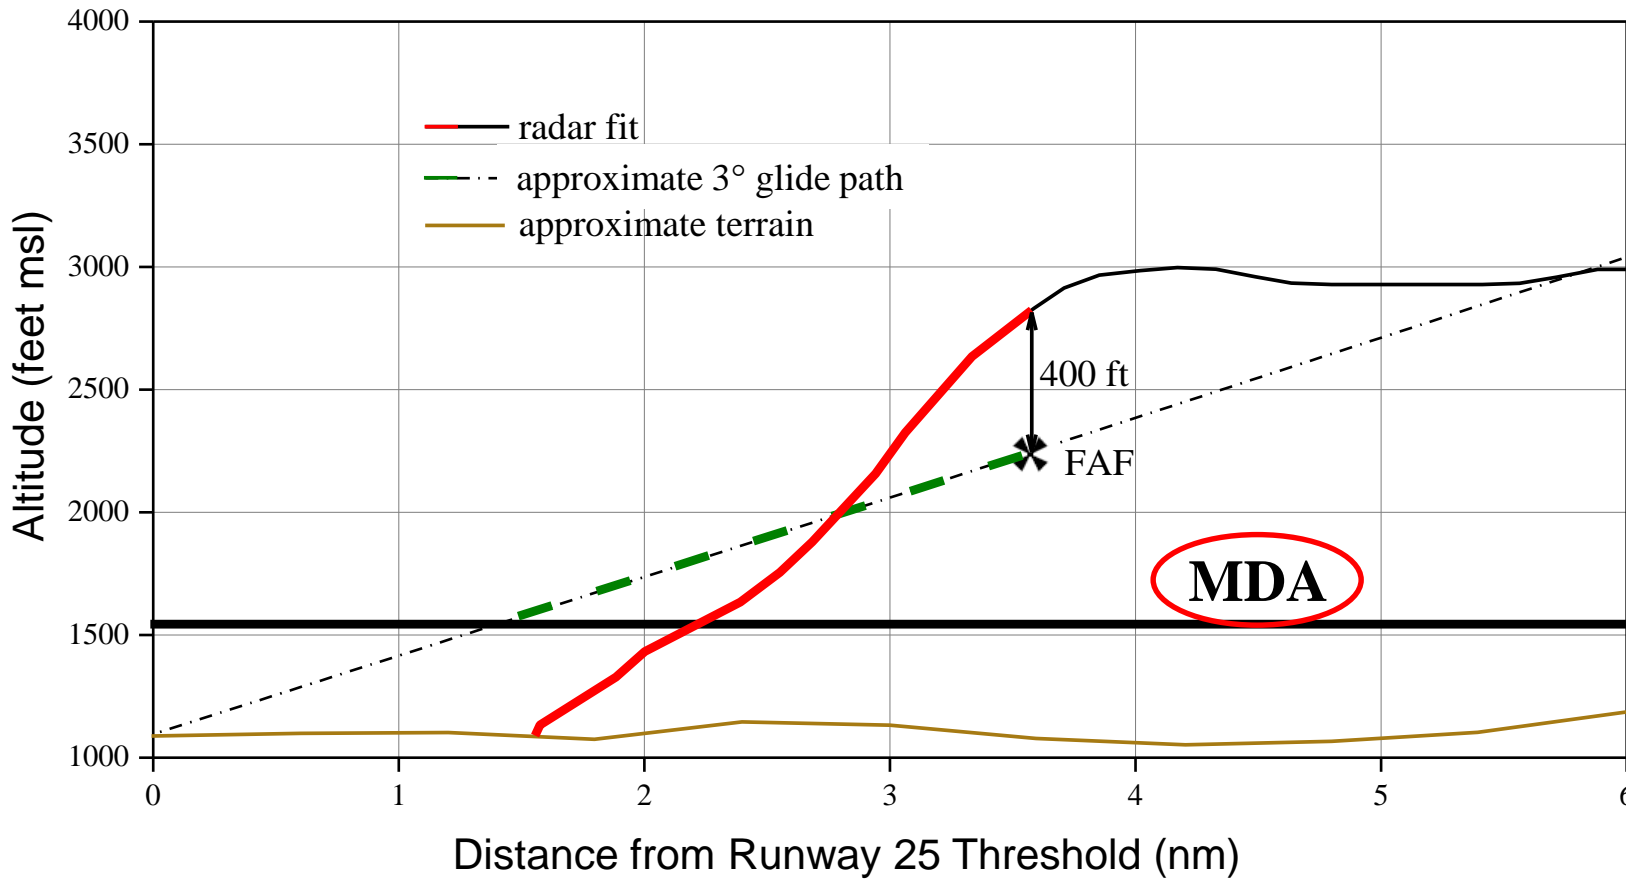
Profile View of Approach

- Approach briefing incomplete, and approach checklist not performed
- Flaps improperly configured to 45°
- Landing checklist never completed
- Captain did not call out “minimums”
- Speed dropped below approach speed without go-around
