How Airbus emptied a packed A380 12 seconds faster than necessary.

BY WAYNE ROSENKRANS

'Over in a Flash'

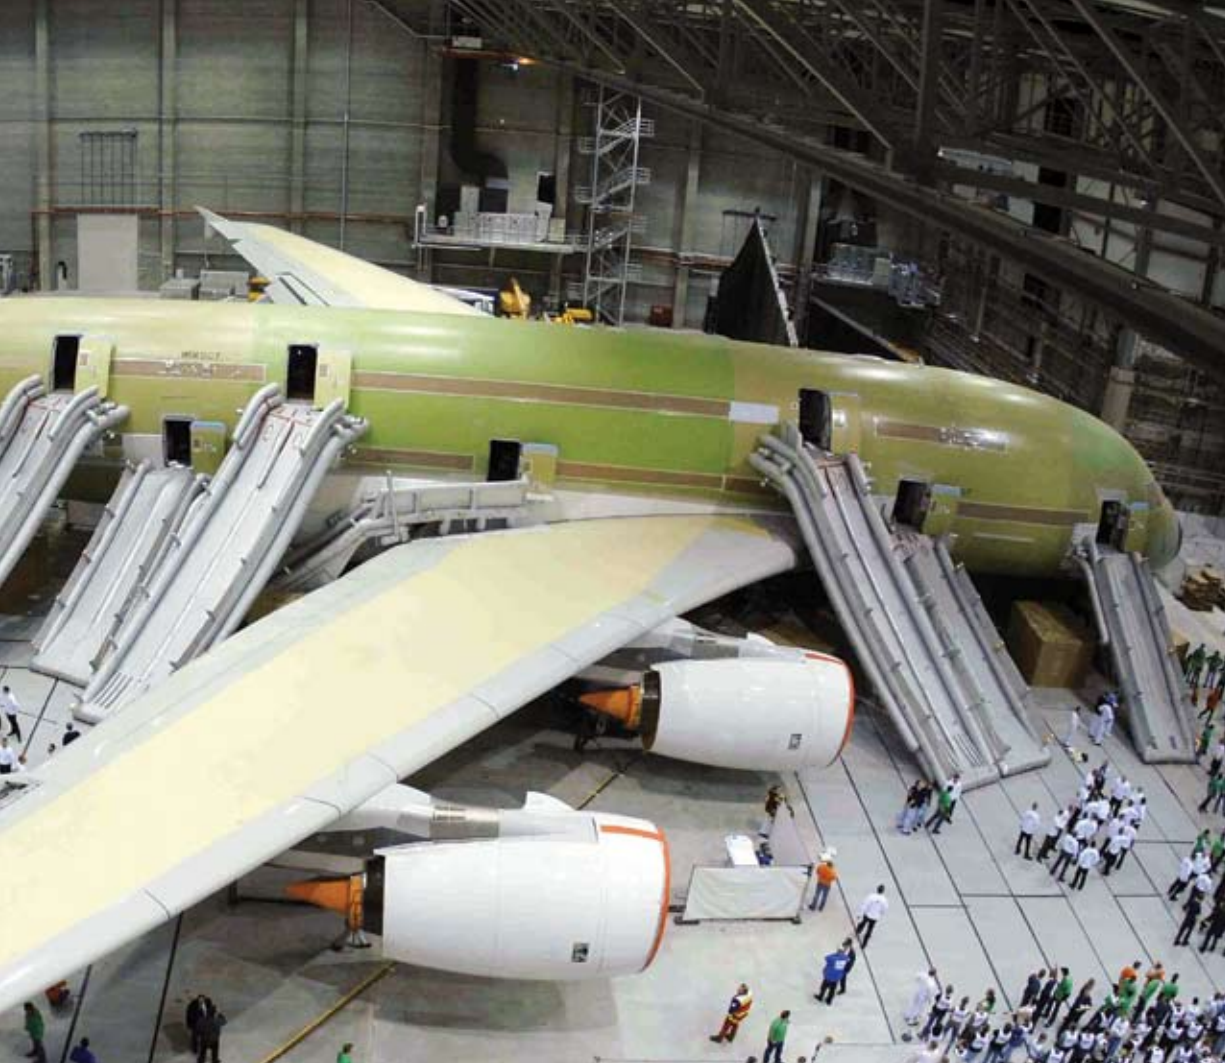
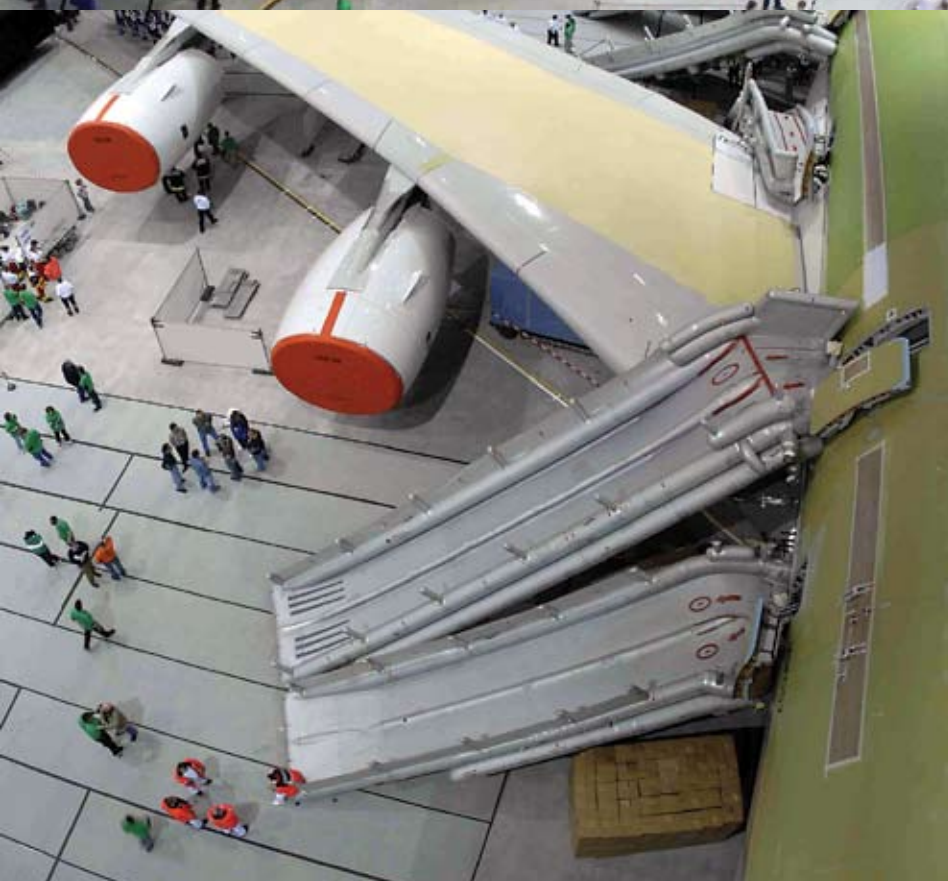
After the demonstration, hangar lighting reveals evacuation system equipment — including predeployed upper deck slides — that had been visually concealed beforehand from volunteer passengers and crewmembers.

Because the upper deck door sills are 7.87 m (25.80 ft) above the ground, the corresponding slide/ramps provide integral blinder walls and a curved ramp to mitigate passenger fear of heights. Each of these slides is 14.7 m (48.25 ft) long. They are designed so that the maximum velocity of a person arriving at the ground is no faster than that for a person descending from a current single-deck aircraft.
