Flight Safety

D I G E S T

OCTOBER 2005

Analysis of CREW CONVERSATIONS

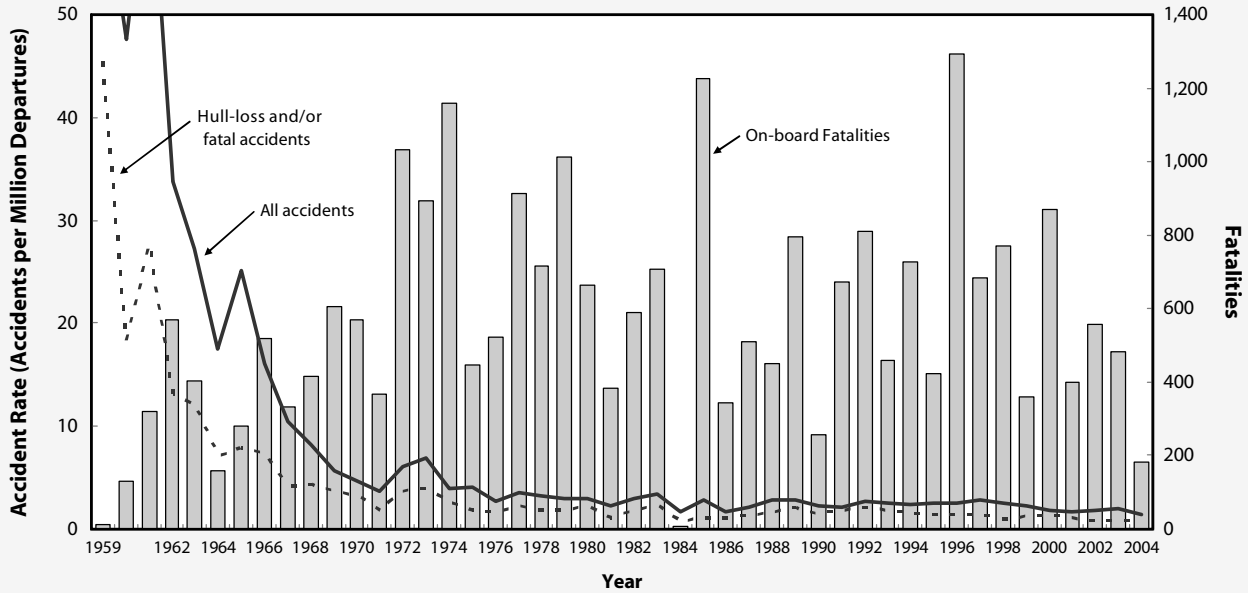
Figure 1
Accident Rates and Fatalities by Year, Worldwide Commercial Jet Fleet, 1956 Through 2004

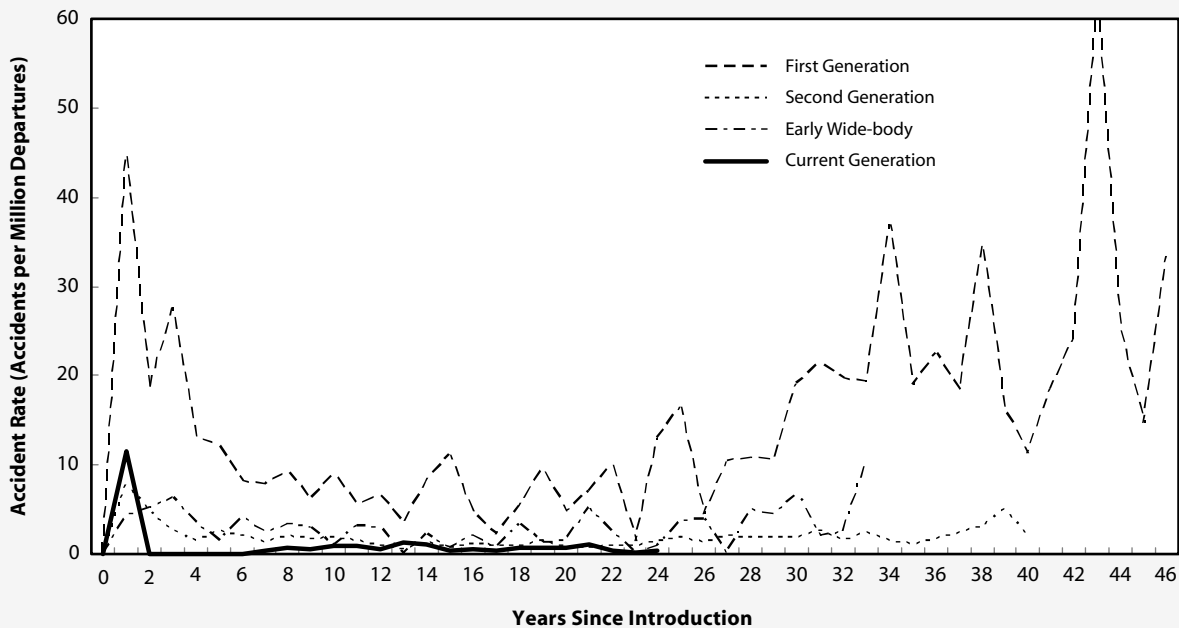
Figure 2
Accident Rates by Years Following Introduction, Hull-loss and/or Fatal Accidents, Worldwide Commercial Jet Fleet, 1959 Through 2004

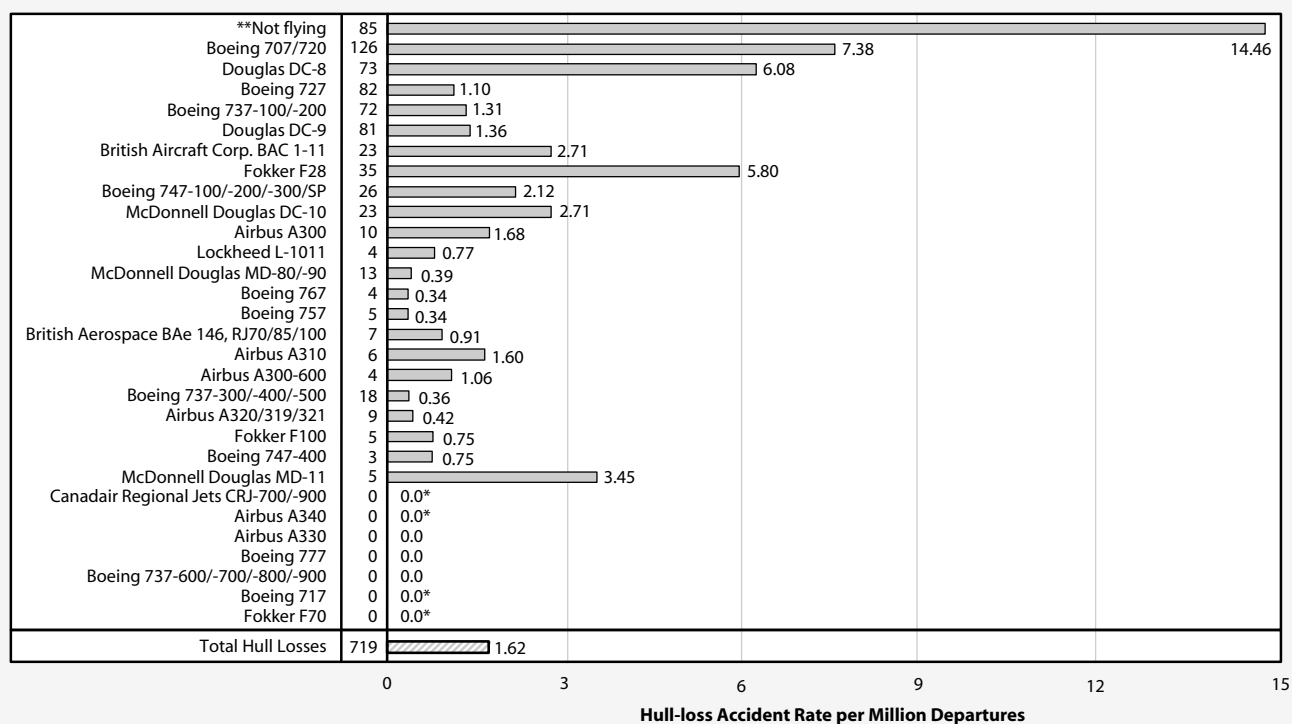
Figure 3
Accident Rates by Airplane Type, Hull-loss and/or Fatal Accidents, Worldwide Commercial Jet Fleet, 1959 Through 2004

* These types have accumulated fewer than one million departures.

** The Comet, CV-880/-990, Caravelle, Concorde, Mercure, Trident and VG-10 are no longer in commercial service, and are combined in the "Not flying" bar.

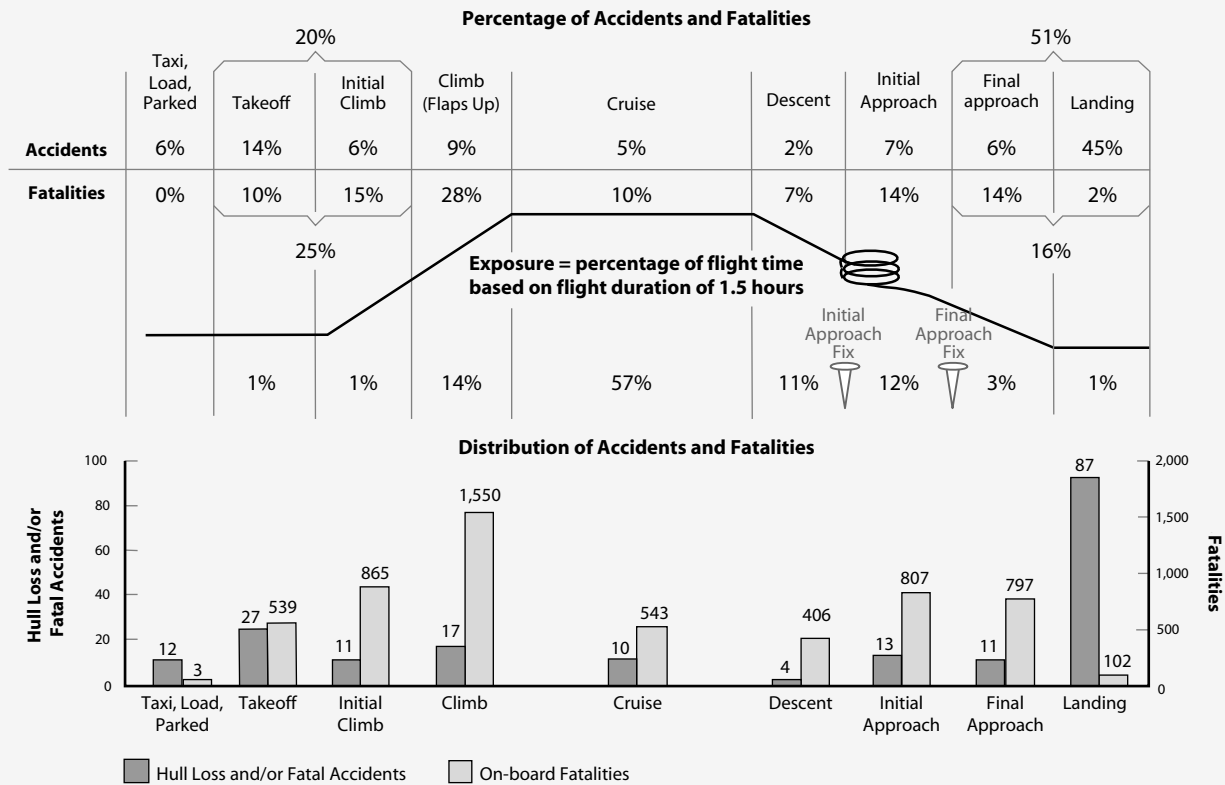
Figure 4
Accidents and On-board Fatalities by Phase of Flight, Hull-loss and/or Fatal Accidents,
Worldwide Commercial Jet Fleet, 1995 Through 2004

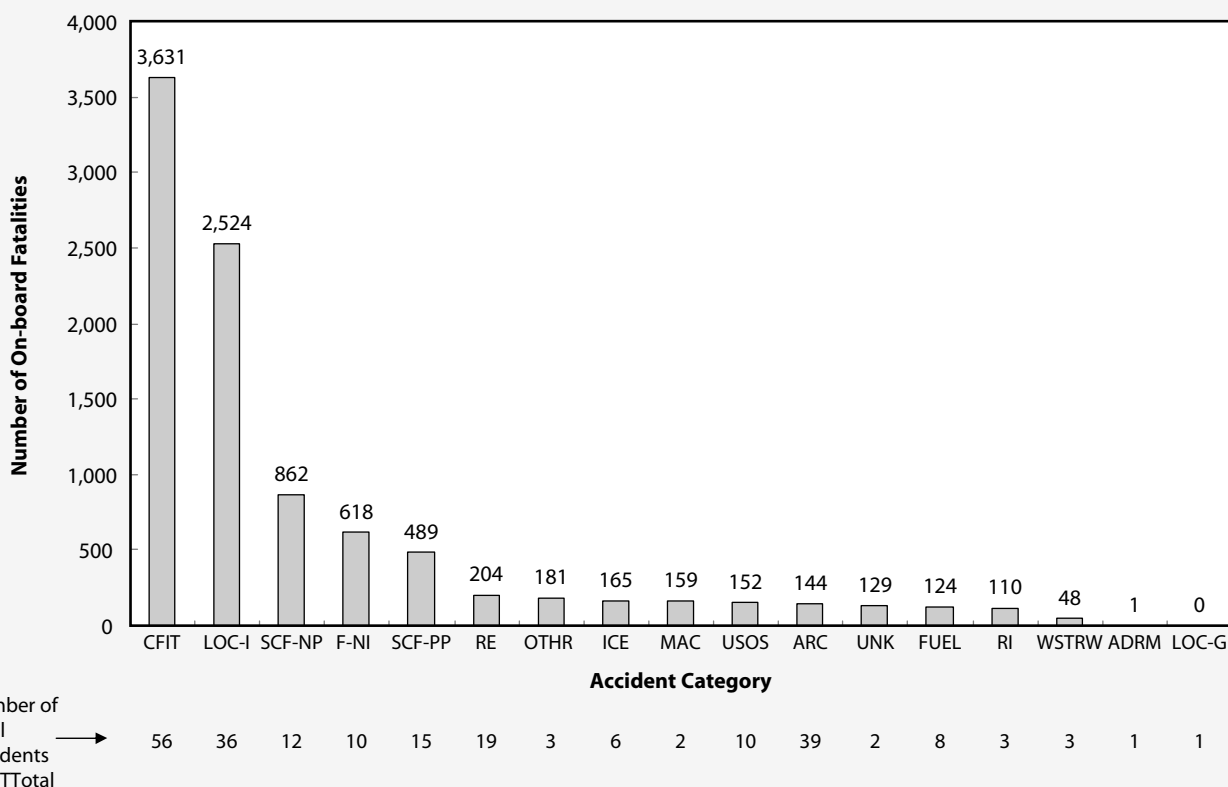
Figure 5
Fatalities by CAST/ICAO Taxonomy Accident Category, Fatal Accidents, Worldwide Commercial Jet Fleet, 1959 Through 2004

Note: CAST/ICAO accident categories are as follows: ARC = abnormal runway contact; ADRM = aerodrome; CFIT = controlled flight into terrain or toward terrain; F-NI = fire/smoke (non-impact); FUEL = fuel-related; ICE = icing; LOC-G = loss of control — ground; LOC-I = loss of control — in flight; MAC = midair/near-midair collision; OTHR = other; RE = runway excursion; RI = runway incursion; SCF-NP = system/component failure or malfunction (non-powerplant); SCF-PP = system/component failure or malfunction (powerplant); USOS = undershoot/overshoot; UNK = unknown or undetermined; WSTRW = wind shear or thunderstorm.
